FOCUSED SOIL GAS AND SUB-SLAB VAPOR INVESTIGATION

OHSU Richard Jones Hall

3222 SW Research Drive
PORTLAND, OR 97239
(ECSI ID 6594)

EVREN NORTHWEST, INC.
Project No. 129-13004-03

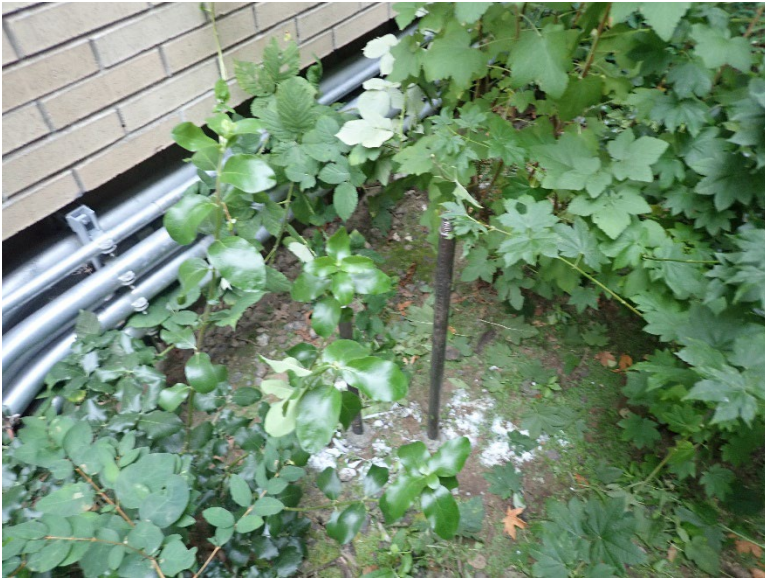
At each soil gas sample location, temporary soil gas probes were installed to collect samples at both 5- and 10-foot depth intervals.

Soil Gas Probe Installation. Soil gas probes SG01 and SG02 were advanced using an electric percussive hammer (jack hammer) or manual slide hammer to target depths of 5- and 10-feet bgs, as per ODEQ guidance. Upon reaching target depth, soil gas tooling was retracted four (4) inches to allow the expendable drive tip to be pushed out, and a section of dedicated ¼-inch Teflon® sample tubing was

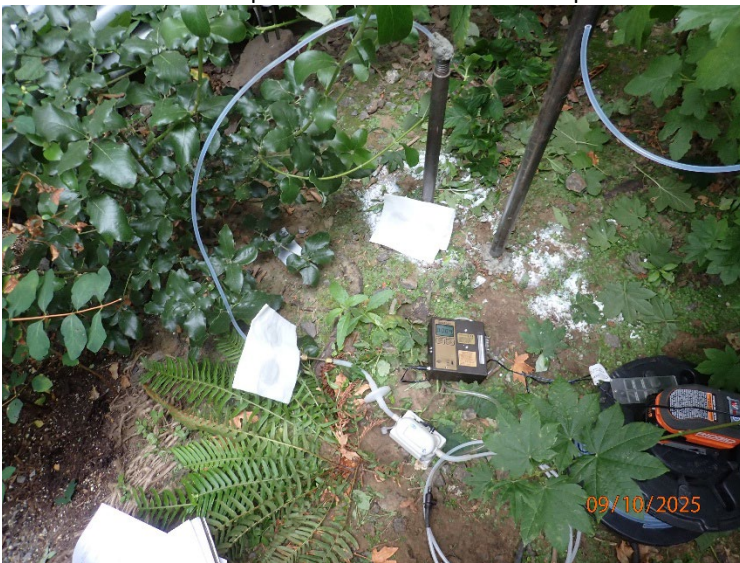
View of soil gas sample collection using EPA Method TO-17. Rags saturated with isopropyl alcohol were placed over sample train connections for leak detection.

Prior to commencement of sampling, new paper towels saturated with isopropyl alcohol were placed around the top of the soil gas probe tooling or Vapor Pin® and around sample train connections to test the sampling points for leakage. Based on initial screening, all samples were collected for 20 minutes (2000 milliliters of air). Sample data was recorded on Field Sampling Data Sheets (FSDS; included as Attachment B). After sampling, each soil gas and sub-slab vapor sample cartridge was capped, appropriately labeled, and immediately placed on ice pending delivery to the laboratory under chain-of-custody protocols.

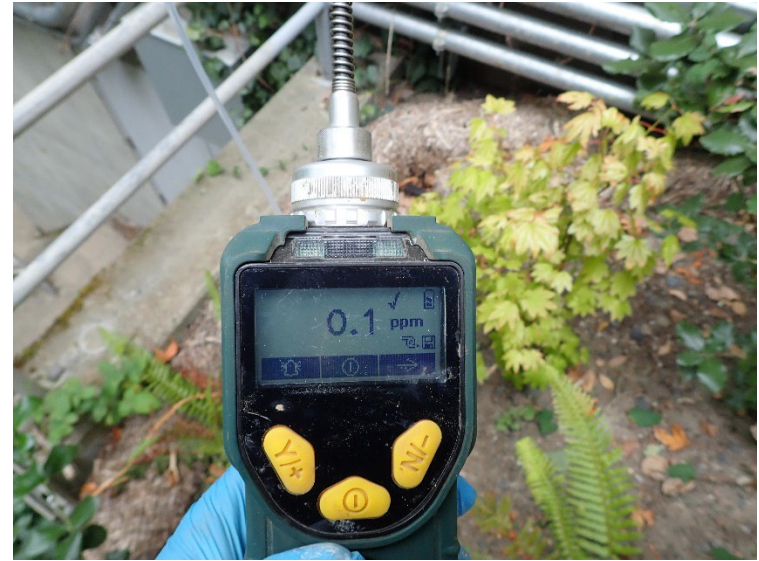
A photoionization detector (PID) was used to purge ambient air from the sample train and screen soil gas for volatile constituents.

Purging. Following an equilibration period of at least 30 minutes, a photoionization detector (PID) and LandTec GEM 5000 landfill gas meter were connected to the tubing at each sample location to perform initial screening of gas levels (further discussed in the next section) and ensure that stagnant or ambient air was removed from the sampling system and the sample collected was representative of subsurface conditions.

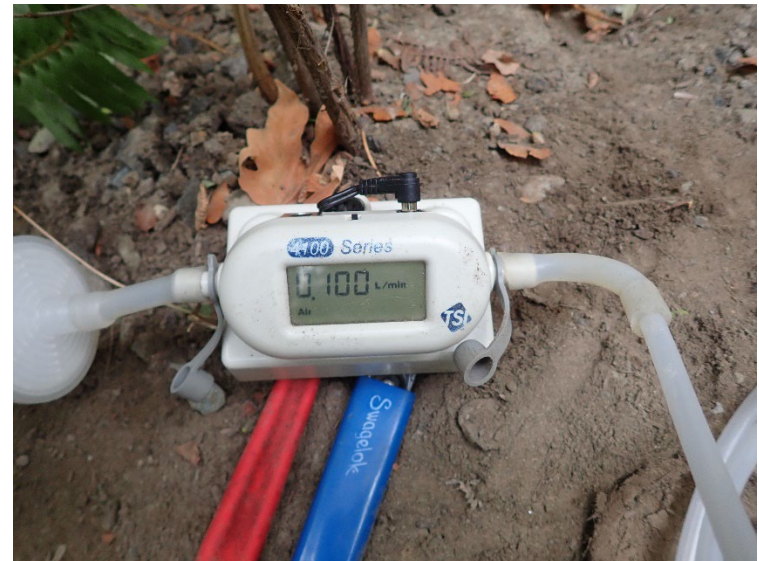
During sample collection, a digital rotameter was utilized to monitor and maintain a steady sample rate.

Sample Collection. Following purging, tubing at all soil gas and sub-slab vapor locations was connected to a flow regulator and finally to a low-flow vacuum pump. The pump was activated, and the flow rate was adjusted to 100 millimeters per minute using the flow regulator. A sample cartridge was inserted into the sampling train in between the down-hole tubing and the flow regulator. The sample cartridge consisted of a stainless-steel sorbent tube packed with activated carbon composed of Carbopack C (a weak sorbent), Carbopack B (a medium sorbent) and Carbosieve SIII (a strong sorbent).

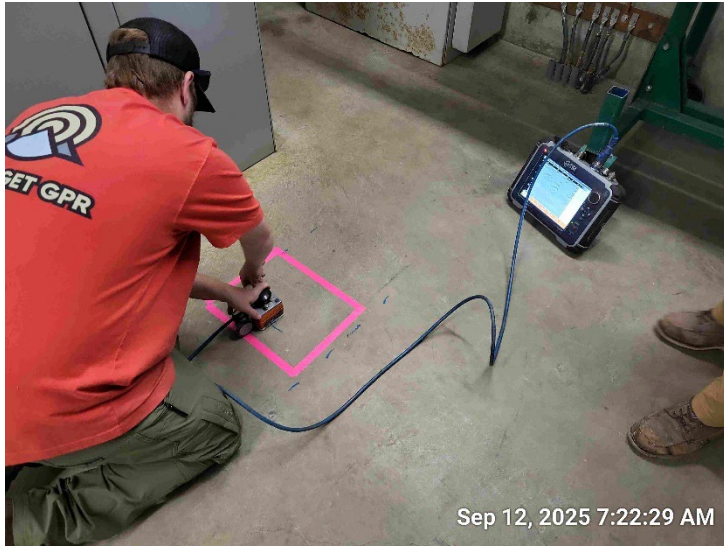
Ground-penetrating radar was used to help site sub-slab sample locations within the lowest level of the RJH building.

One Call Notification. ENW notified "One Call" locates and coordinated private utility locates prior to the installation of temporary soil gas probes and sub-slab vapor pins. Private locates were conducted by Recon Locates, LLC and On Target GPR to clear target sample locations.

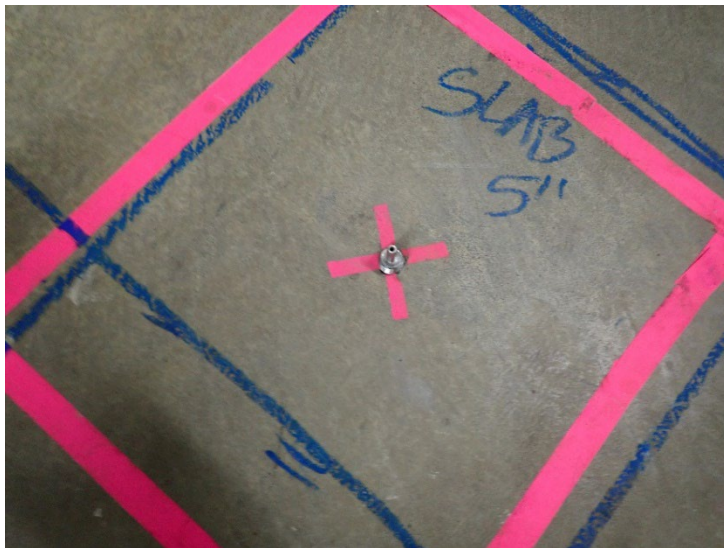
View of vapor pin installed at location SUB01 within the RJH building.

Sub-Slab Vapor Pin Installation. Sub-slab vapor samples SUB01 and SUB02 were collected from semi-permanent stainless-steel Vapor Pin® inserts installed through the floor slab of the lowest level of the RJH building near the release location. A masonry hole saw was used to drill a 5/8-inch hole through the concrete slab at each sample location, into which a semi-permanent Vapor Pin® with new silicon seal was installed. A section of Teflon® tubing secured to the Vapor Pin® provided a sealed vapor pathway to the sampling manifold.

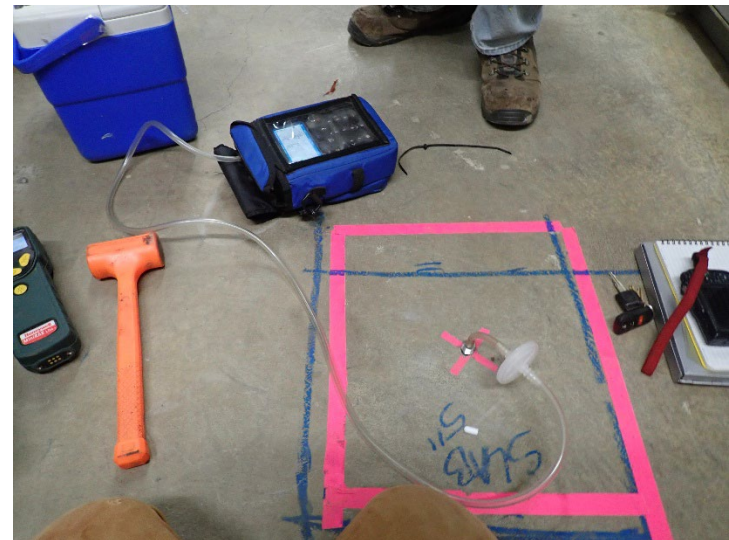
A landfill gas meter was utilized to measure concentrations of oxygen and other gases.

Measured landfill gas readings suggested oxygen concentrations near ambient levels at all sample locations. Similarly, carbon dioxide concentrations were within a normal range relative to atmospheric levels at all sample locations. Oxygen concentrations were significantly greater than 2 percent, which is the threshold value for active aerobic biodegradation of VOCs in the subsurface, suggesting active aerobic biodegradation is likely at all soil gas and sub-slab vapor locations.
