# REMEDIAL ACTION CONSTRUCTION SUMMARY REPORT

## DEMOLITION AND REMOVAL

MCCORMICK & BAXTER CREOSOTING COMPANY  
PORTLAND, OREGON

**May 2006**

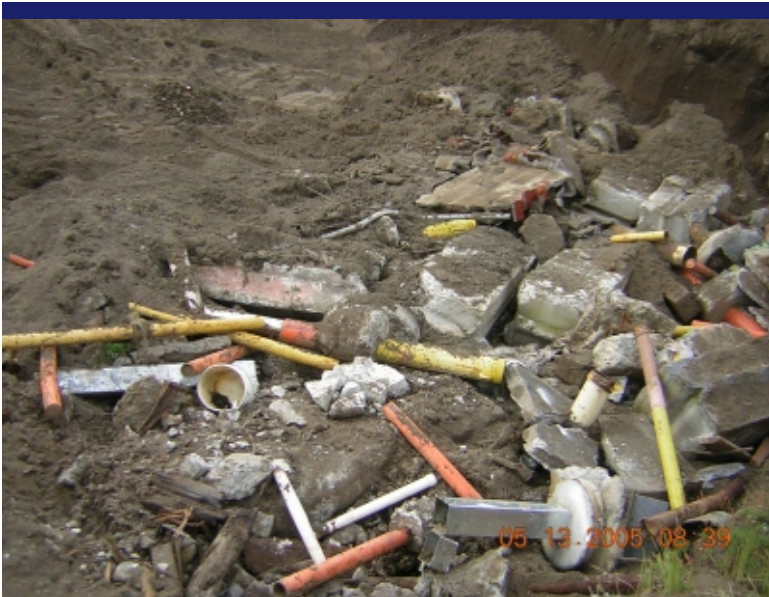
Photo 1 On-site disposal pit.  
*Direction:*

Concrete originating from the old shop building slab, tank supports, and miscellaneous areas was broken into pieces and transported to an on-site debris disposal area for burial. The debris disposal area was moved from the design location to a location just northeast of the “Buried Concrete Debris” area shown in the drawings.

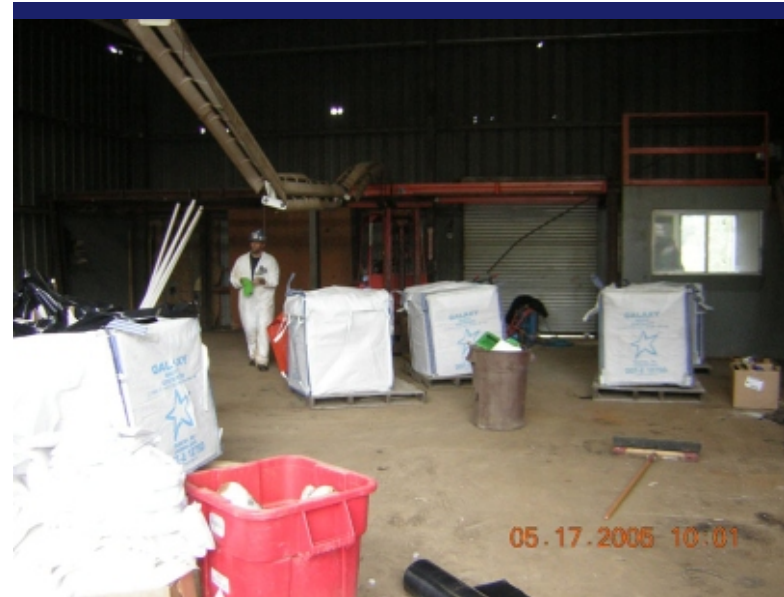
Photo 2 Hazardous material from shop building being placed in super sacks for off-site disposal.  
*Direction:* Southwest

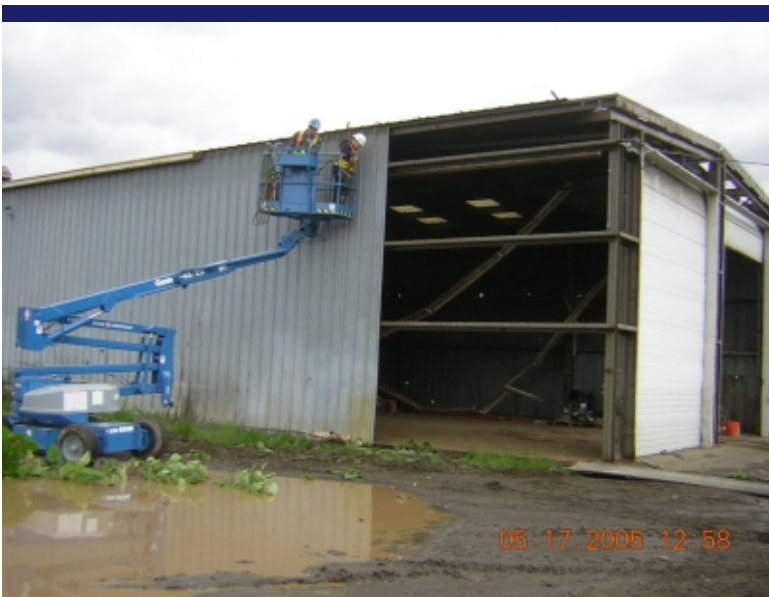
Photo 3 Shop siding being removed.  
*Direction:* West

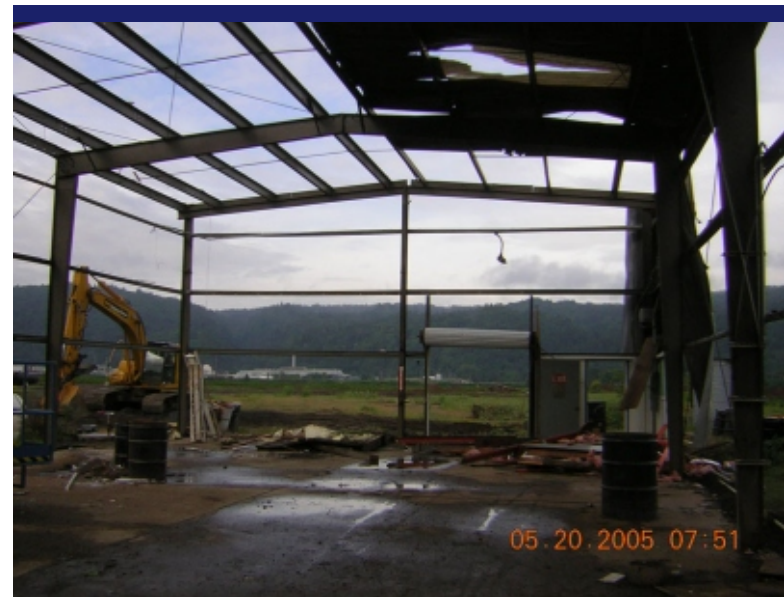
Photo 4 Shop building with siding removed.  
*Direction:* West

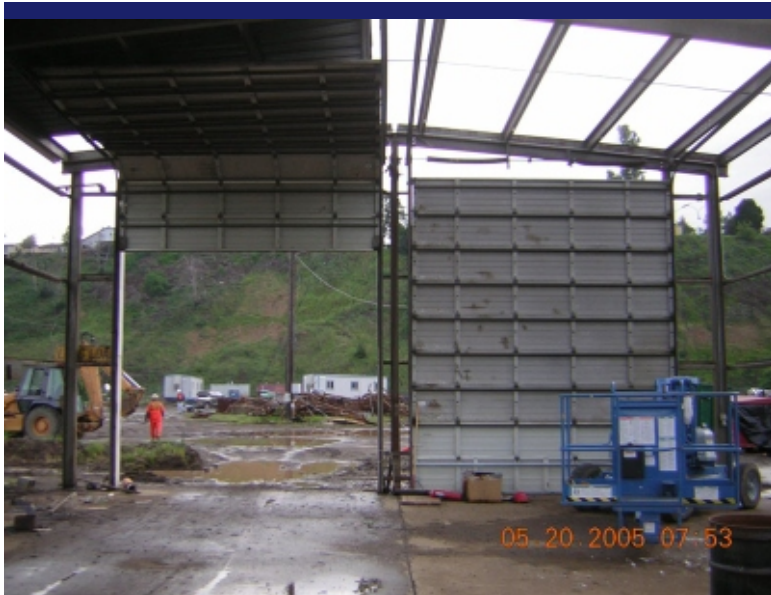
Photo 5 Shop building with siding removed.  
*Direction: East*

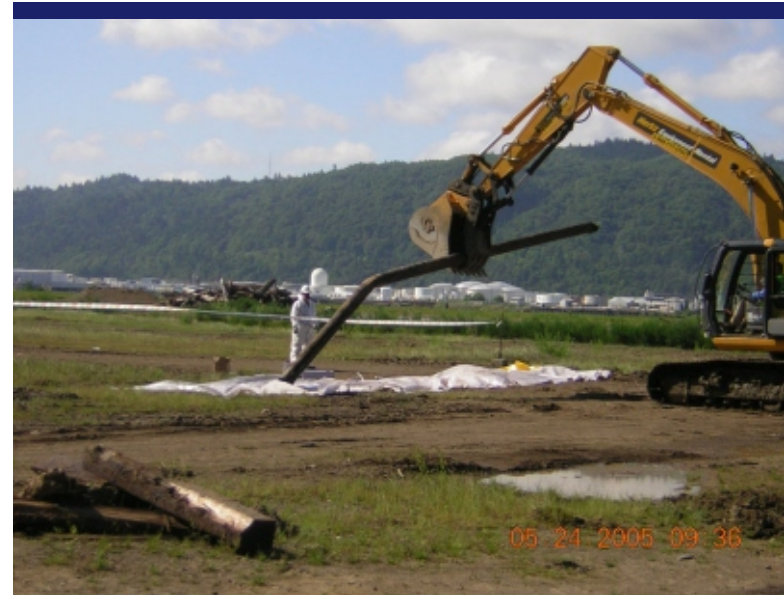
Photo 6 Asbestos pipe being placed on 6 mil plastic sheeting as part of the asbestos abatement.  
*Direction: West*

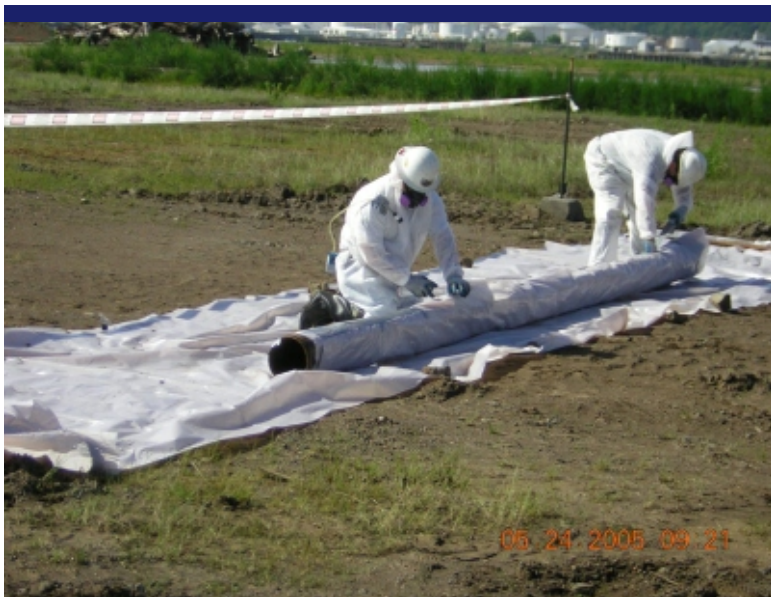
Photo 7 Asbestos pipe being wrapped by PAS, Inc. in two layers of 6 mil plastic sheeting.  
*Direction: West*

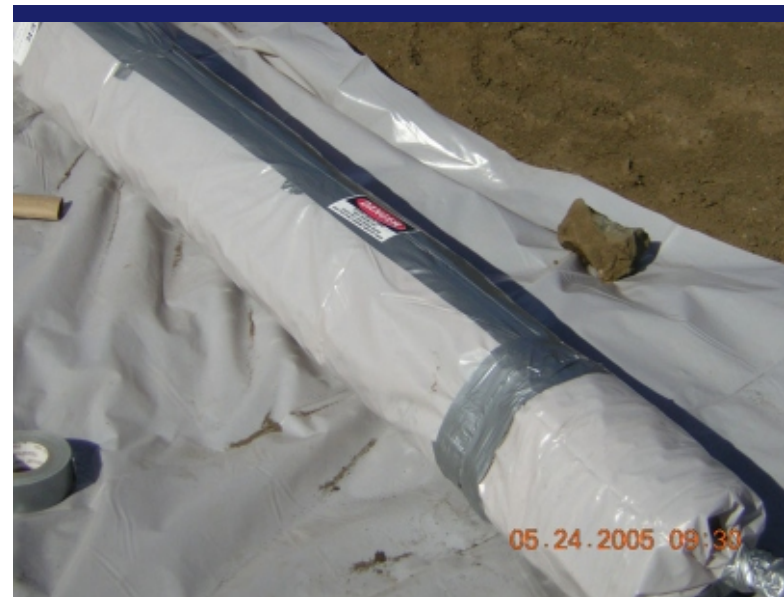
Photo 8 Close up of asbestos pipe completely wrapped in two layers of plastic sheeting.  
*Direction:*

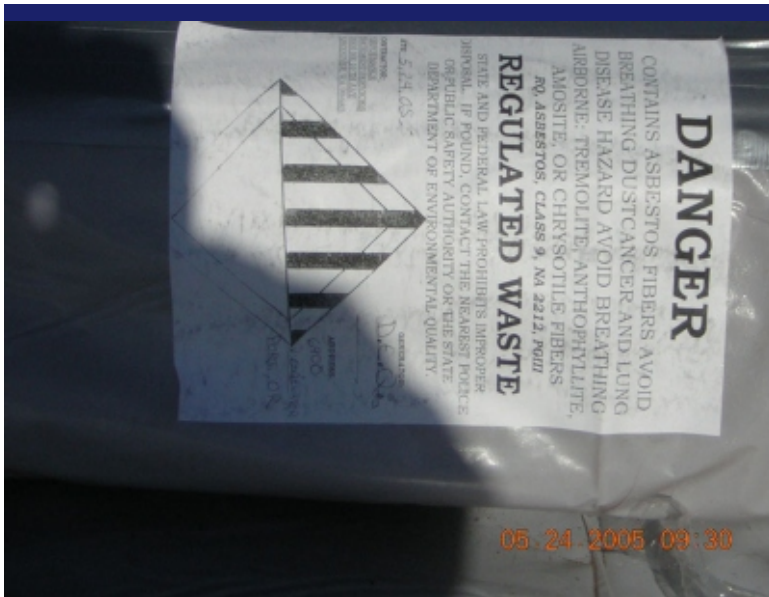
Photo 9 Asbestos hazard label affixed to each wrapped pipe.  
*Direction:*

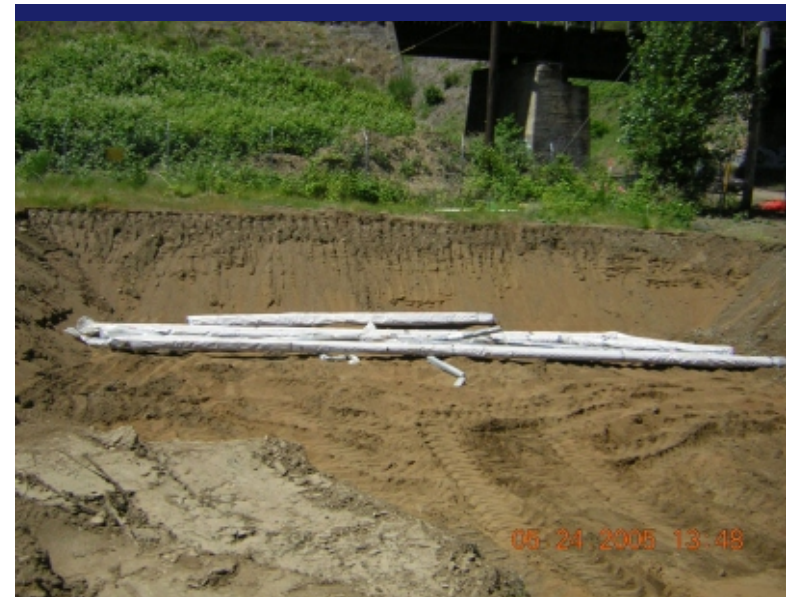
Photo 10 Disposal pit for buried asbestos pipe after it has been wrapped. Located in N corner of site.  
*Direction: Northwest*

- **05/23/05** – Wilder excavates the pit for the disposal of water pipe containing asbestos wrap. Wilder also buries the oversized concrete located at the south end of the site at the pre-determined location. PGE installs the replacement utility pole outside the north fence line.
