FOCUSED SUB-SLAB VAPOR AND SOIL GAS ASSESSMENT

Ollison Estate

23737 SW Newland Road
Wilsonville, Oregon

EVREN NORTHWEST, INC.
Project No. 114-19002-05

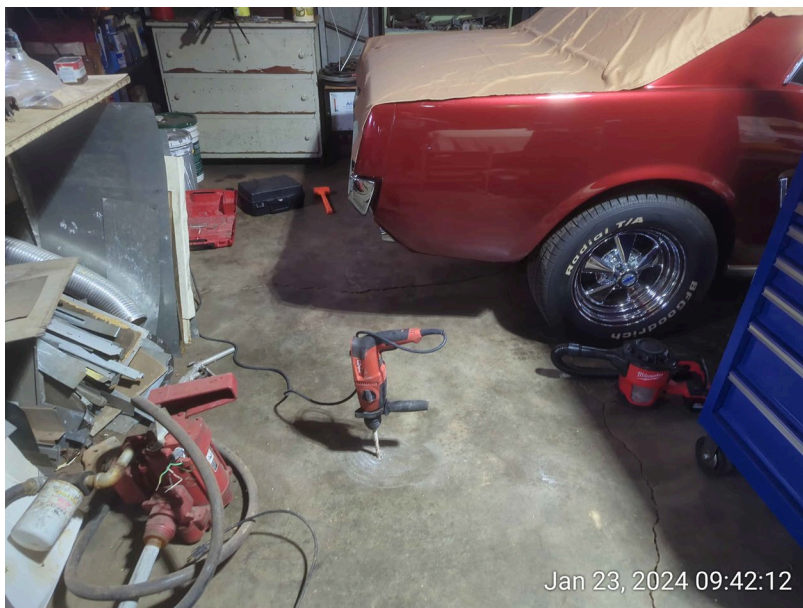
Jan 23, 2024 09:42:12

Installing vapor pin for sub-slab vapor monitoring in garage.

Vapor Pin Installation. Sub-slab vapor pins SUB01 through SUB03 were advanced beneath the northeast and west central portions of the residence, and the northeast portion of the on-site shop building, respectively. The sampling points were advanced by drilling a 5/8-inch hole through the approximately four (4) to six (6) inch concrete floor slabs and pressing a dedicated Vapor Pin® with a silicon sleeve into the drilled sampling point. Disposable Teflon sample tubing was connected to a barbed fitting on the Vapor Pin at the ground surface to allow for purging and collection of the sub-slab vapor samples.

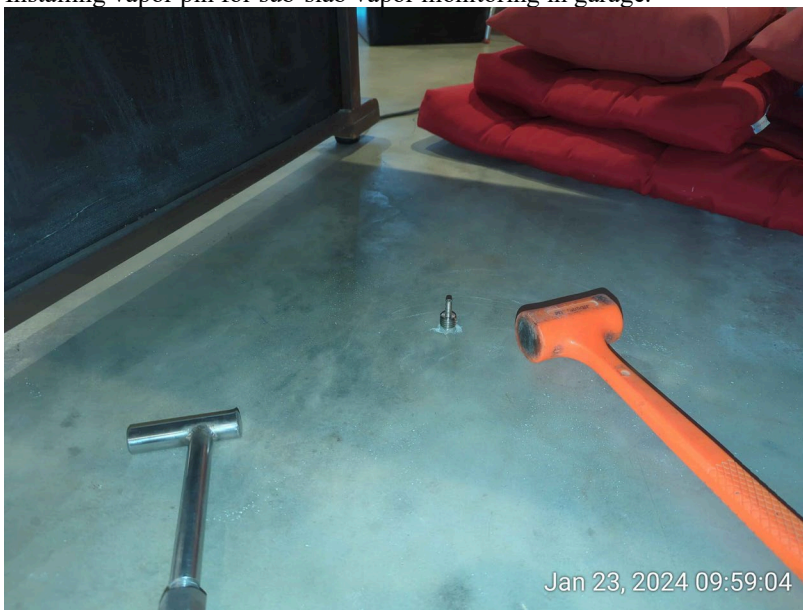
Jan 23, 2024 09:59:04

Vapor pin installed.

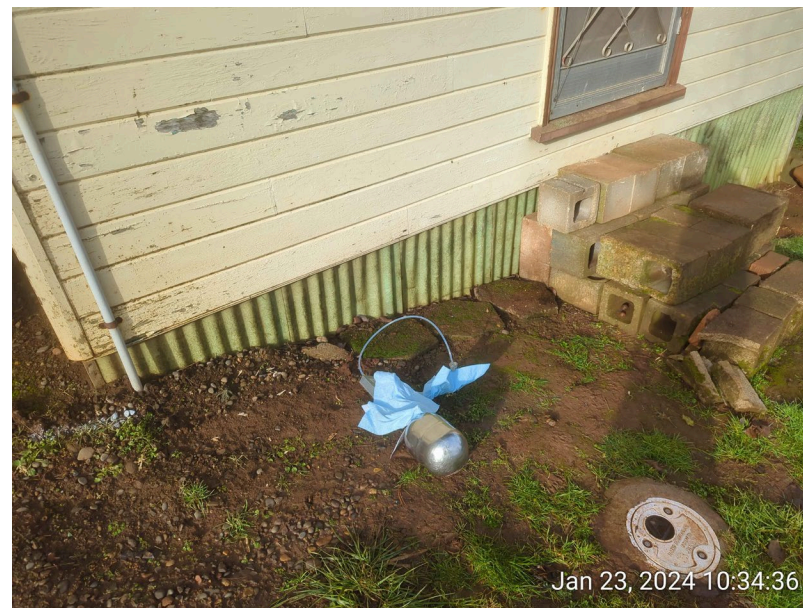
Jan 23, 2024 10:34:36

Typical soil gas sampling set up (note blue rags saturated with IPA for leak check)

After the end of an approximately a 30-minute equilibration period, the completely assembled sampling train was leak tested by connecting the purge cannister to the manifold to generate a vacuum on the system, then allowing the sealed sampling train to sit with an approximate 30 inches of mercury (in Hg) negative pressure vacuum over a period of five (5) minutes. In addition, as a leak check to the sample tubing connections at the Vapor Pin and at the manifold, rags saturated with isopropyl alcohol (2-propanol or IPA) were placed near the Vapor Pin and over the manifold at the time of sample collection. If the connections leaked, elevated concentrations of isopropyl alcohol would be detected.

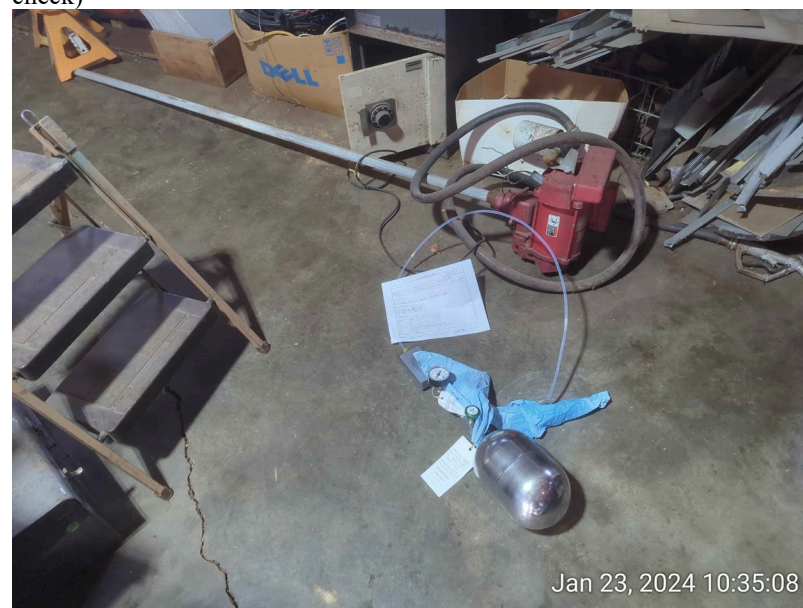
Jan 23, 2024 10:35:08

Typical sub-slab vapor sampling set up.

Sample Collection. The Teflon® sample tubing from each sampling point was connected to a sample manifold, which in turn was connected to two (2) laboratory-supplied SUMMA cannisters. One (1) uncertified 3-liter SUMMA cannister was used for purging and leak testing, and one dedicated 3-Liter batch-certified Summa cannister was used at each location for collecting the sample.

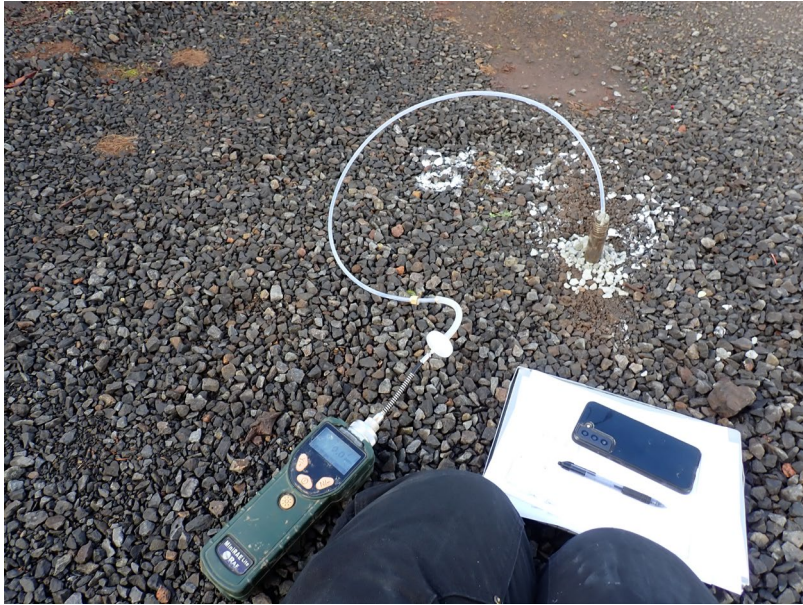
Purging and screening soil gas with PID

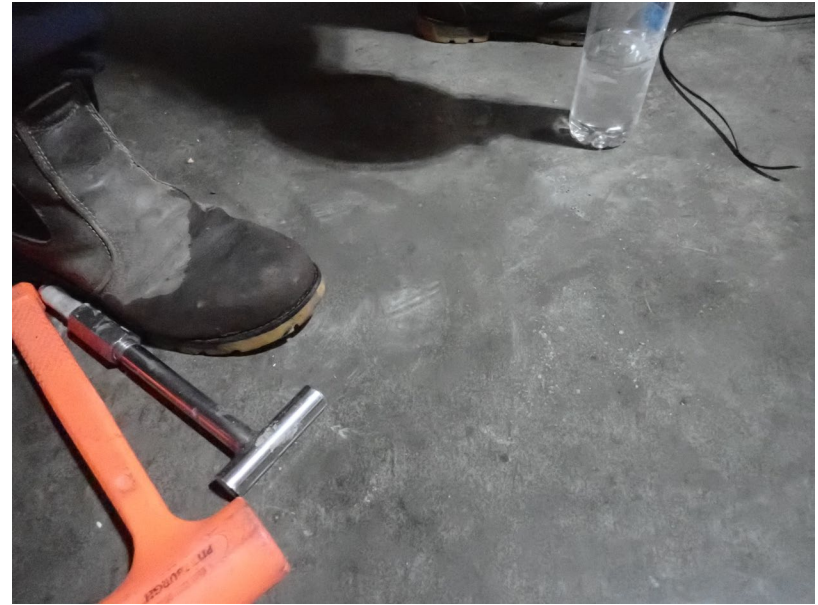
Vapor pin removed and floor restored.
