## DEQ SITE ASSESSMENT PROGRAM - STRATEGY RECOMMENDATION

**Site Name:** Texaco Bulk Plant – Klamath Falls

**Date:** October 31, 2006

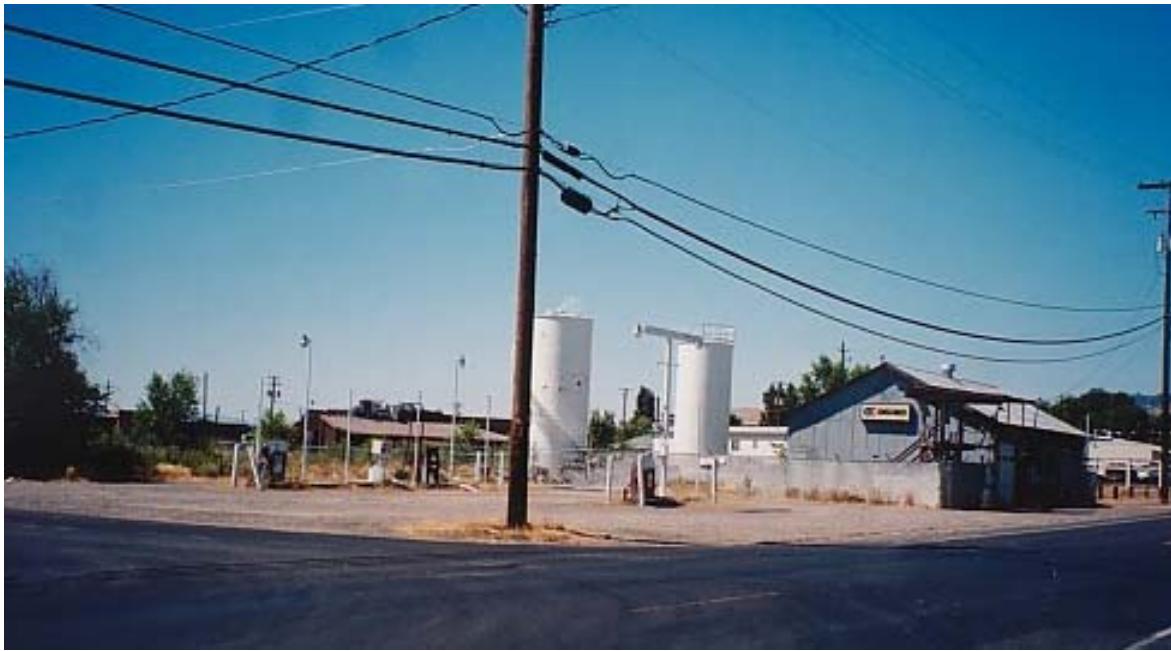
*August 8, 2000 photo of the petroleum bulk plant and card-lock fueling facility.*

facility that operated for more than 70 years. The bulk plant has been mostly inactive since being damaged by fire during 1999 and the card-lock facility was closed during 2002.

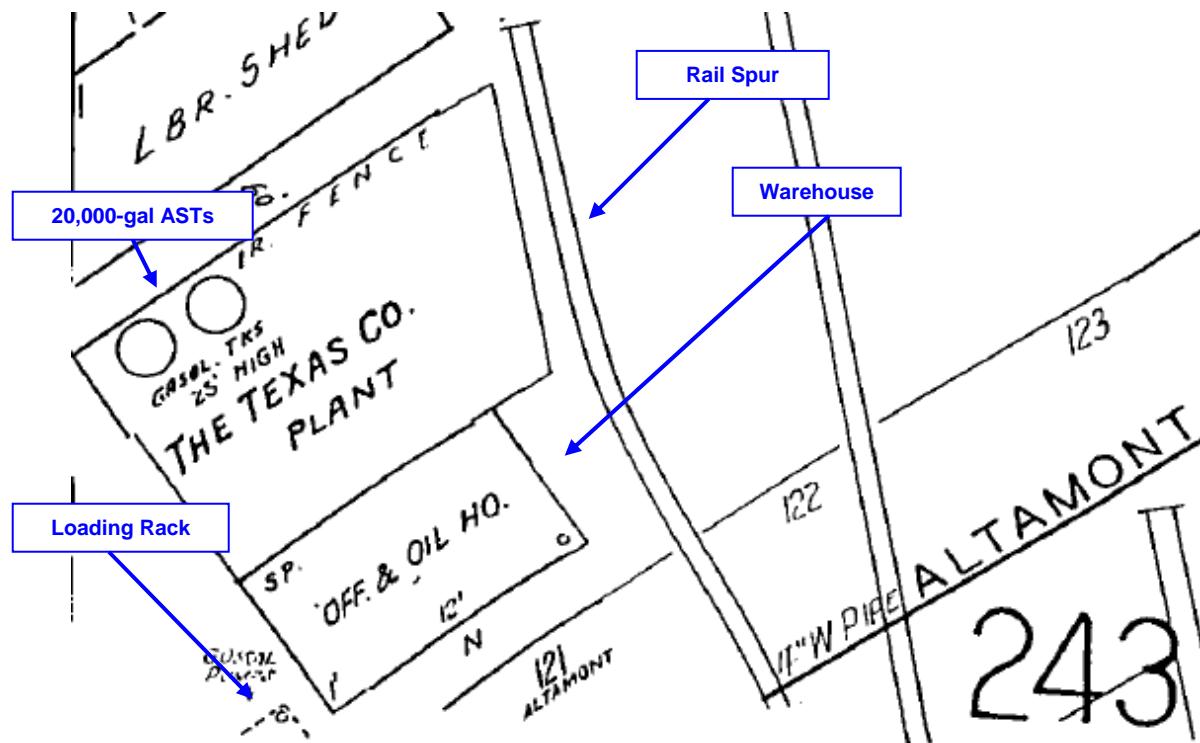
1949 Sanborn map.

The earliest Sanborn maps indicate the bulk plant consisted of a warehouse, two 20,000-gallon ASTs, a loading rack, and associated piping. Two more 20,000-gallon ASTs and a 12,000-gallon AST were added over time. The ASTs were most likely filled by rail cars during the early years and the Sanborn maps show a rail spur along the northern border of the site.

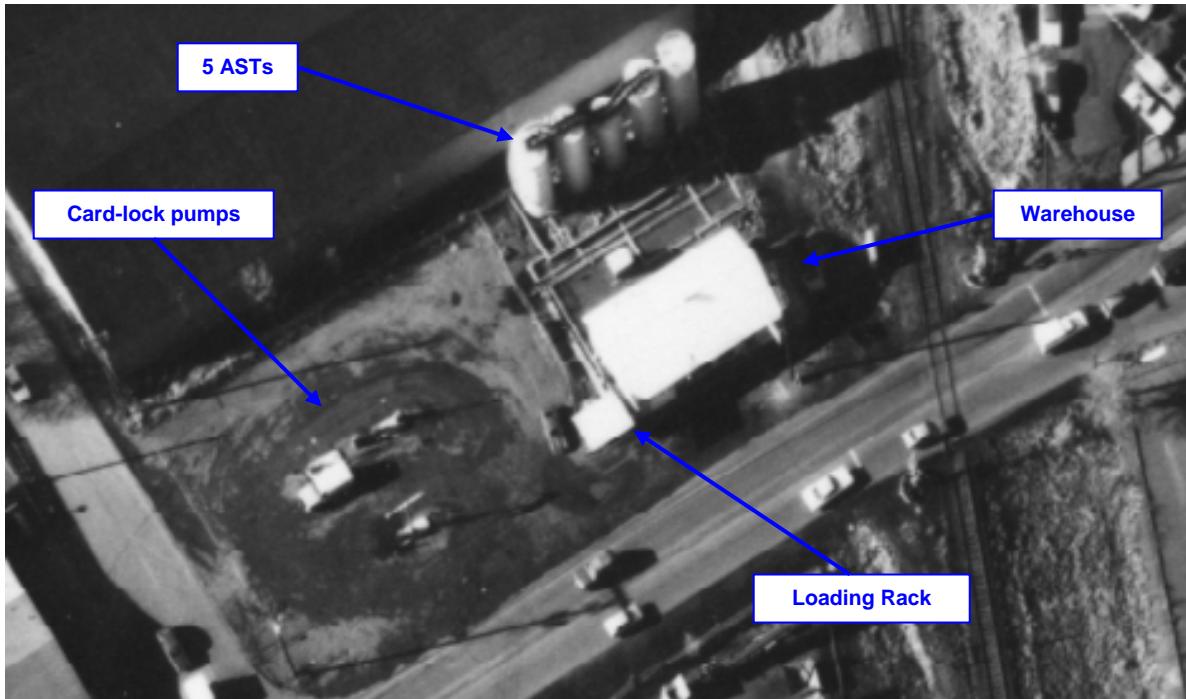
*December 17, 1986 aerial.*

The site, with an AST storage capacity ranging from 40,000 to 92,000 gallons, was likely to have handled well more than a million gallons of fuel during the course of the operation. Releases at bulk plants can occur when tanks are overfilled, hoses are allowed to drain onto the ground, piping joints or valves break or leak, or containers are punctured. In addition to the storage and distribution of petroleum products, other activities that may have resulted in releases include tank cleaning and sludge disposal, AST painting or sand-blasting, and vehicle maintenance (for the delivery vehicles). There are no registered underground storage tanks (USTs) on-site.

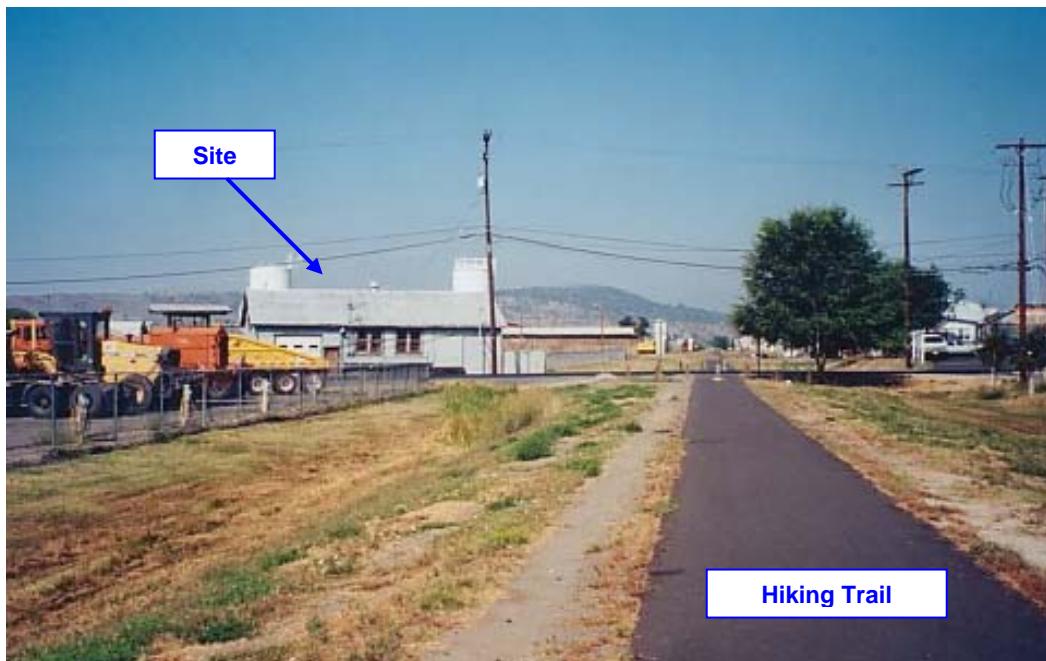
**Air** – Releases to soil and groundwater have been confirmed in the right-of-ways adjacent to the site and the potential for inhalation of contaminated dust is a pathway of concern, particularly to users of the hiking trail as well as the potential for vapor intrusion in nearby buildings.

*A public hiking trail is next to the site (8/10/00 photo).*

The site is a high priority for assessment based on the long-term use as a petroleum bulk plant in the close proximity of a public hiking trail and a registered drinking water well. Additional sampling is also required to determine if the confirmed release to soil and groundwater in the right-of-ways immediately east and south of the site is related to former operations at the site. ER/SAS recommends that the potentially responsible parties (PRP) be given the option to join DEQ's Voluntary Cleanup program (VCP) or wait for DEQ to complete the assessment under the authority of the Site Response Section, where work is conducted under an enforcement order.
