Revised Source Control Evaluation Work Plan

Various Tax Lots – Tindall Family Properties, Inc.

Near 9233 NW Cast (ECSI No. 999)

ACC Project Number: 10366-001.00

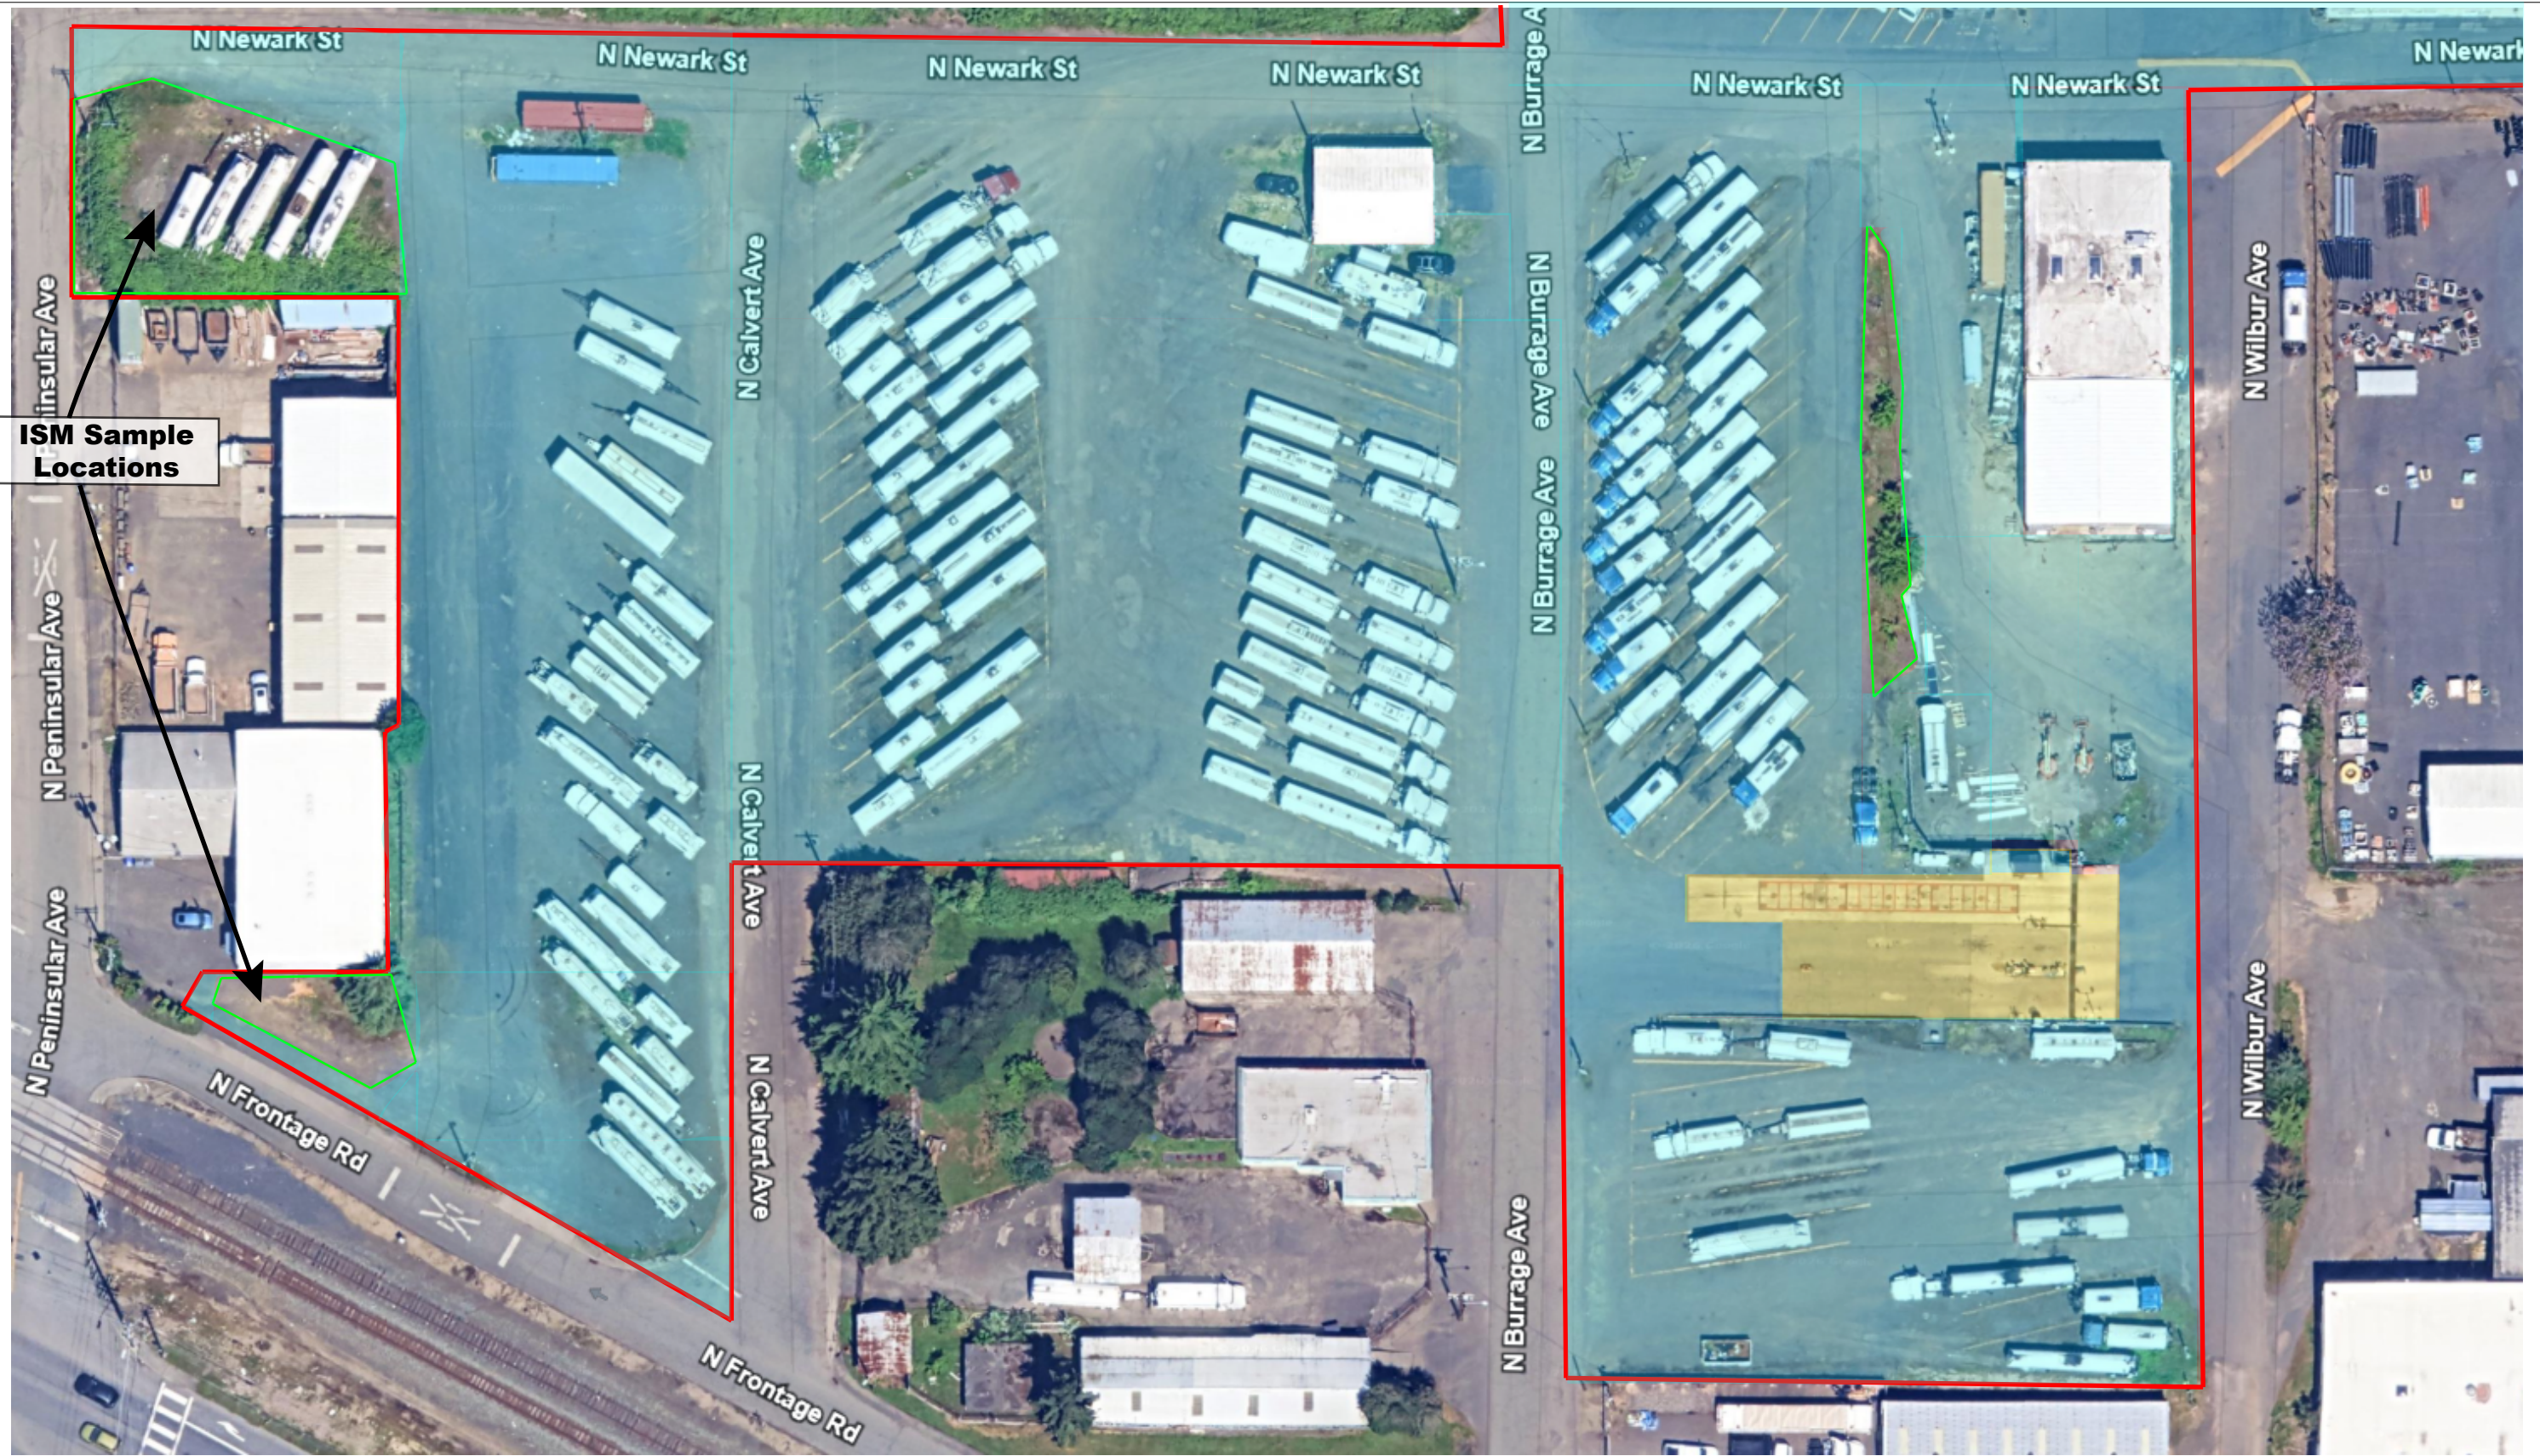
FIGURE 4
Site Surface Conditions & Proposed ISM Sample Locations
BLUE LINE TRANSPORTATION
PORTLAND, OREGON

- Approximate Boundary of Site
- Surface Soil
- Concrete
- Asphalt & Graded Asphalt Hardscape

Upland ISM soil sampling. Tax lots within the Facility that contain exposed, bare soil will be sampled in order to characterize near surface soil that could potentially affect stormwater conditions. It should be noted that the majority of the Facility is asphalt- or concrete-paved and taxlots within the Facility that include areas of exposed surface soil are primarily limited to taxlots 400 and 900.

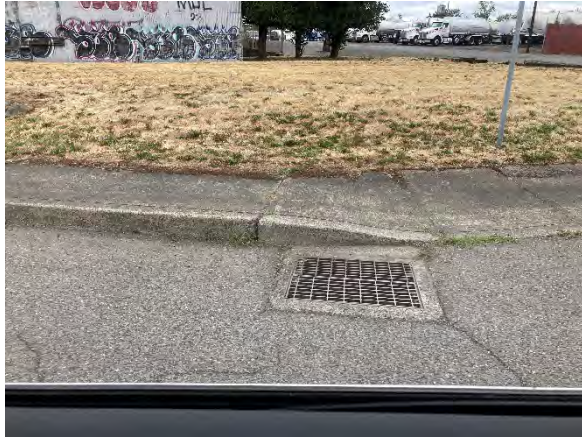
Photo #1 ANB990: Potentially receiving from 9243 W/N Burrage Ave – Tax Lot Suffix 2000 (view from N Frontage Rd)

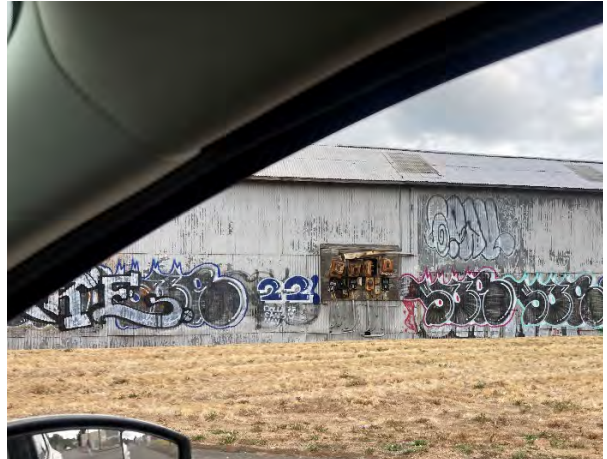
Photo #2 Dilapidated electrical panel – Just north of ANB990 (view from N Frontage Rd)

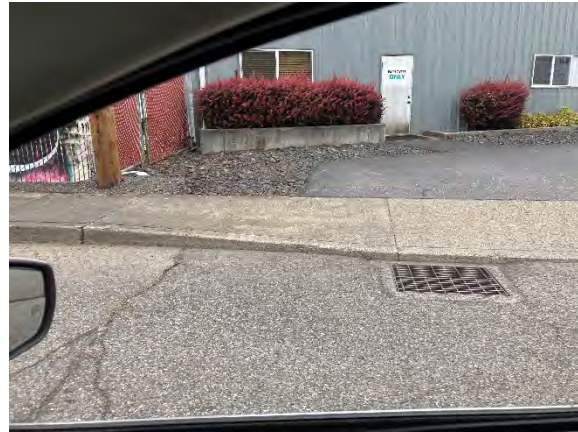
Photo #3 ANB991: Potentially receiving from 9130 N Burrage Ave – Tax Lots 2400 & 2500 (view from N Frontage Rd)

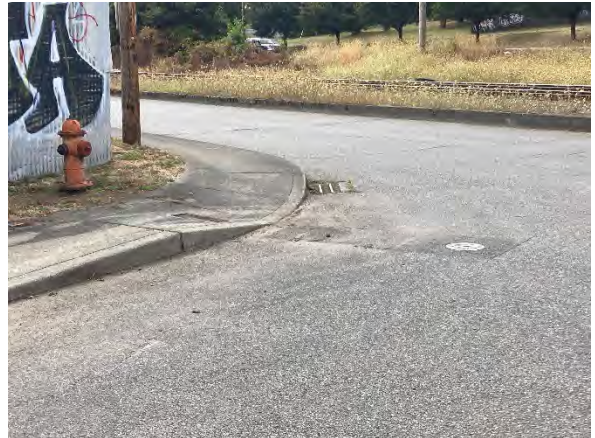
Photo #4 ANB989: Receiving from 9243 W/N Burrage Ave – Tax Lot 1700 (on N Calvert, looking SE towards N Frontage Rd)

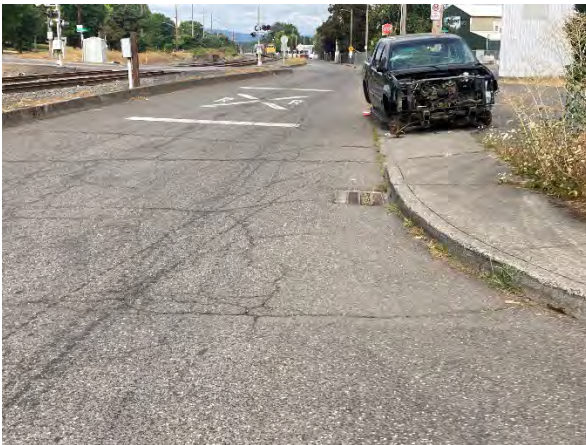
Photo #5 ANB988: Receiving from N Colombia Blvd – Tax Lot 900 (view West looking down N Frontage Rd, NW Cast is to the right).

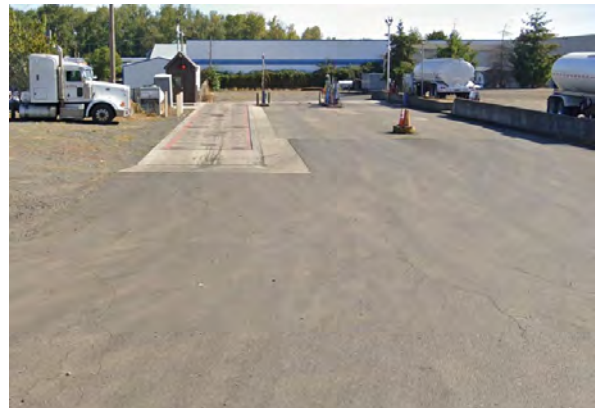
Photo #10 Taxlot 2300 with fueling area including UST and dispensers, facing east.

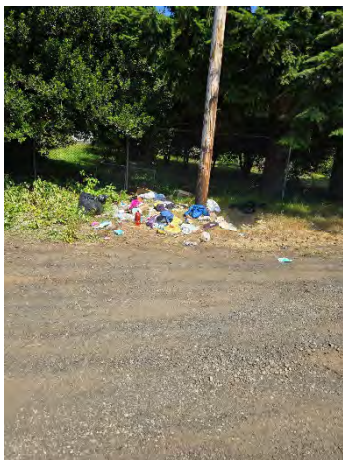
Photo #13 Illegal dumping along N. Calveret Ave. (east side) and hydraulically upgradient of ANB982/ANB989.

- **Illegal dumping and street racing.** Illegal dumping of fluorescent light bulbs, car parts, tires, brake pads, and other materials have been documented at and near the Facility (including adjacent to the catch basins) by DEQ, Blue Line and others (see attached Photo Log for example). According to Jason Tindall, Blue Line has found such debris dumped on a regular basis (multiple times per year). Additionally, debris associated with illegal street racing (ie., tire material, brake dust, etc.; see Photo Log) have been observed. Brake and tire dust are potential sources of TPH, PAHs, metals, and other contaminants.. In January 2025, DEQ noted that fluorescent light bulbs had been dumped near off-Facility catch basin ANN198. While the catch basin is off-Facility, it drains to the City conveyance system upgradient of the Facility (see Figure 3). The dumping are a likely source of mercury, PCBs, PAHs, and other contaminants. Therefore, we consider illegal dumping a potential source.

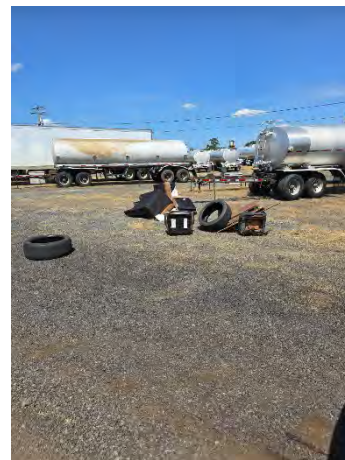
Photo #14 Illegal dumping along N. Calveret Avenue (west side) and hydraulically upgradient of ANB982/ANB989.

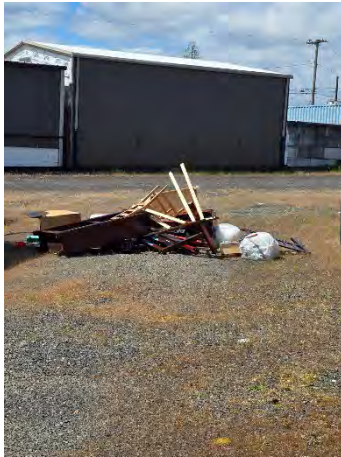
Photo #7 Illegal dumping along the former NW Cast site ANB088.

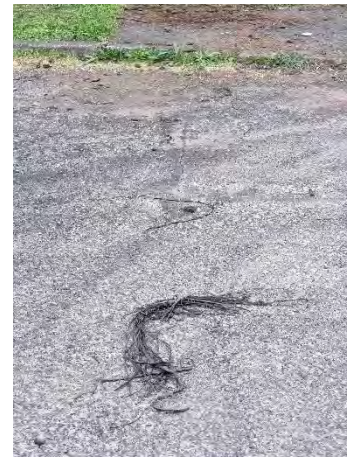
Photo #8 Tire debris from street racing at intersection of N. Calvert Ave. and N. Frontage Road (near ANB982/ANB989).

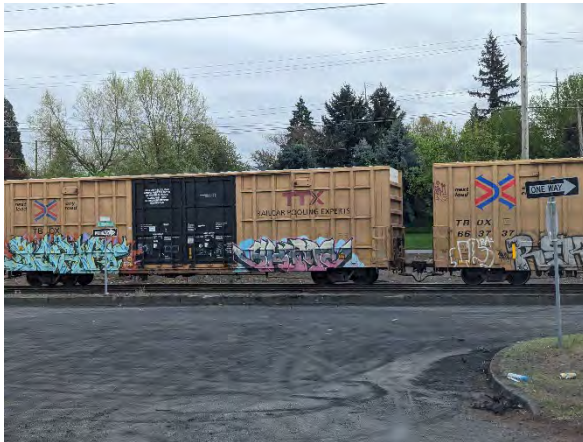
Photo #15 Tracks and tire debris from street racing at intersection of N. Calvert Ave. and N. Frontage Road (near ANB982/ANB989).
