State of Oregon  
Department of Environmental Quality

Memorandum

**Subject:** Staff Memorandum in Support of a Conditional No Further Action Determination  
Former ESCO Plants #1 and #2  
ECSI #6285

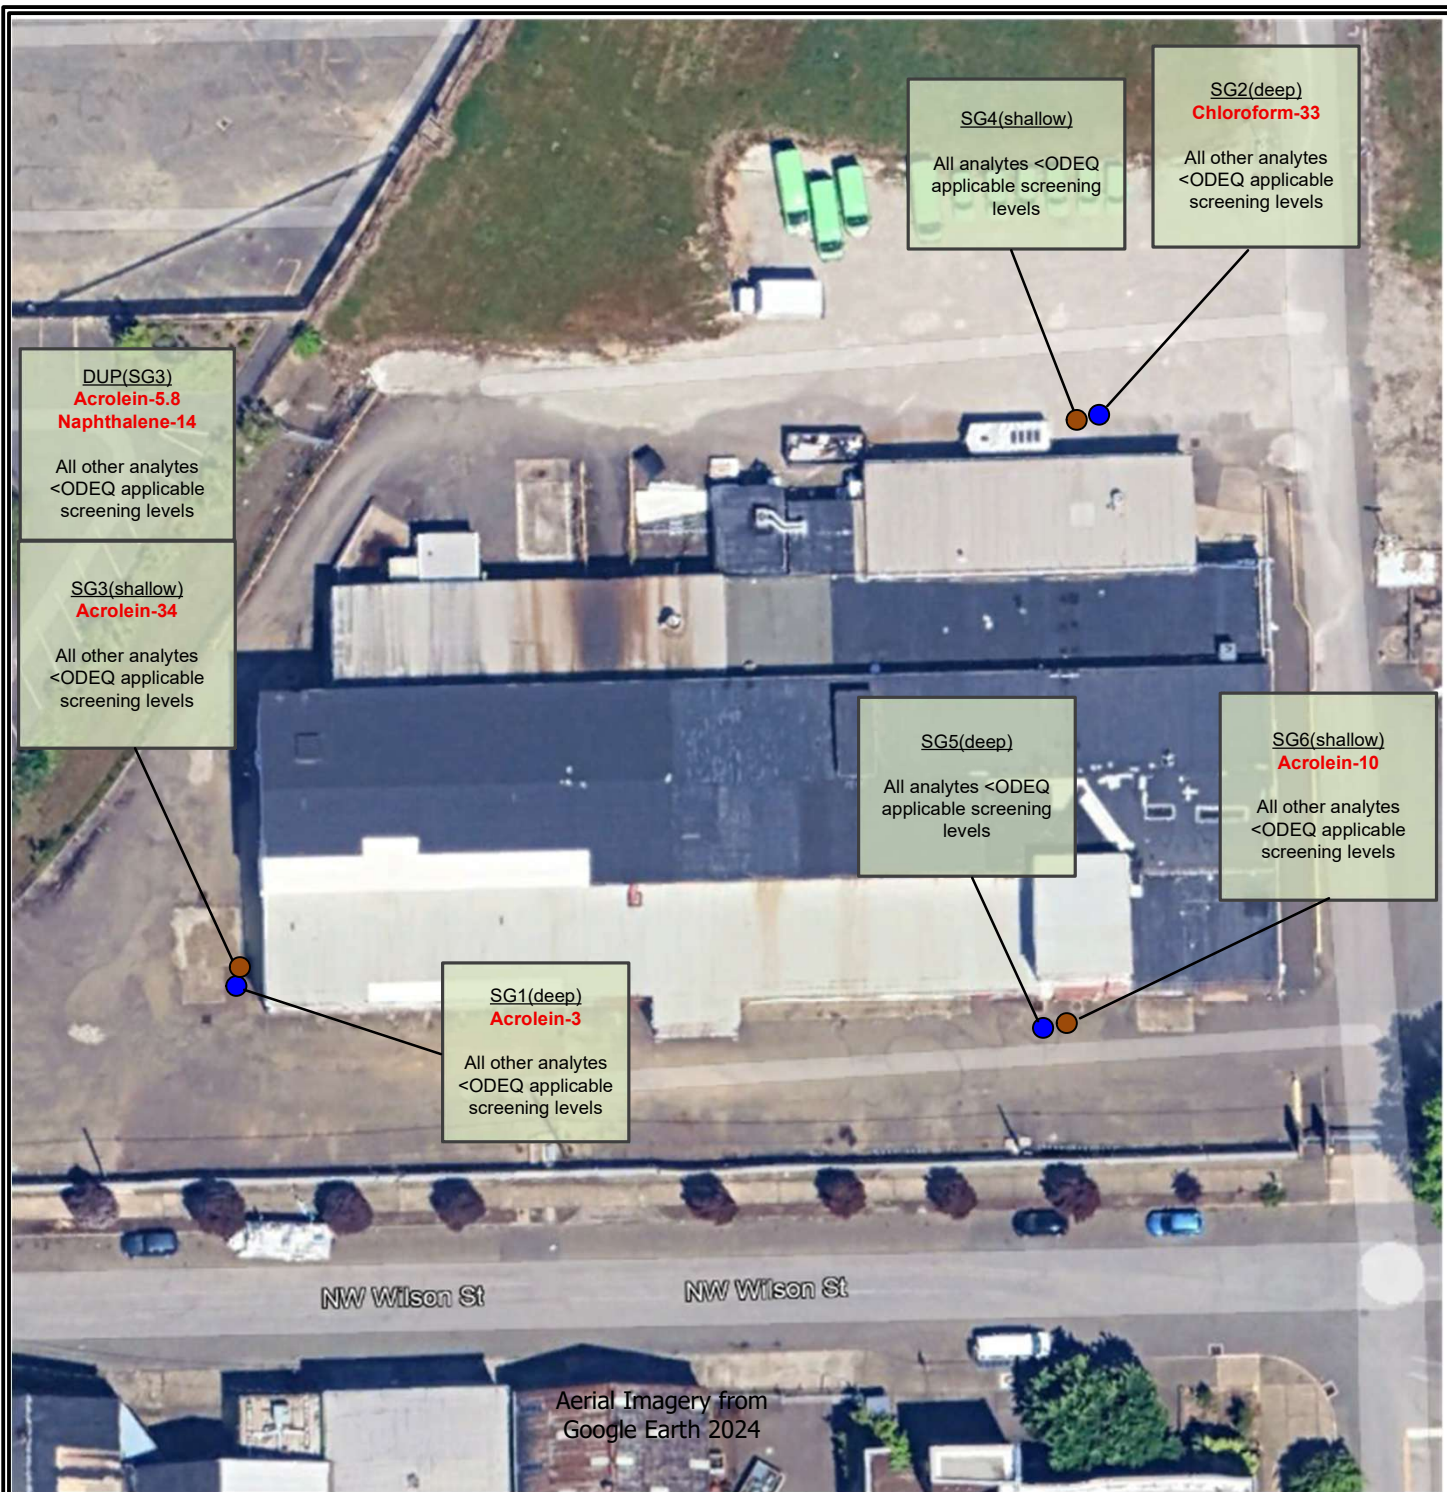
**FIGURE 9a: BUILDING 4 SAMPLE LOCATION DIAGRAM (>RBCsv for commercial receptors; September 2025)**

- Two 2025 vapor intrusion investigations for Building #4. These investigations were completed following the submittal of the Closure Report and are reported in the *Building #4 Vapor Intrusion Investigation Report*<sup>7</sup> and the *Building #4 Additional Vapor Intrusion Investigation Report*<sup>8</sup>. Figures 9a through 10b present the results of these sampling events.

Two rounds of soil gas samples were collected from the vicinity of Building 4. The first round of soil gas sampling included shallow samples, collected approximately 5 feet bgs, and deep samples, collected from 55 to 57 feet bgs (i.e., immediately above groundwater). The following exceedances of commercial and residential RBCs were observed:

- One deep soil gas sample exceeded the commercial and residential RBC for chloroform. An additional deep soil gas samples exceeded the residential RBC for chloroform. Chloroform did not exceed commercial or residential RBCs in shallow soil gas samples, indicating vertical attenuation at shallower depths.

- A duplicate shallow soil gas sample exceeded the commercial RBC naphthalene by a factor of 1.17, but the parent sample was below the commercial RBC. DEQ does not consider the commercial RBC exceedance to be significant. Three shallow soil gas sample locations exceeded the residential RBC for naphthalene. Future redevelopment into residential use should mitigate potential vapor intrusion risks associated with naphthalene.

- Three shallow soil gas sample locations exceeded the residential RBC for benzene. Future redevelopment into residential use should mitigate potential vapor intrusion risks associated with benzene.

- Multiple locations exceeded the commercial and residential RBCs for acrolein. Acrolein detections are commonly associated with background conditions and/or interference from sampling equipment.

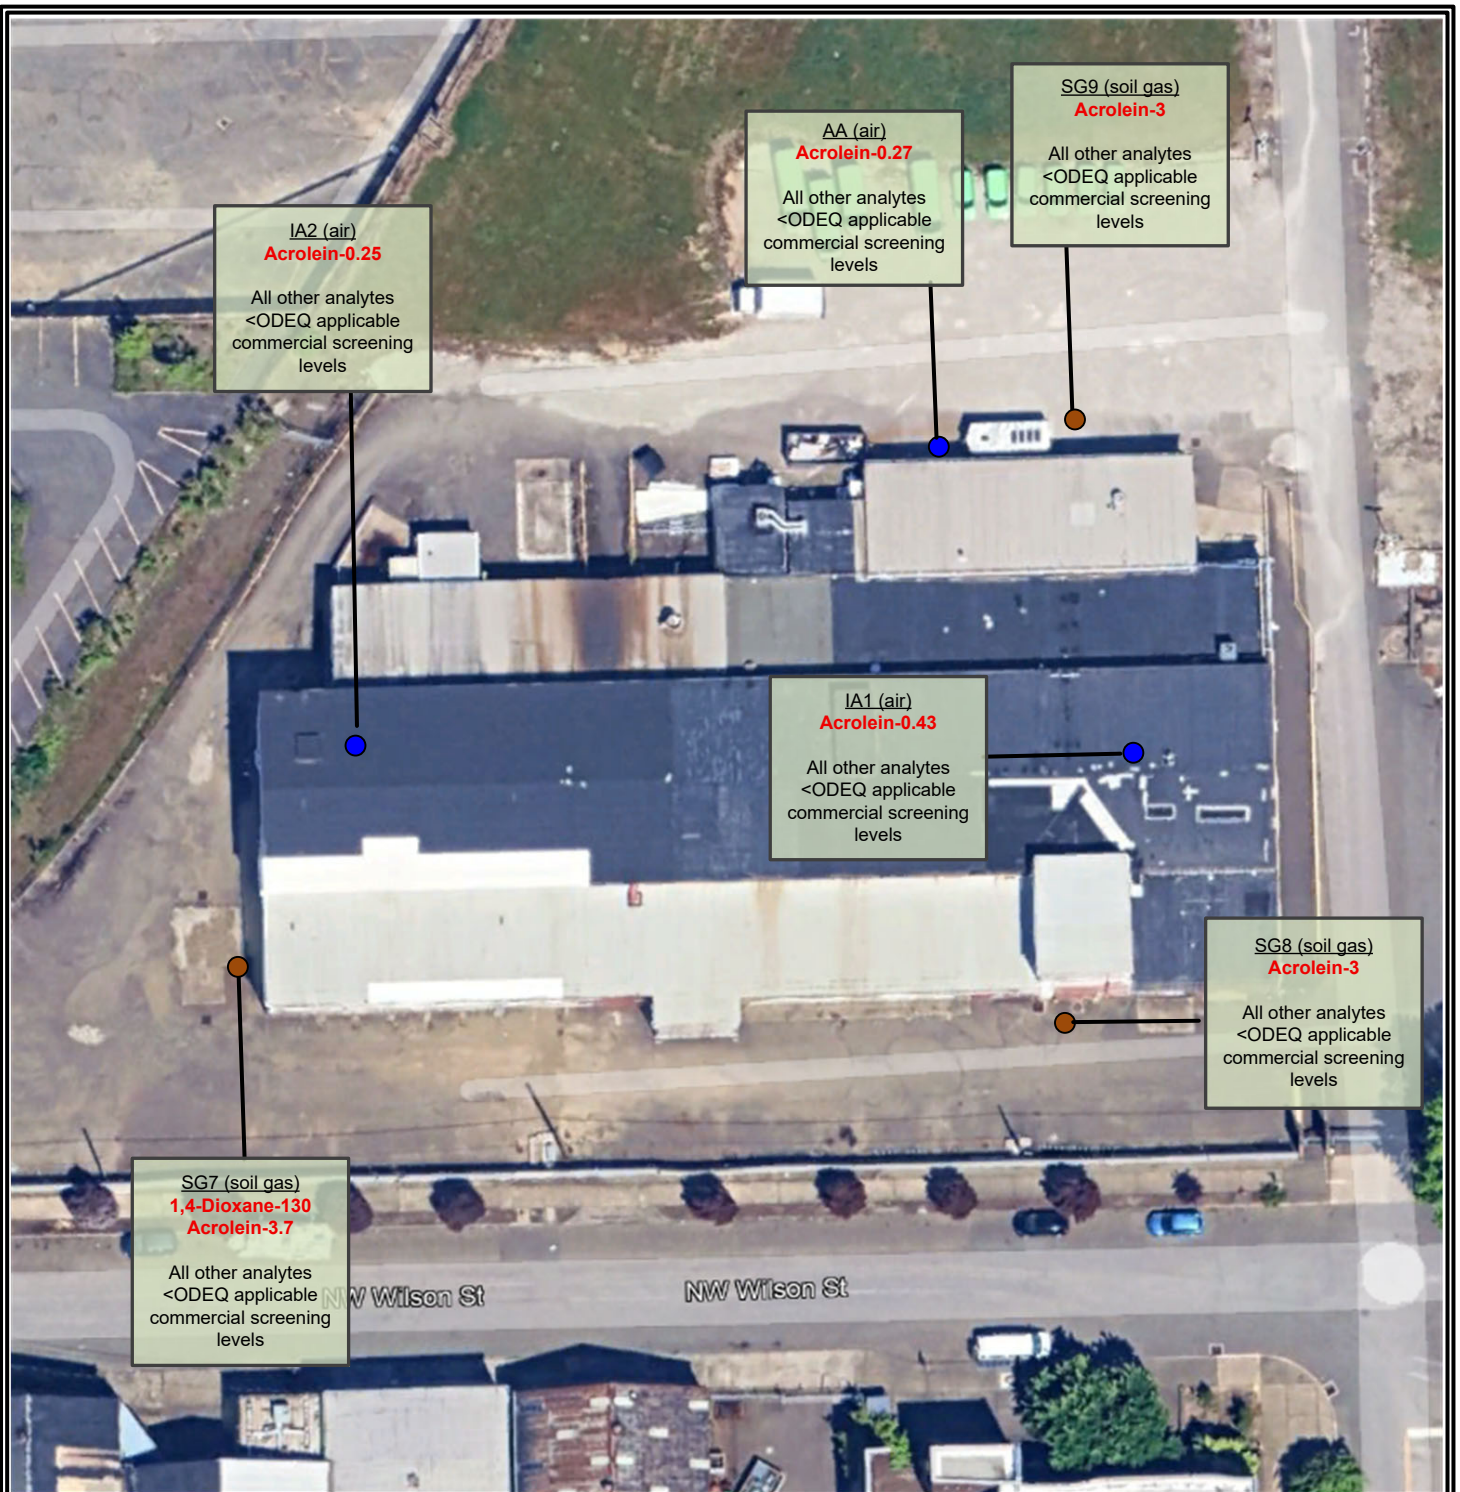
**FIGURE 9b: BUILDING 4 SAMPLE LOCATION DIAGRAM (>RBCsv/RBCair for commercial receptors; November 2025)**

A second round of shallow soil gas samples were collected to further assess acrolein detections and confirm initial sample results. One outdoor air (background) and two indoor air samples were also collected to support data interpretations. The following exceedances of commercial and residential RBCs were observed:

- All the shallow soil gas samples, the outdoor air (background), and indoor air samples exceeded commercial and residential RBCs for acrolein. Exceedances of the commercial soil gas RBC are low (exceedance ratios between 1.03 and 1.28). Other contributing factors lead to uncertainty about these acrolein detections, including the potential presence of ambient or background sources and/or interference of from sampling equipment (notably the breakdown of 1,3 butadiene and plastics used in sample ports). Acrolein in indoor air may also be related to storage of fire-damaged materials within Building 4 by the current tenant. The sample results do not definitively rule out the possibility that acrolein is associated, in part, to a subsurface release at the site; however, the most recent soil gas detections do not suggest that subsurface acrolein poses

- One shallow soil gas sample exceeded the commercial and residential RBCs for 1,4-Dioxane. 1,4-Dioxane was not detected in indoor air. There are no known potential on-site sources of 1,4-Dioxane.

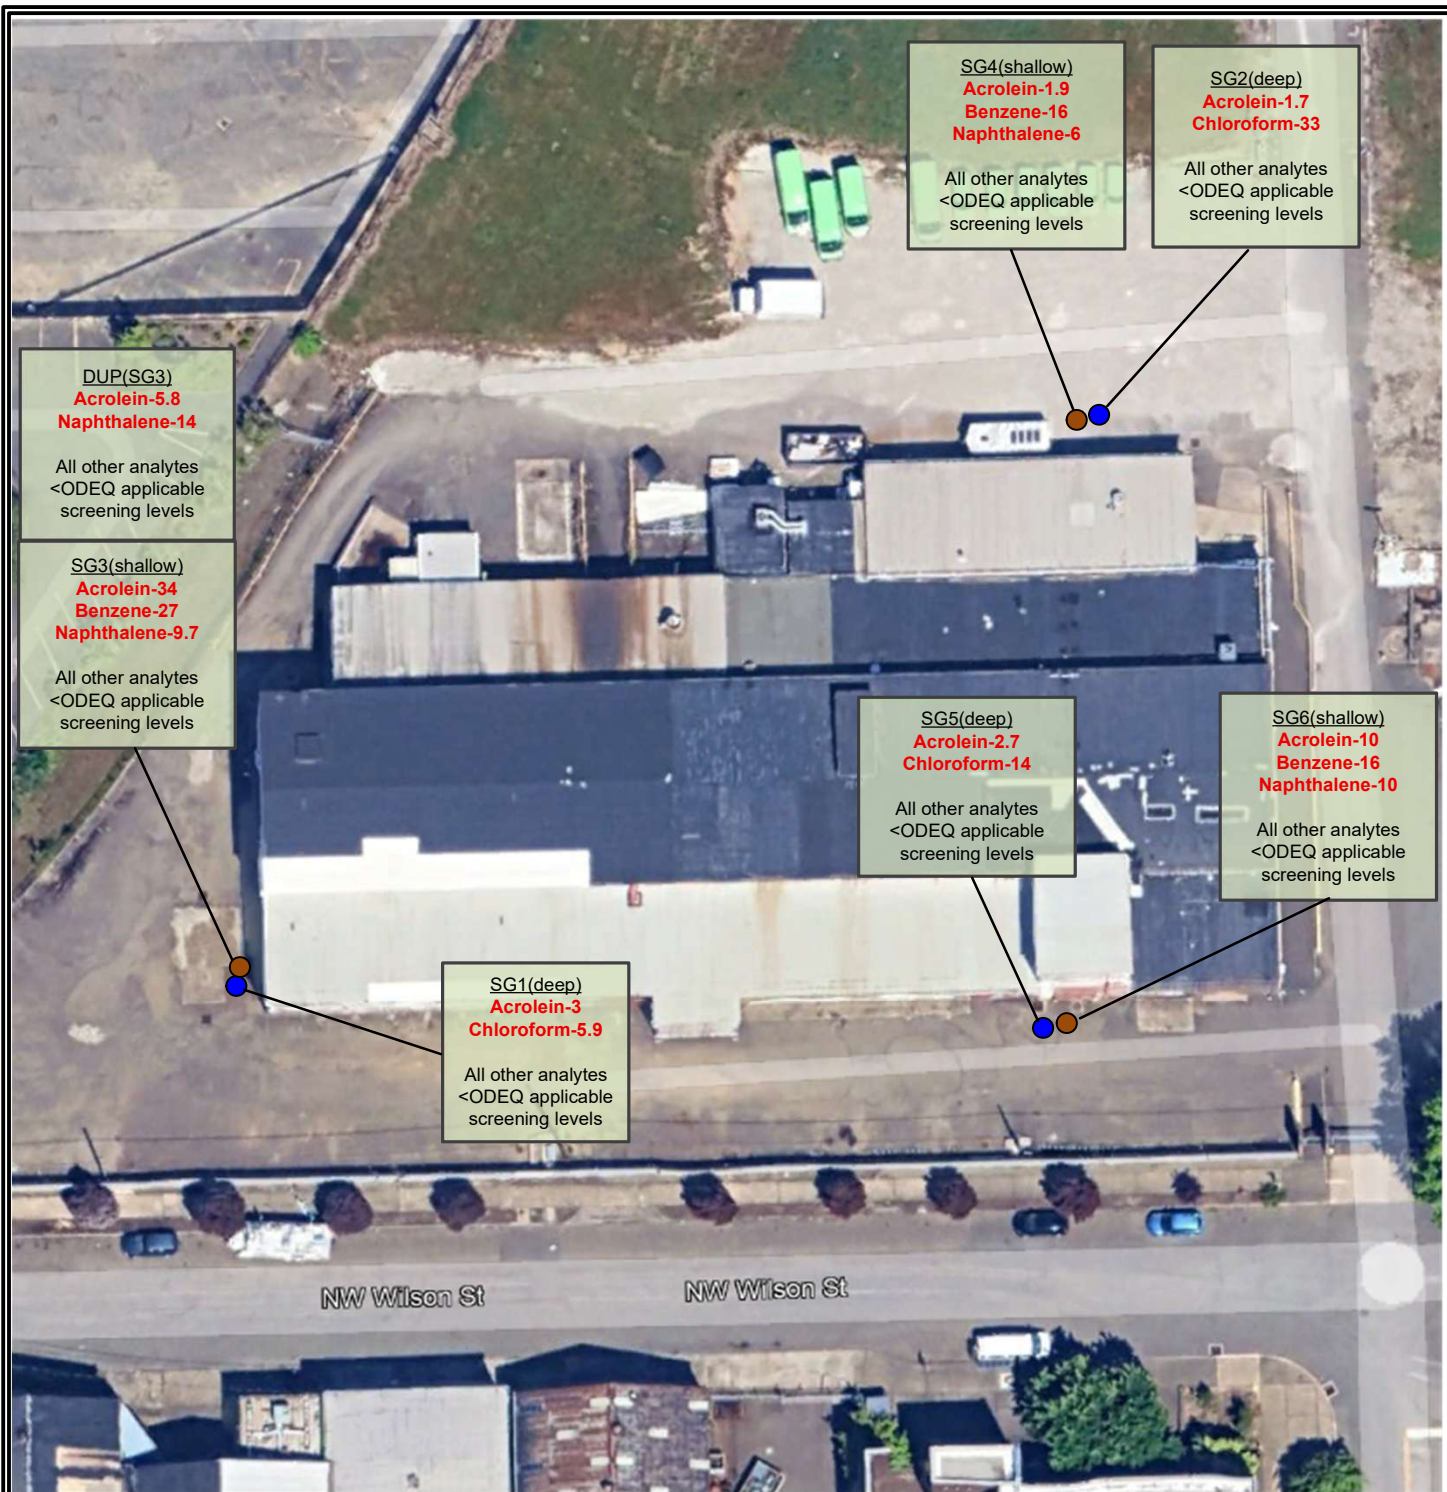
**FIGURE 10a: BUILDING 4 SAMPLE LOCATION DIAGRAM (>RBCsv for residential receptors; September 2025)**

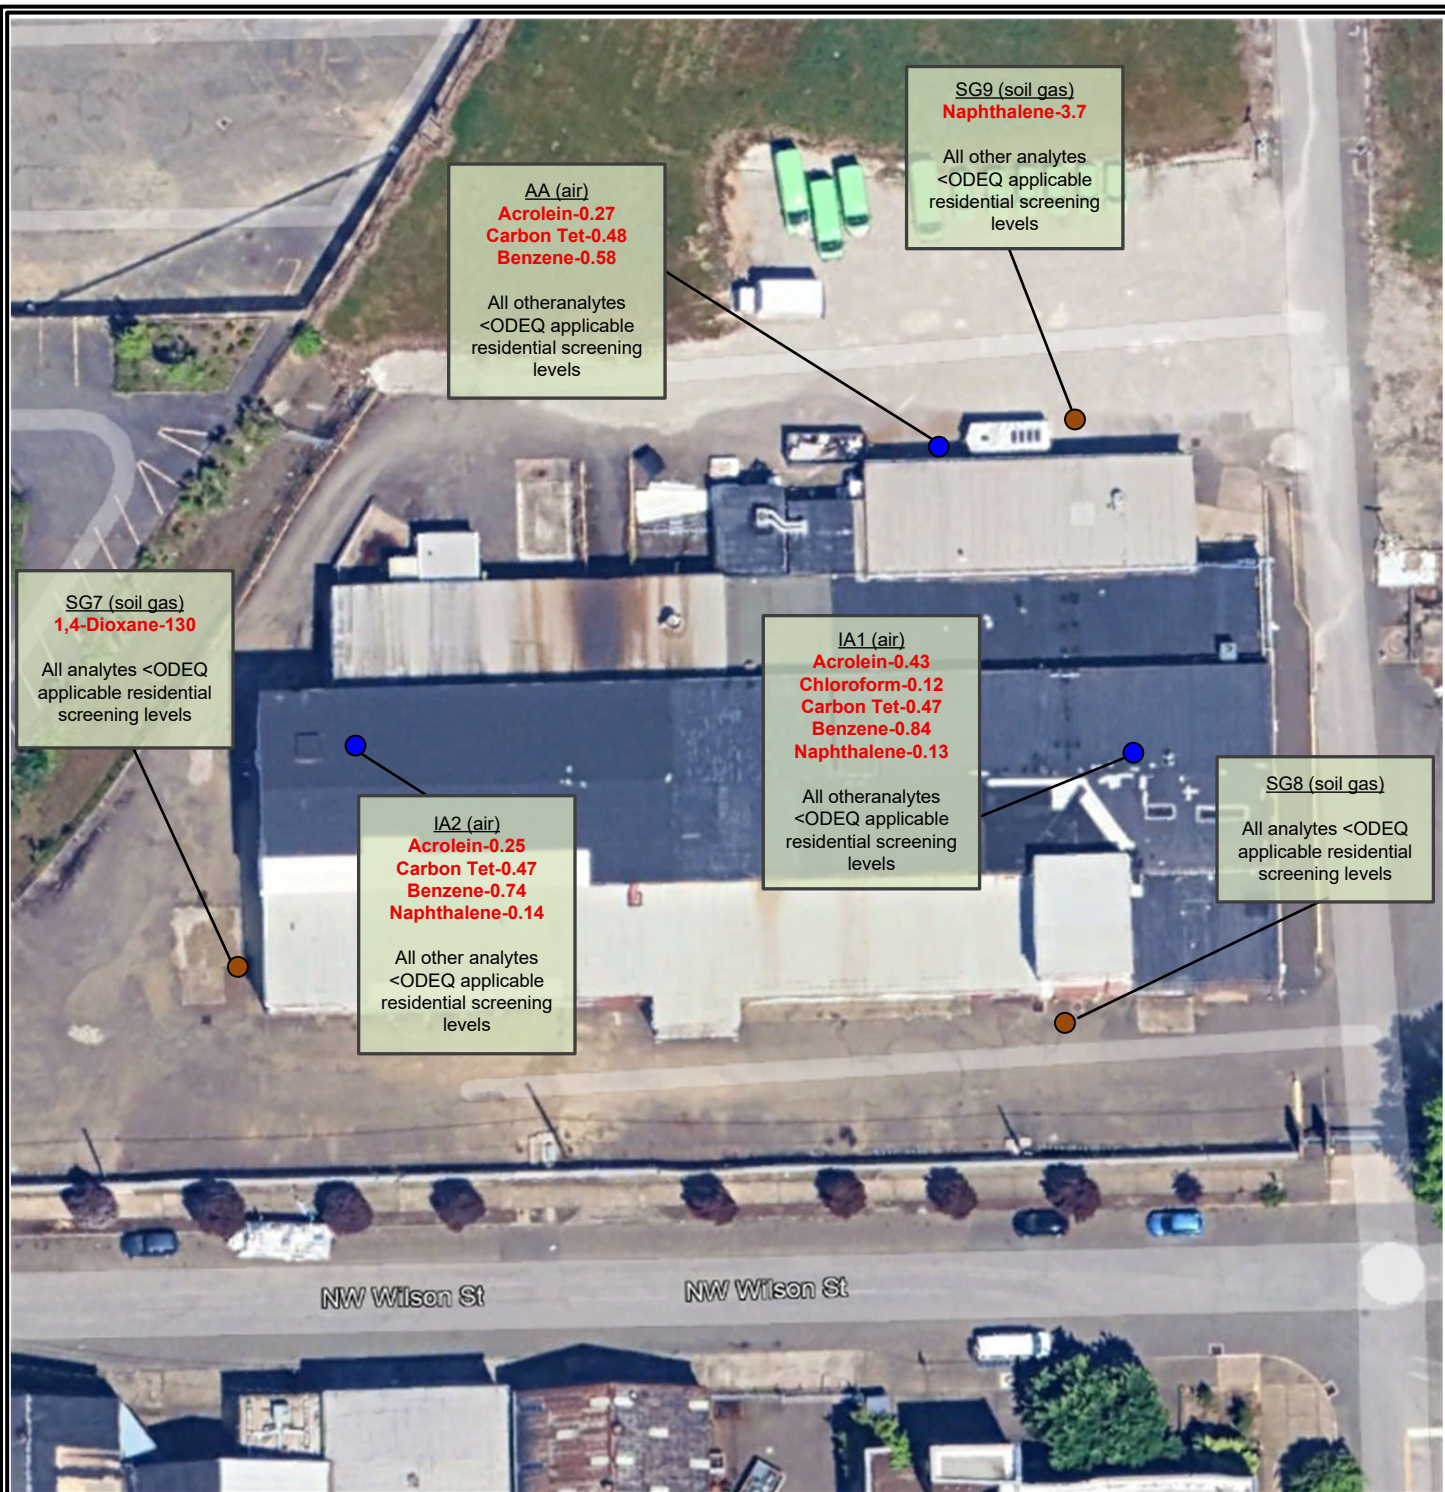
**FIGURE 10b: BUILDING 4 SAMPLE LOCATION DIAGRAM (>RBCsv/RBCair for residential receptors; November 2025)**

unacceptable risk to occupational building users. Acrolein was detected in soil gas at concentrations above the residential RBC, and future redevelopment into residential use should further assess and mitigate potential vapor intrusion risks associated with acrolein.

- One soil gas sample exceeded the residential RBC for naphthalene. Future redevelopment into residential use should mitigate potential vapor intrusion risks associated with naphthalene.

- The outdoor (background) and indoor air samples exceeded the residential RBC for carbon tetrachloride. Carbon tetrachloride was not detected in soil gas and appear to be associated with an ambient background condition.

- The outdoor (background) and indoor air samples exceeded the residential RBC for benzene. The indoor air benzene results are consistent with outdoor air, indicating that indoor air detections of benzene may be associated with a regional background condition. However, benzene was previously detected in soil gas at concentrations above the residential RBC, and future redevelopment into residential use should further assess and mitigate potential vapor intrusion risks associated with benzene.
