Temperature TMDL Supplemental Information: Geomorphology and Groundwater Connectivity Assessment

Rogue River Tributary – Little Butte Creek
Geomorphology and Groundwater Connectivity
Assessment

Final Report

December 2008

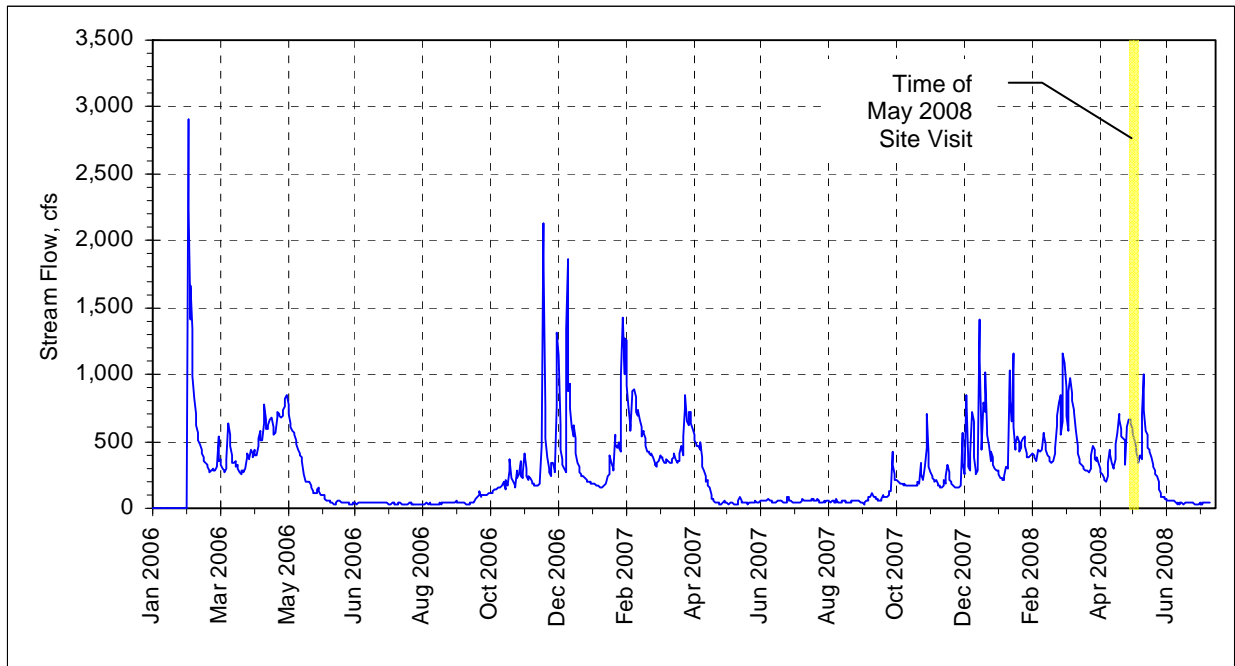
Figure 2-2
Recent Stream Flows of Little Butte Creek at Eagle Point.
(USBR, 2008)

At the time of the site visit, the watershed was generally characterized by flows that were atypically high for mid- to late spring. Though the weather was warm and there was no precipitation in the days leading up to the site visit, flows throughout the creek were relatively high. High flows were the result of the late and substantial snowfall and subsequent snowmelt/runoff in April. Flows seemed to be near bankfull depth at most or all locations along the Mainstem and North and South Forks. Although bankfull depth was generally difficult to discern because channelization of the creek was typical, flow depths were judged to be near bankfull as vegetation at the lower stream bank was mostly underwater (see Appendix B, page B-7 Harnish Park, and page B-8 Agate Road Bridge).

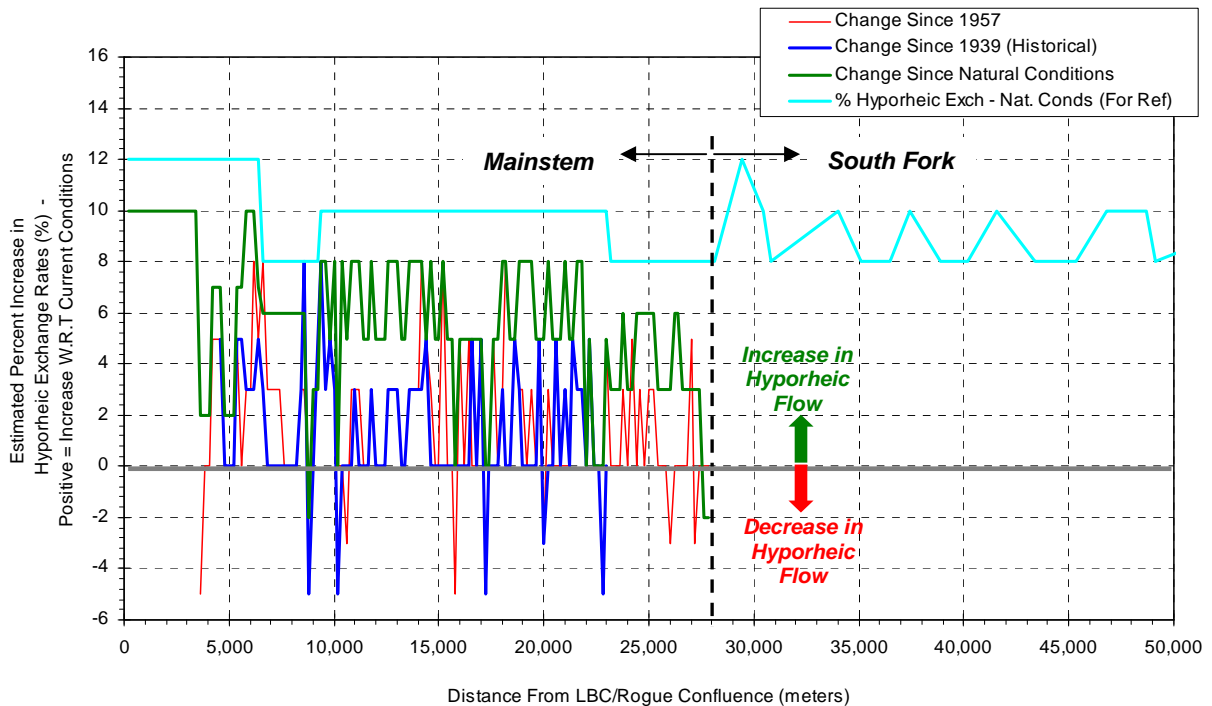
Figure 3-1
Estimated Percent Changes in Hyporheic Flow Exchange in Little Butte Creek (Mainstem and South Fork).

Figure 3-1 displays the longitudinal variation of *changes in hyporheic exchange* for the various periods of comparison. This figure corresponds to but is different from Table 3-2 and Table 3-3 in that it shows changes in hyporheic exchange, rather than the hyporheic flow percents at a particular snapshot in time as do the tables. Changes in hyporheic flow can be either positive (increase in historical flow exchanges relative to current conditions) or negative (decrease in flow exchanges relative to current conditions). The red line in the figure indicates the relatively recent comparison to 1957 conditions; the darker blue line represents changes relative to 1939; and the green line indicates the change relative to natural conditions.

Results show that on average the hyporheic exchange of the natural conditions (pre-development) ranges from -2% to 10% higher than current conditions (see Table 3-4 or Figure 3-1). The negative value in the range indicates a particular location where flow exchange was estimated to be greater today than what occurred naturally. This is a plausible result and could be caused for example by a relatively intact channel-floodplain connection that exists today, or by a particularly incised or eroded reach of stream that was visible in the historic aerial photos.

Figure 3-1 also shows the total percent hyporheic exchange of the natural conditions (light blue line) for reference. These values were provided as input to the temperature model to simulate the Natural Thermal Potential (NTP) scenario. It is important to note that this curve does not represent the change in flows relative to current conditions as do the other curves; rather, it represents the total magnitude of flows.

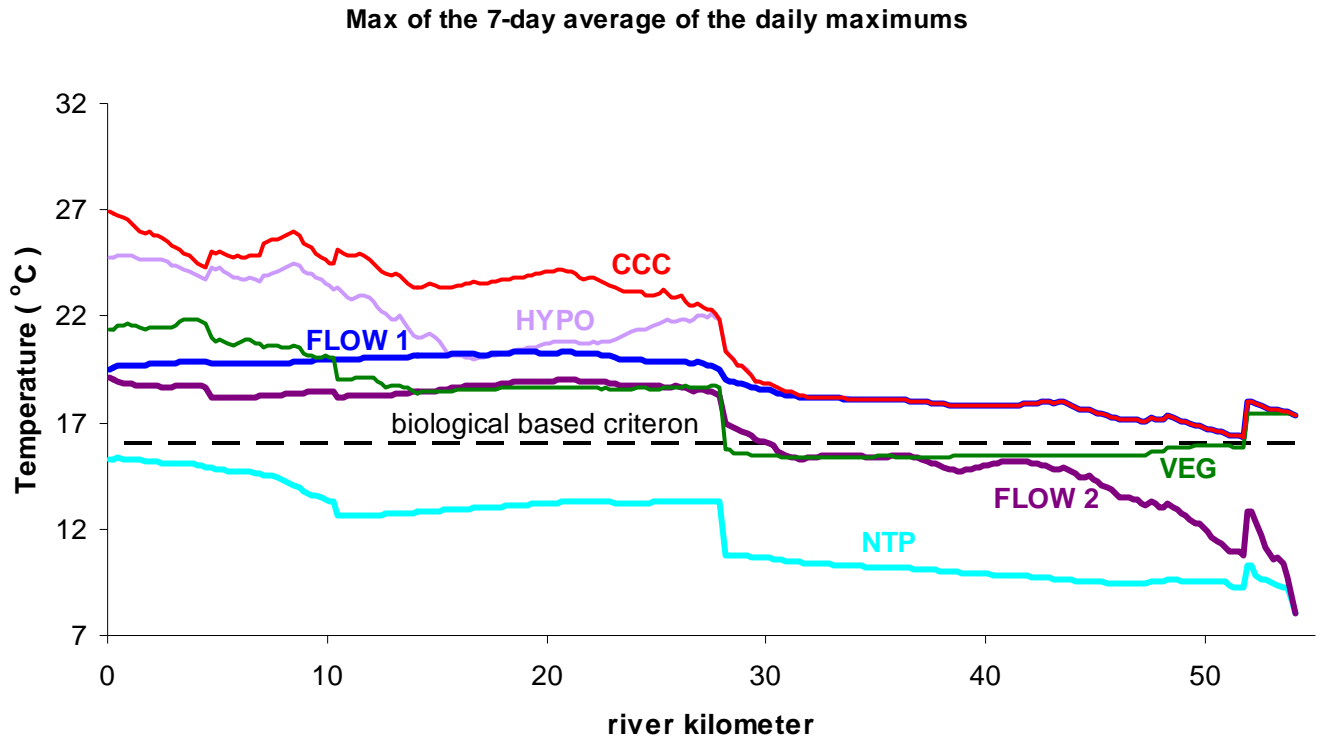
Figure 3-2
Comparison of Results for Various Temperature Scenario Simulations; Note Comparison of the Current Conditions (“CCC”) Shown as a Red Line Versus the Hyporheic Conditions (“Hypo”) Shown in Lavender. Other ODEQ Modeling Scenarios are Shown for Reference Only and Do Not Pertain Directly to the Hyporheic Flow Scenario.

In addition and as part of *Step 5* of the approach described in Section 3.1.1, hyporheic estimates were evaluated in the ODEQ temperature model and found to have reasonable and expected impacts on stream temperatures. Impacts to stream temperatures are shown in Figure 3-2. The plot shows stream temperatures as a function of river kilometer, beginning at kilometer zero at the confluence with the Rogue River. The scenarios of interest are the current conditions, “CCC,” shown in red, and the hyporheic scenario, “Hypo,” shown in lavender. The hyporheic scenario is based on the current conditions and also includes the hyporheic flow estimates representing the natural conditions (light blue line in Figure 3-1). Differences between these lines indicate the impacts of incorporating hyporheic flow into the model. On average the difference in stream temperatures is 1.0 degrees Celsius, and the maximum difference is approximately 3.5 degrees Celsius. These impacts on stream temperatures are well within the ranges cited in literature (see Section 2.4).

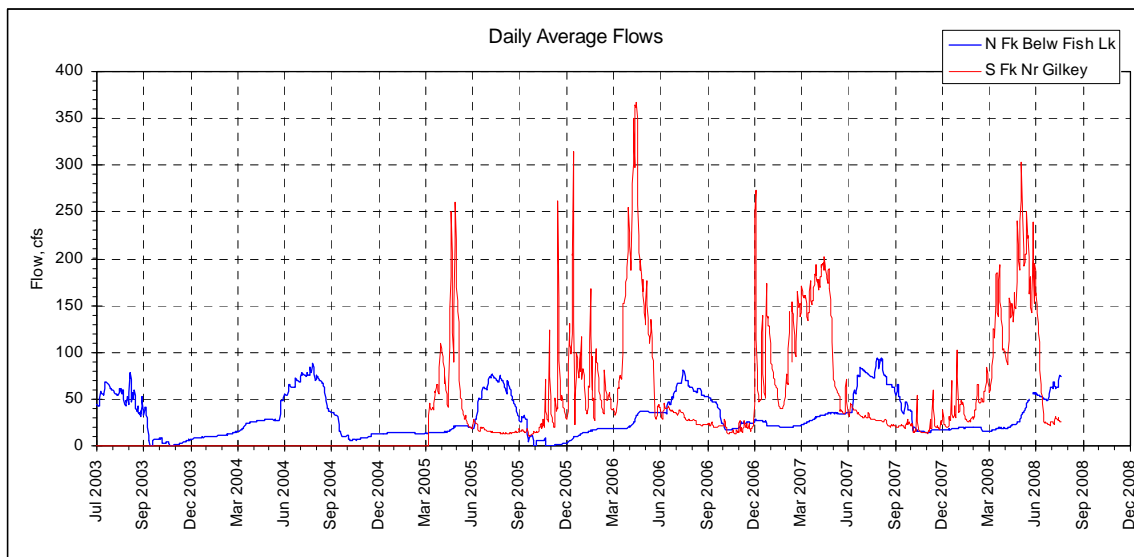
Figure 4-7
North Fork and South Fork Daily Flows.

Another contributing factor to the larger diurnal fluctuation in the South Fork could be its relatively small flow. During August the average flow in the South Fork is approximately 22 cfs versus approximately 70 cfs in the North Fork. The spring-fed inflows in the South Fork likely experience some degree of atmospheric heat exchange by the time they reach Gilkey.

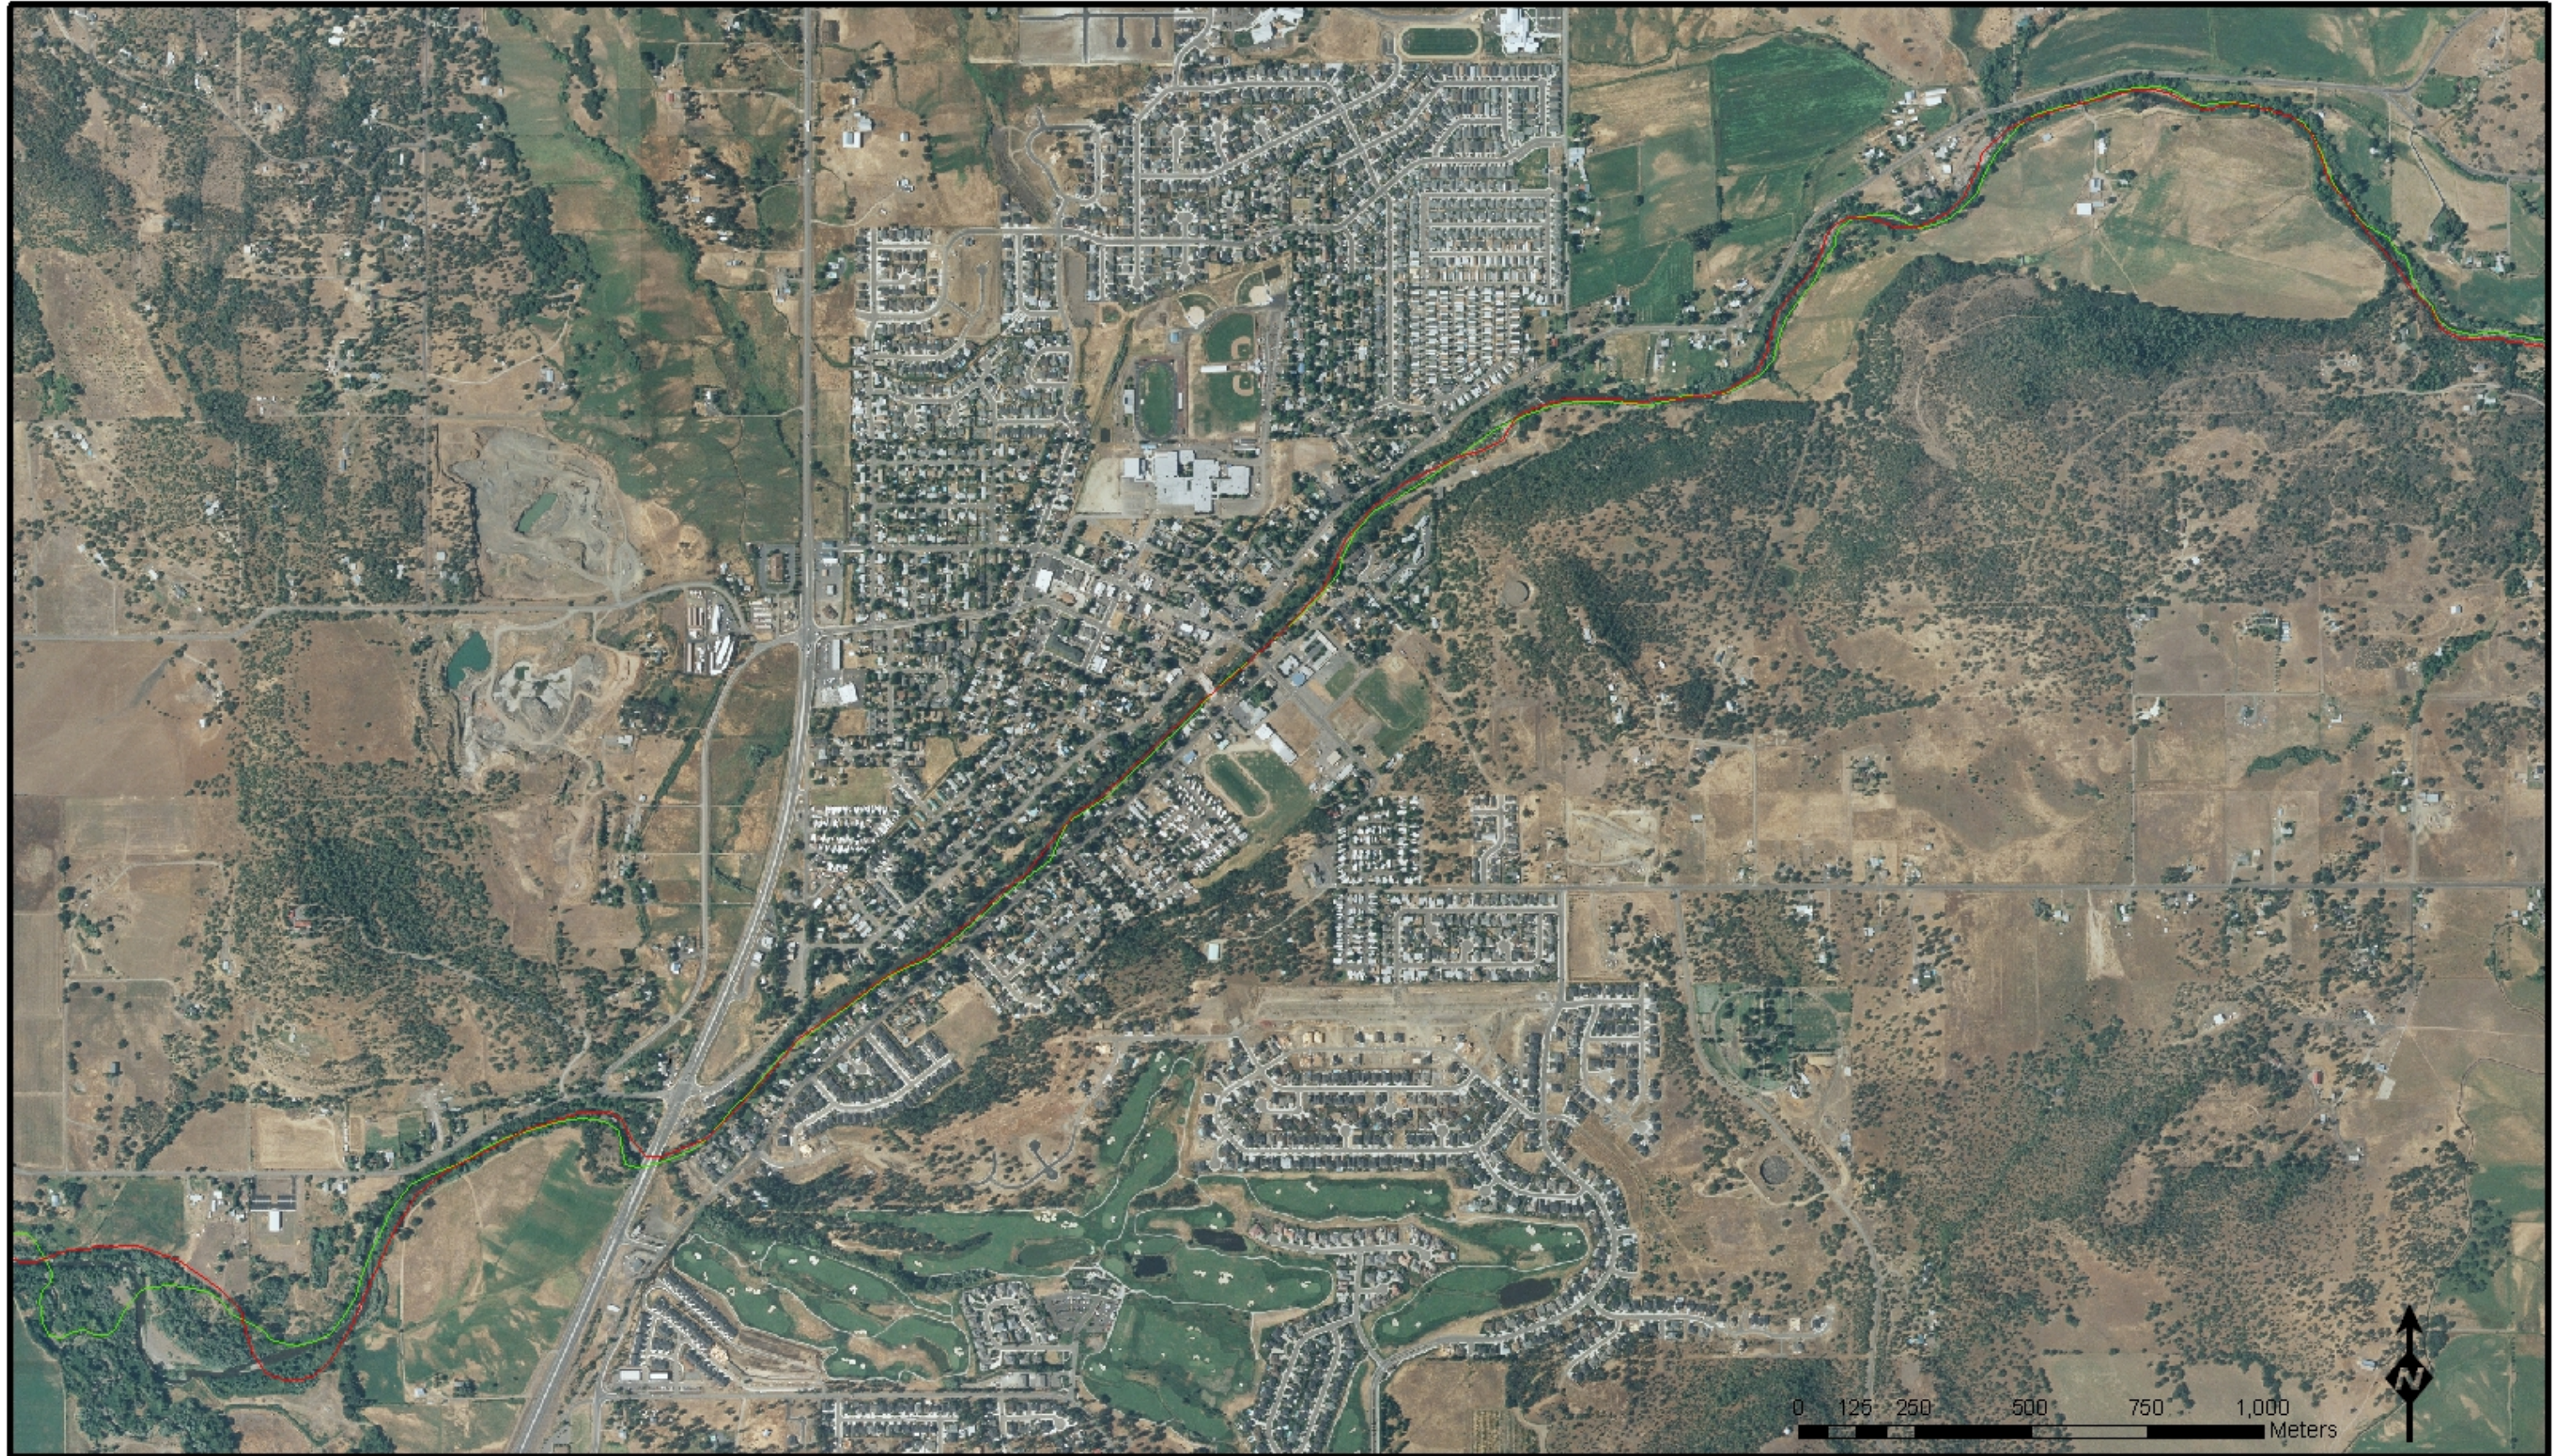
PLATE I - 2005

Aerial Photograph Analysis

The aerial photo-records are shown in series of plates in Appendix A. The plates are organized by time period, beginning with the most recent period and progressing backwards in time. This convention is followed because changes in the stream are recorded relative to the baseline condition which is the current condition (2005 photographs). For each time period, the plates are organized from upstream to downstream. For example “Plate I-2005” is the first series of photographs for 2005 beginning at the Rogue River Confluence, and Plate II-2005 is the second and downstream series of photographs, etc.

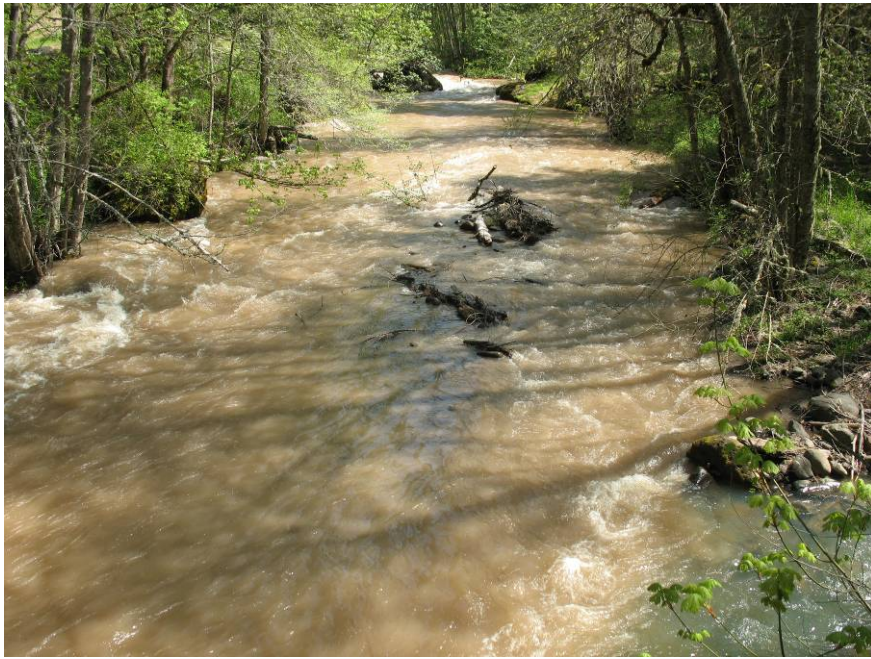
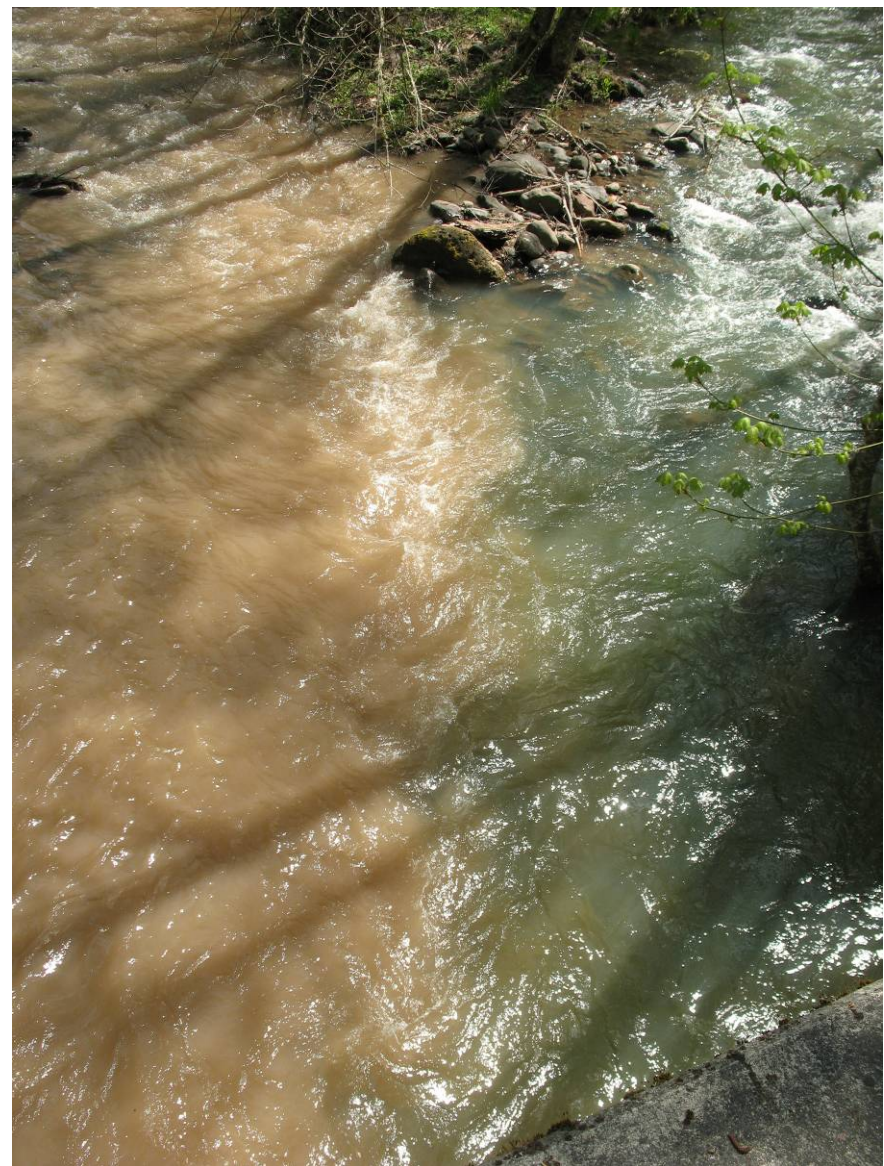
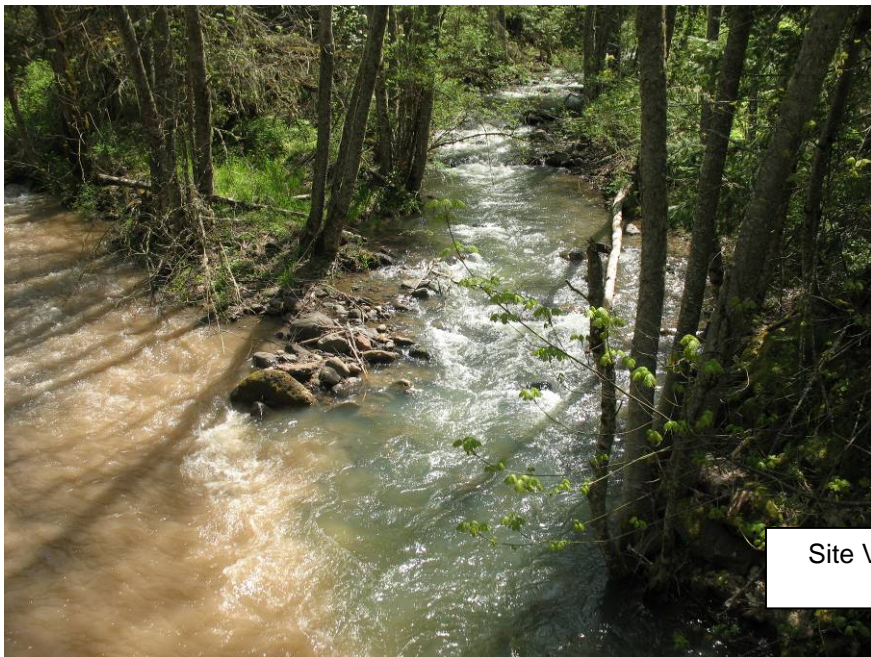
Site Visit – South Fork LBC (turbid) / Soda Creek (clear) Confluence
(05/08/08 Approx 12:00 pm)

ODEQ staff has in the past observed other similar large-scale mass wasting events that cause high suspended sediment pulses in the South Fork. To date the source or specific location of the high sediment loads during the site visit has not been confirmed. The photos on page B-11 show the contrasting turbid waters of the South Fork and the Soda Creek tributary, which was not influenced by the erosion event. In this series of photos, the South Fork is on the left (looking upstream), and Soda Creek is on the right.

Excessive suspended sediment loading was also observed throughout the Mainstem and South Fork reaches. It was hypothesized that a landslide, bank failure, or similar mass wasting event had occurred somewhere in the upper watershed. The high sediment loads were not seen on the North Fork. After driving up the South Fork as far as Camp Latagawa (near Dead Indian Soda Springs), the bankslope failure event was not observed and was presumed to have occurred farther upstream because high sediment loads were visible at this location.

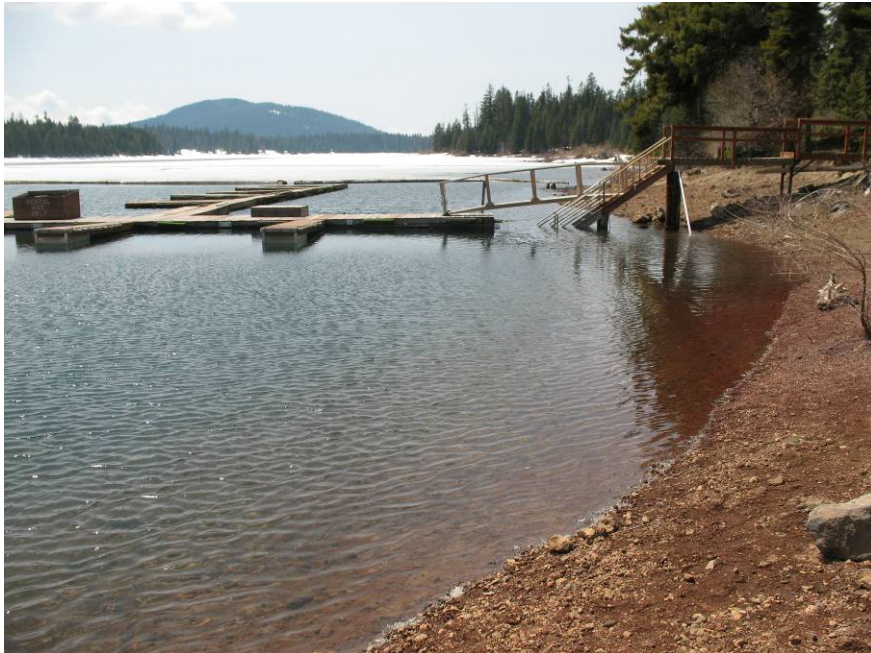
Site Visit – Fish Lake
(05/08/08 Approx 2:00 pm)

The particularly cold spring and late snowfall was also apparent at Fish Lake where a large portion of the lake was covered with ice (Appendix B, page B-12). During the visit, the resort maintenance manager commented that they had only recently gained access to the floating boat and fishing docks because of the late-season ice.
