From:	Ahlquist, Stephen
To:	WELLS-ALBERS Rebecca * DEQ; DAUGHERTY Katie * DEQ; MASTER Kara E * DEQ
Cc:	SCHATZ Jeff * DEQ; Rick Ernst; Casler, Jennifer; Steve Mahony; Klopfenstein, Andy
Subject:	RE: Johnson Oil IRAM Implementation Field Summary
Date:	Friday, May 13, 2022 4:34:57 PM
Attachments:	image001.png image002.png

Here is a quick update on work completed this week at the Johnson Oil site:

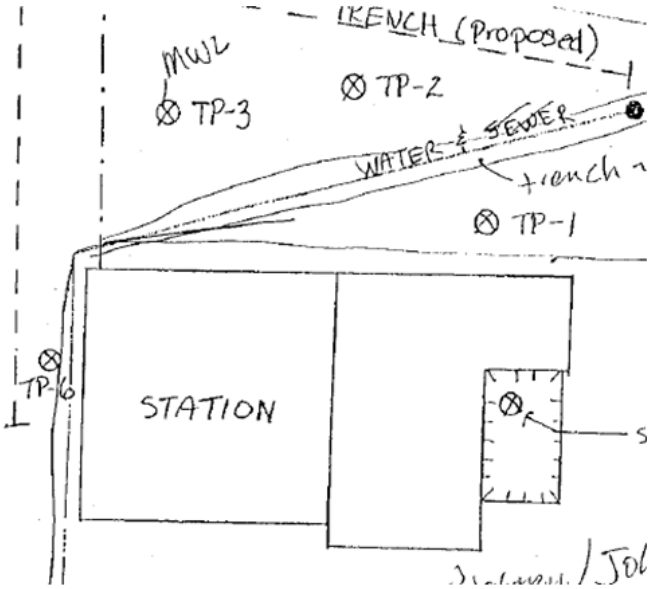
- Unknown well destroyed – A 4-inch PVC well was discovered in the general area of abandoned well MW-11. The well was capped and buried under at least a foot of gravel fill. The well was removed by excavation to approximately 10 feet bgs. Based on a sketch from a 1987 report provided by Rick (see below), it appears this was well MW-2, installed in 1987.
