From:	Ahlquist, Stephen
To:	WELLS-ALBERS Rebecca * DEQ; DAUGHERTY Katie * DEQ; MASTER Kara E * DEQ
Cc:	SCHATZ Jeff * DEQ; Rick Ernst; Casler, Jennifer; Steve Mahony; Klopfenstein, Andy
Subject:	Re: Johnson Oil IRAM Implementation Field Summary
Date:	Monday, May 16, 2022 4:13:29 PM
Attachments:	image001.png image002.png

From: Ahlquist, Stephen
Sent: Friday, May 13, 2022 4:34:40 PM
To: WELLS-ALBERS Rebecca * DEQ <Rebecca.WELLS-ALBERS@deq.oregon.gov>; DAUGHERTY Katie * DEQ <Katie.DAUGHERTY@deq.oregon.gov>; MASTER Kara E * DEQ <Kara.E.MASTER@deq.oregon.gov>
Cc: SCHATZ Jeff * DEQ <Jeff.SCHATZ@deq.oregon.gov>; Rick Ernst <rernst@gsiws.com>; Casler, Jennifer <JCasler@haleyaldrich.com>; Steve Mahony <SMahony@haleyaldrich.com>; Klopfenstein, Andy <AKlopfenstein@haleyaldrich.com>
Subject: RE: Johnson Oil IRAM Implementation Field Summary
Hi All,
Here is a quick update on work completed this week at the Johnson Oil site:

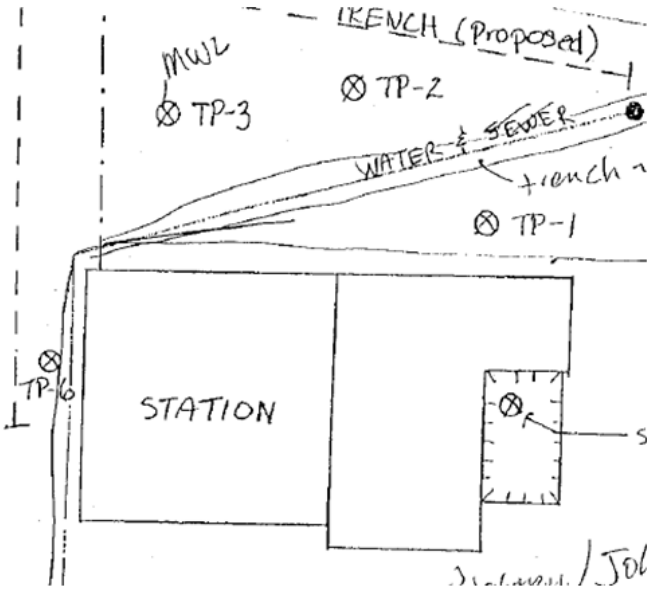
- Unknown well destroyed – A 4-inch PVC well was discovered in the general area of abandoned well MW-11. The well was capped and buried under at least a foot of gravel fill. The well was removed by excavation to approximately 10 feet bgs. Based on a sketch from a 1987 report provided by Rick (see below), it appears this was well MW-2, installed in 1987.
