From:	Ahlquist, Stephen
To:	MASTER Kara E * DEQ
Subject:	RE: Johnson Oil IRAM Sample location figure/map
Date:	Thursday, May 26, 2022 12:04:41 PM
Attachments:	image001.png image002.png Draft JO excavation sample locations.pdf

From: Ahlquist, Stephen <SAhlquist@haleyaldrich.com>
Sent: Tuesday, May 10, 2022 9:44 PM
To: DAUGHERTY Katie * DEQ <Katie.DAUGHERTY@deq.oregon.gov>; MASTER Kara E * DEQ <Kara.E.MASTER@deq.oregon.gov>
Cc: WELLS-ALBERS Rebecca * DEQ <Rebecca.WELLS-ALBERS@deq.oregon.gov>; SCHATZ Jeff * DEQ <Jeff.SCHATZ@deq.oregon.gov>; Rick Ernst <rernst@gsiws.com>; Casler, Jennifer <JCasler@haleyaldrich.com>; Steve Mahony <SMahony@haleyaldrich.com>; Klopfenstein, Andy <AKlopfenstein@haleyaldrich.com>
Subject: Johnson Oil IRAM Implementation Field Summary

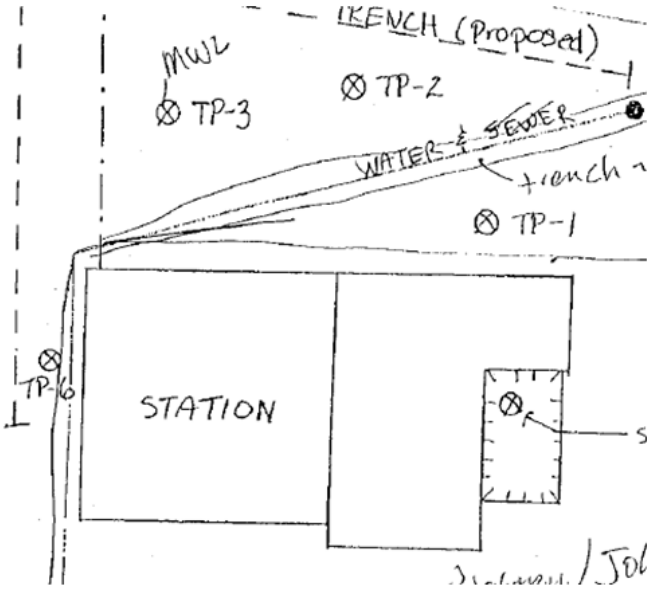
- Unknown well destroyed – A 4-inch PVC well was discovered in the general area of abandoned well MW-11. The well was capped and buried under at least a foot of gravel fill. The well was removed by excavation to approximately 10 feet bgs. Based on a sketch from a 1987 report provided by Rick (see below), it appears this was well MW-2, installed in 1987.
