From:	MASTER Kara E * DEQ
To:	"Ahlquist, Stephen"
Subject:	RE: Johnson Oil IRAM Sample location figure/map
Date:	Thursday, May 26, 2022 12:18:02 PM
Attachments:	image001.png image002.png

From: Ahlquist, Stephen
Sent: Friday, May 13, 2022 4:34:40 PM
To: WELLS-ALBERS Rebecca * DEQ <Rebecca.WELLS-ALBERS@deq.oregon.gov>; DAUGHERTY Katie * DEQ <Katie.DAUGHERTY@deq.oregon.gov>; MASTER Kara E * DEQ <Kara.E.MASTER@deq.oregon.gov>
Cc: SCHATZ Jeff * DEQ <Jeff.SCHATZ@deq.oregon.gov>; Rick Ernst <rernst@gsiws.com>; Casler, Jennifer <JCasler@haleyaldrich.com>; Steve Mahony <SMahony@haleyaldrich.com>; Klopfenstein, Andy <AKlopfenstein@haleyaldrich.com>
Subject: RE: Johnson Oil IRAM Implementation Field Summary
Hi All,
Here is a quick update on work completed this week at the Johnson Oil site:

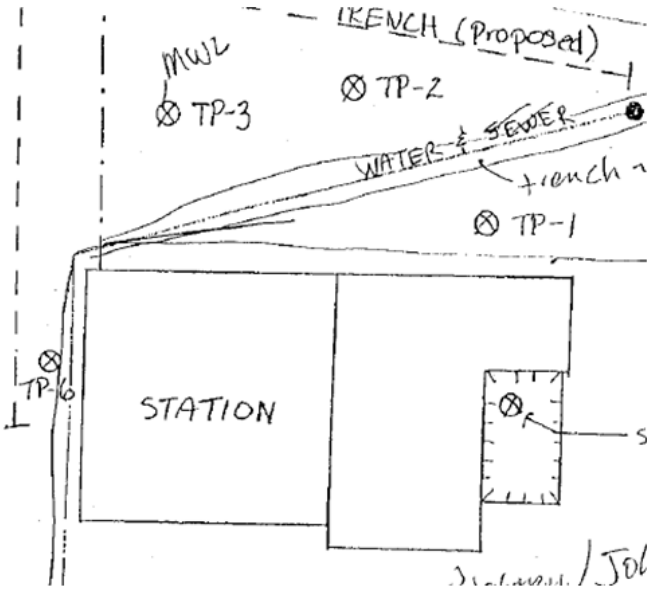
12 feet deep so this pipe must discharge to the river but we could not locate the outfall in the thick vegetation along the stream bank.
    - Unknown well destroyed – A 4-inch PVC well was discovered in the general area of abandoned well MW-11. The well was capped and buried under at least a foot of gravel fill. The well was removed by excavation to approximately 10 feet bgs. Based on a sketch from a 1987 report provided by Rick (see below), it appears this was well MW-2, installed in 1987.
