From:	Ahlquist, Stephen
To:	WELLS-ALBERS Rebecca * DEQ; DAUGHERTY Katie * DEQ; MASTER Kara E * DEQ
Cc:	SCHATZ Jeff * DEQ; Rick Ernst; Casler, Jennifer; Steve Mahony; Klopfenstein, Andy
Subject:	RE: Johnson Oil IRAM Implementation Field Summary
Date:	Tuesday, May 17, 2022 5:22:34 PM
Attachments:	image001.png image002.png

Here is a quick update on work completed this week at the Johnson Oil site:

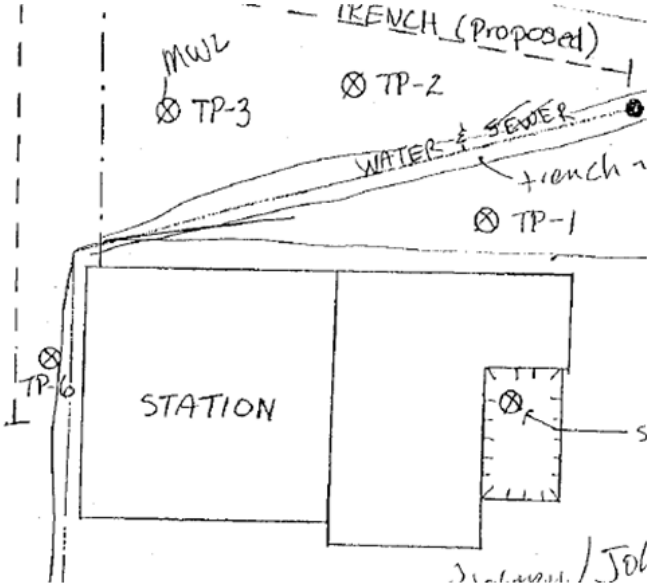
- Unknown well destroyed – A 4-inch PVC well was discovered in the general area of abandoned well MW-11. The well was capped and buried under at least a foot of gravel fill. The well was removed by excavation to approximately 10 feet bgs. Based on a sketch from a 1987 report provided by Rick (see below), it appears this was well MW-2, installed in 1987.
