From:	MASTER Kara E * DEQ
To:	"Ahlquist, Stephen"; WELLS-ALBERS Rebecca * DEQ; DAUGHERTY Katie * DEQ
Cc:	SCHATZ Jeff * DEQ; Rick Ernst; Casler, Jennifer; Steve Mahony; Klopfenstein, Andy; GRAEPER Melyssa * DEQ
Subject:	RE: Johnson Oil IRAM Implementation Field Summary
Date:	Friday, May 13, 2022 9:07:37 AM
Attachments:	image001.png image002.png 20220510_123020resized.jpg 20220510_145103resized.jpg 20220511_100058resized.jpg 20220511_151832resized.jpg 20220512_111825resized.jpg 20220512_125439resized.jpg

From: Ahlquist, Stephen <SAhlquist@haleyaldrich.com>
Sent: Thursday, May 12, 2022 6:42 PM
To: WELLS-ALBERS Rebecca * DEQ <Rebecca.WELLS-ALBERS@deq.oregon.gov>; DAUGHERTY Katie * DEQ <Katie.DAUGHERTY@deq.oregon.gov>; MASTER Kara E * DEQ <Kara.E.MASTER@deq.oregon.gov>
Cc: SCHATZ Jeff * DEQ <Jeff.SCHATZ@deq.oregon.gov>; Rick Ernst <rernst@gsiws.com>; Casler, Jennifer <JCasler@haleyaldrich.com>; Steve Mahony <SMahony@haleyaldrich.com>; Klopfenstein, Andy <AKlopfenstein@haleyaldrich.com>
Subject: RE: Johnson Oil IRAM Implementation Field Summary

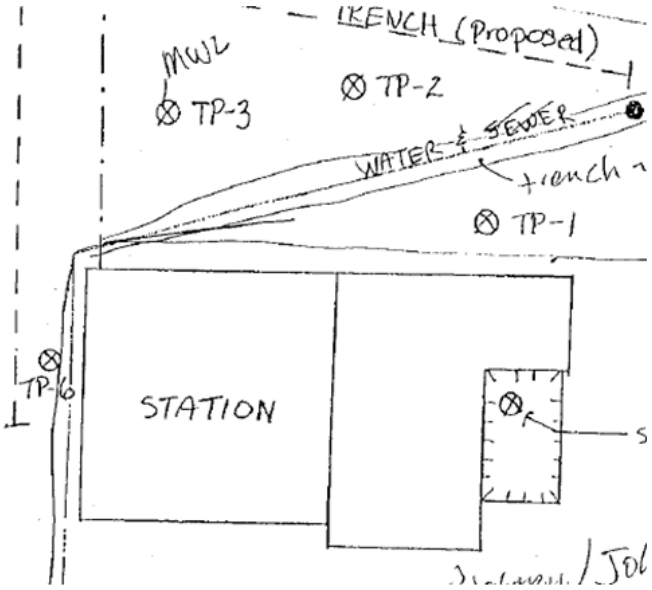
- Unknown well destroyed – A 4-inch PVC well was discovered in the general area of abandoned well MW-11. The well was capped and buried under at least a foot of gravel fill. The well was removed by excavation to approximately 10 feet bgs. Based on a sketch from a 1987 report provided by Rick (see below), it appears this was well MW-2, installed in 1987.
