### **CITY OF THE DALLES HISTORIC LANDMARKS COMMISSION**

HLC #57-01, 6<sup>th</sup> Street Bridge
- VII. Presentation by The Dalles Mural Society on possible new murals.**
- VIII. Next meeting date: March 28, 2001 – 4:00 p.m.**
- IX. Adjournment**

# Technical Evaluation Report

## West 6th Street Bridge Over Mill Creek

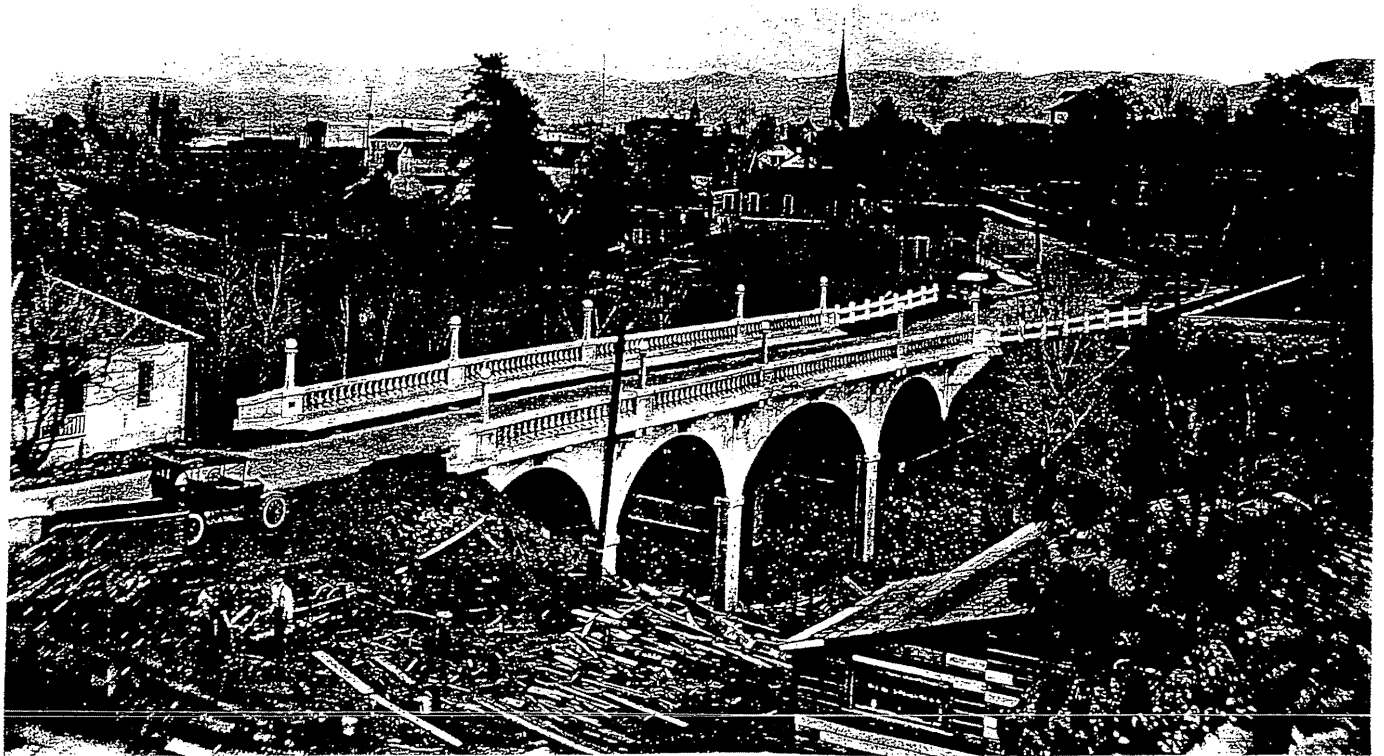
Photo 2 - A photo taken in 1920 when the bridge was nearing completion. This is one of best photographs of the complete bridge available as it was taken before the surrounding trees matured and obscured full views of the bridge. The photo is taken from a vantage point on the bluff southwest of the bridge, looking northeasterly.

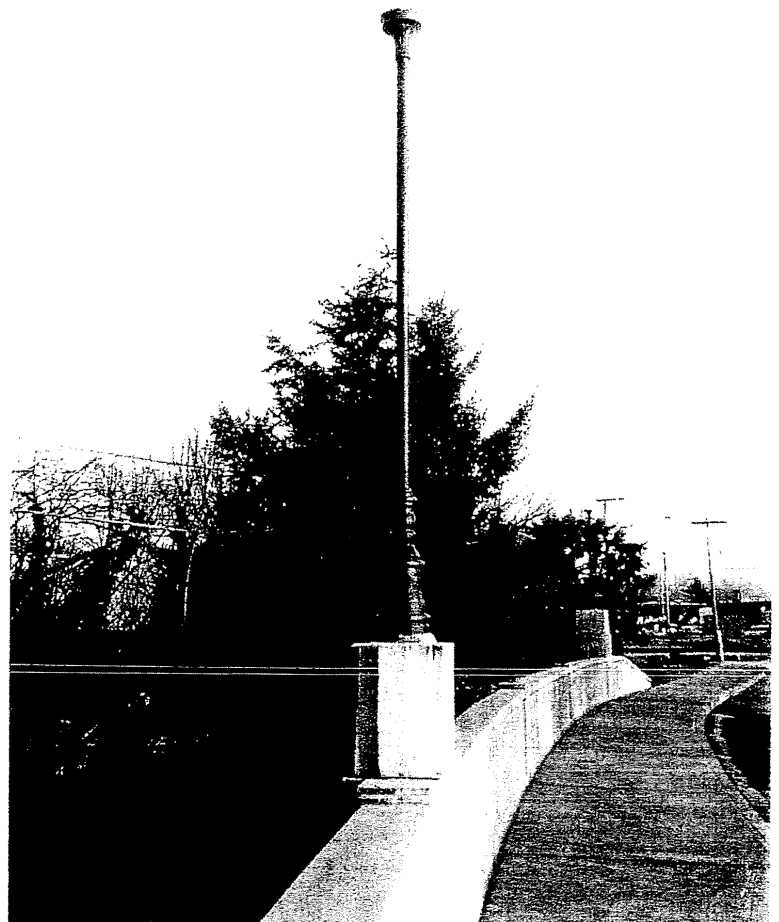
Photo 14 - This photo shows another view of the metal bridge rail posts used at Ehlman Road. The metal posts were about 9' tall, placing the lamps about 15 to 16 feet above the bridge deck. It would probably be better to have the lamps located about 10' above the bridge deck. This is high enough to reduce vandalism, but low enough to impart warm, low-level light to the sidewalk.

We recommend the street lights on the bridge be replaced by replications of the existing concrete lamp posts or metal lamp posts with antique configurations appropriate to the early 20<sup>th</sup> century replication. The posts will be capped with globe lighting fixtures with energy efficient long-life high pressure sodium 50 watt lamps, similar in function and appearance to the original, but with the globes made of translucent break resistant glass or plastic. If during demolition, it is demonstrated that the posts can be removed without damage and that the embedded conduit is not corroded beyond reuse, consideration will be given to restoring them to their original function in the replicated bridge rail. Examples of the metal lamp posts are shown in Photo 13 which shows the nine foot high metal lamp posts used at Ehlman Road bridge in the Aurora Historic District. These posts are available in shorter lengths making it possible to situate the lamps about ten feet above the bridge surface.

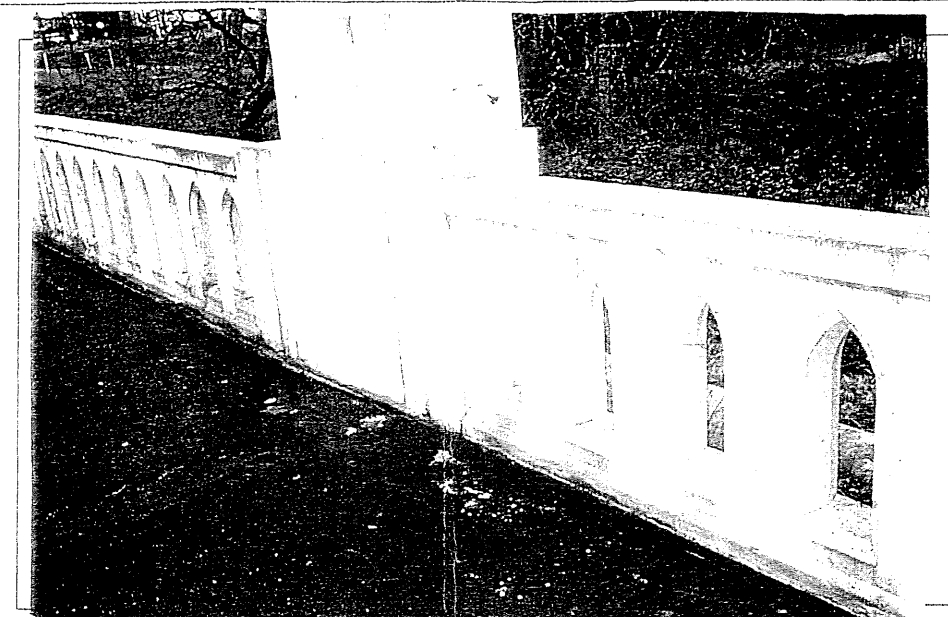
Notice the steel posts (about 9' tall) They are capped with high pressure sodium lamps (50 watt) in plastic globes. These could be used instead of the 4' high concrete lamp posts.

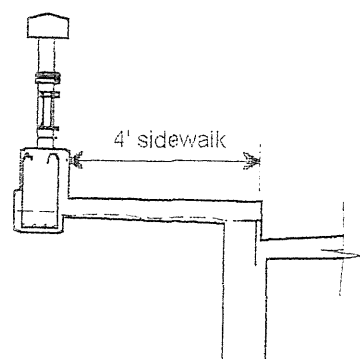
4' tall concrete lamp posts (shown) need replaced. Could use either a replicated concrete post or use taller 9' metal posts of historic configuration. Taller posts less susceptible to vandalism. Many post styles to chose from

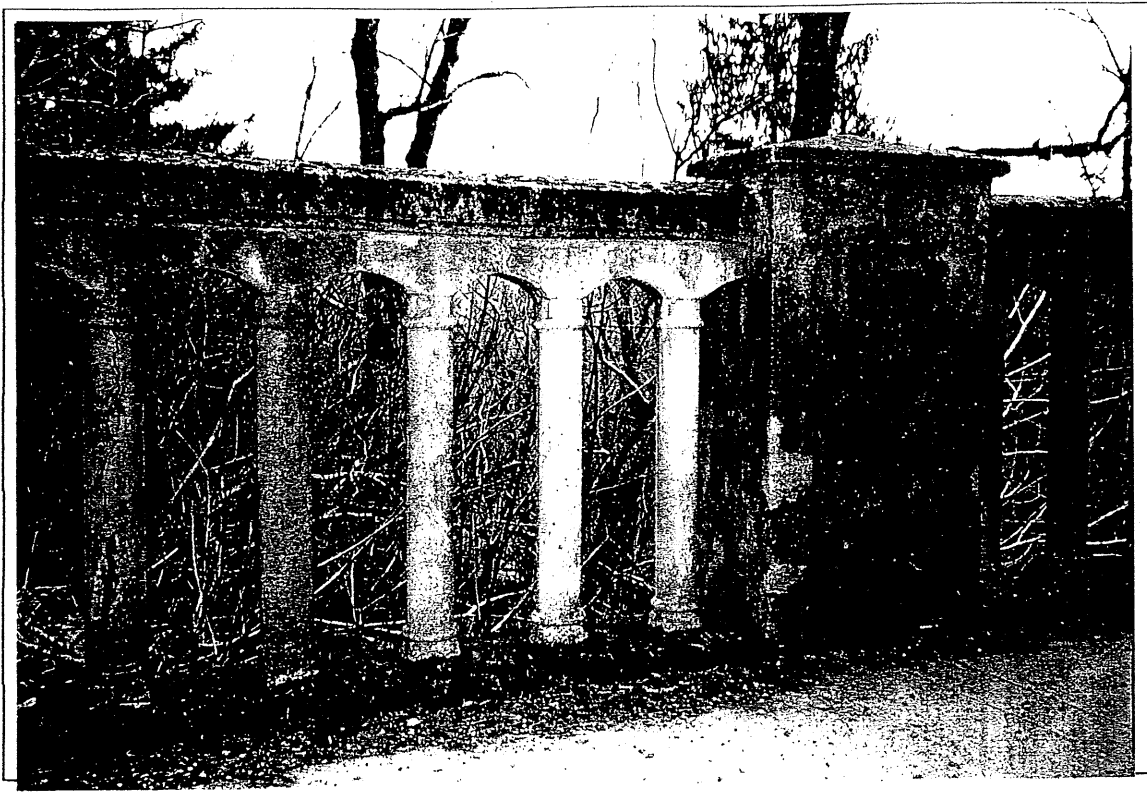
This is the bridge rail shown at the bridge at Latourel Falls (Guy Webster Talbot Wayside). This has precast balusters (4" diameter concrete) at 12 " ctrs with rail posts at 10' centers. This guardrail could be replicated' to meet pedestrian rail standards and bridge rail standard at the West 6th Street Bridge.

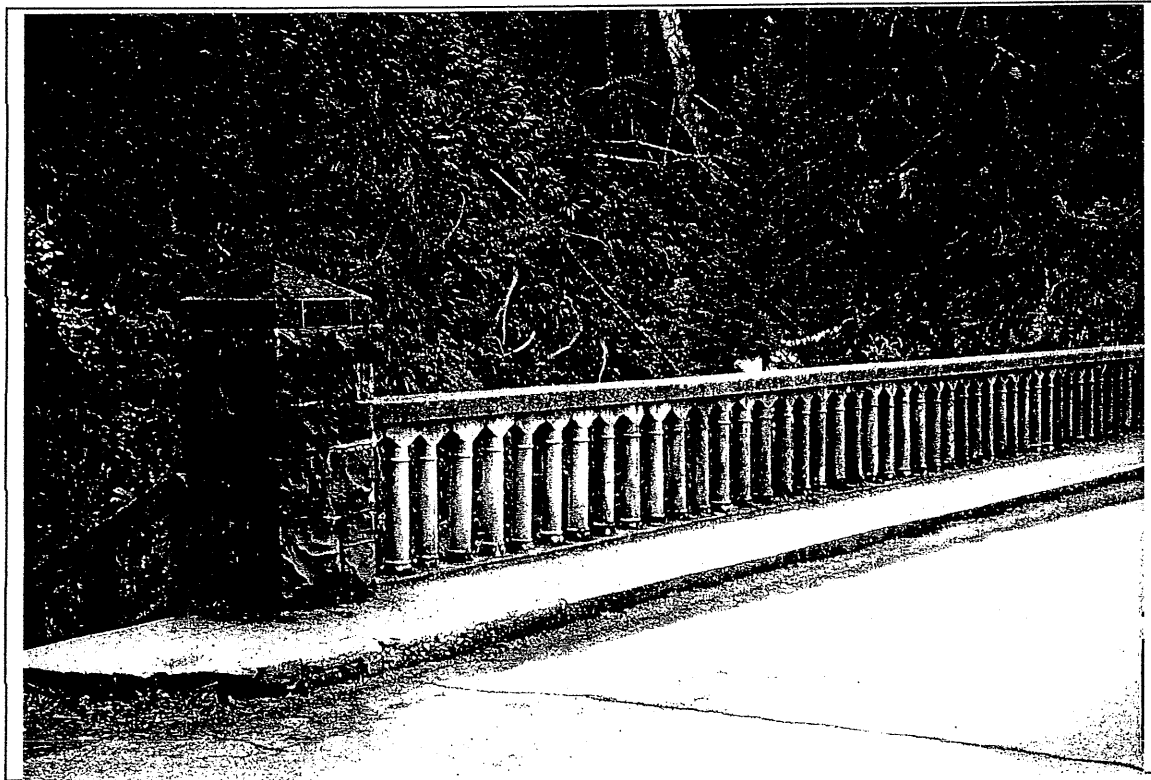
This is the bridge rail at Shepherds Dell Bridge. It is similar to the bridge rail at Latourel Falls, but has 5" diameter balusters. It is very questionable if this bridge rail could be configured to meet even a pedestrian rail standard. It has no bridge rail posts and depends entirely on the balusters for post action. It almost certainly would never meet a bridge rail standard.

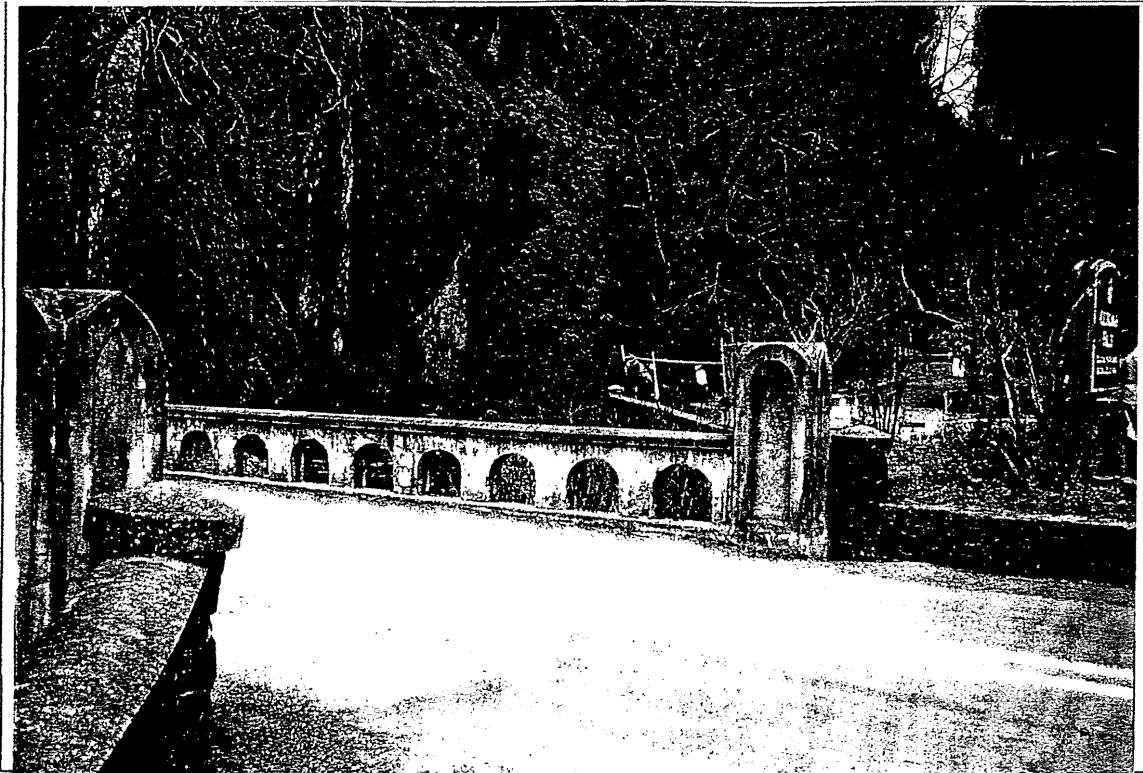
Photo at Multnomah Falls, lower bridge near walkway to restaurant and gift shop. This rail had no sidewalk. This bridge rail could be made to accomodate both bridge rail and pedestrian rail specifications. The openings are presently so wide that some form of accomodation would have to be made to close in the opening. At the coast, (Hwy 101 over the Rogue River), openings which are too wide were closed in by embedding smooth steel rods (epoxy anchored) to make the openings smaller. The steel rods are not visually noticable in that application. This is the rail shown on original W. 6th Street Bridge plans.

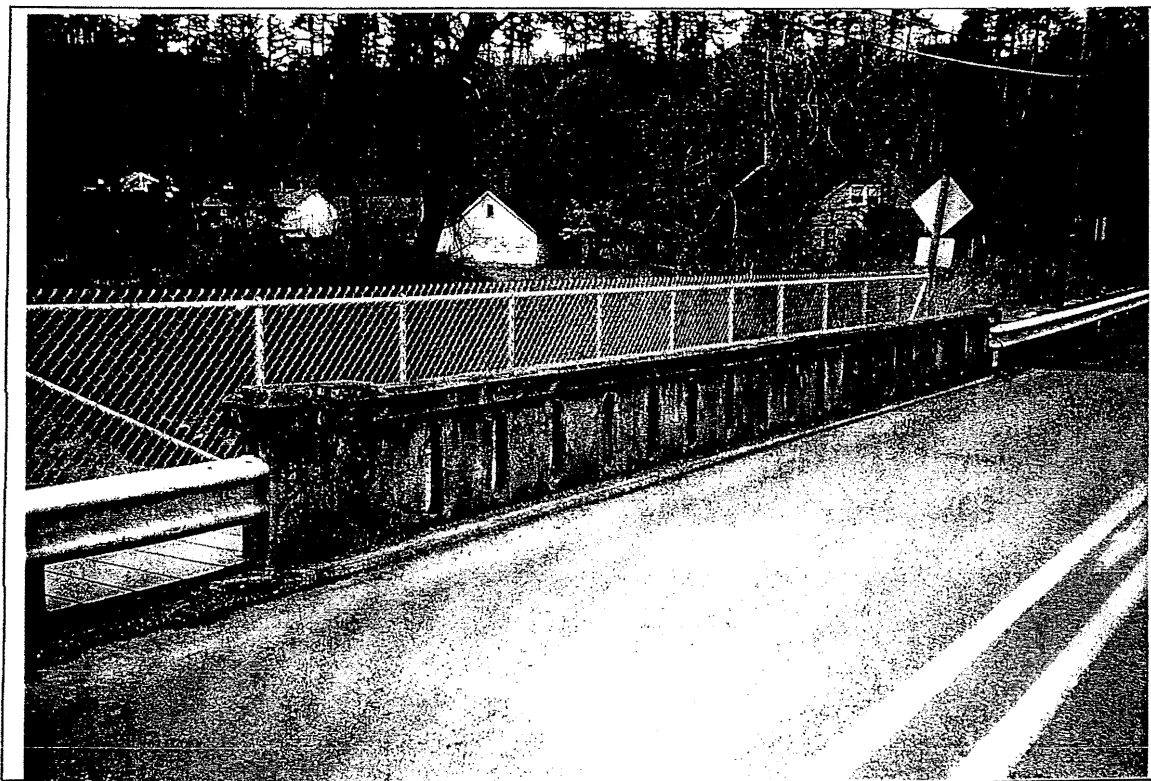
Bridge Rail on the Columbia Gorge Scenic Highway just east of Troutdale. This bridge rail could be made to meet all standards for bridge rail and pedestrian rail.
