2014 ANNUAL MONITORING AND MAINTENANCE REPORT

Ross Island Sand & Gravel Company
Portland, Oregon

Annual Monitoring and Maintenance Report

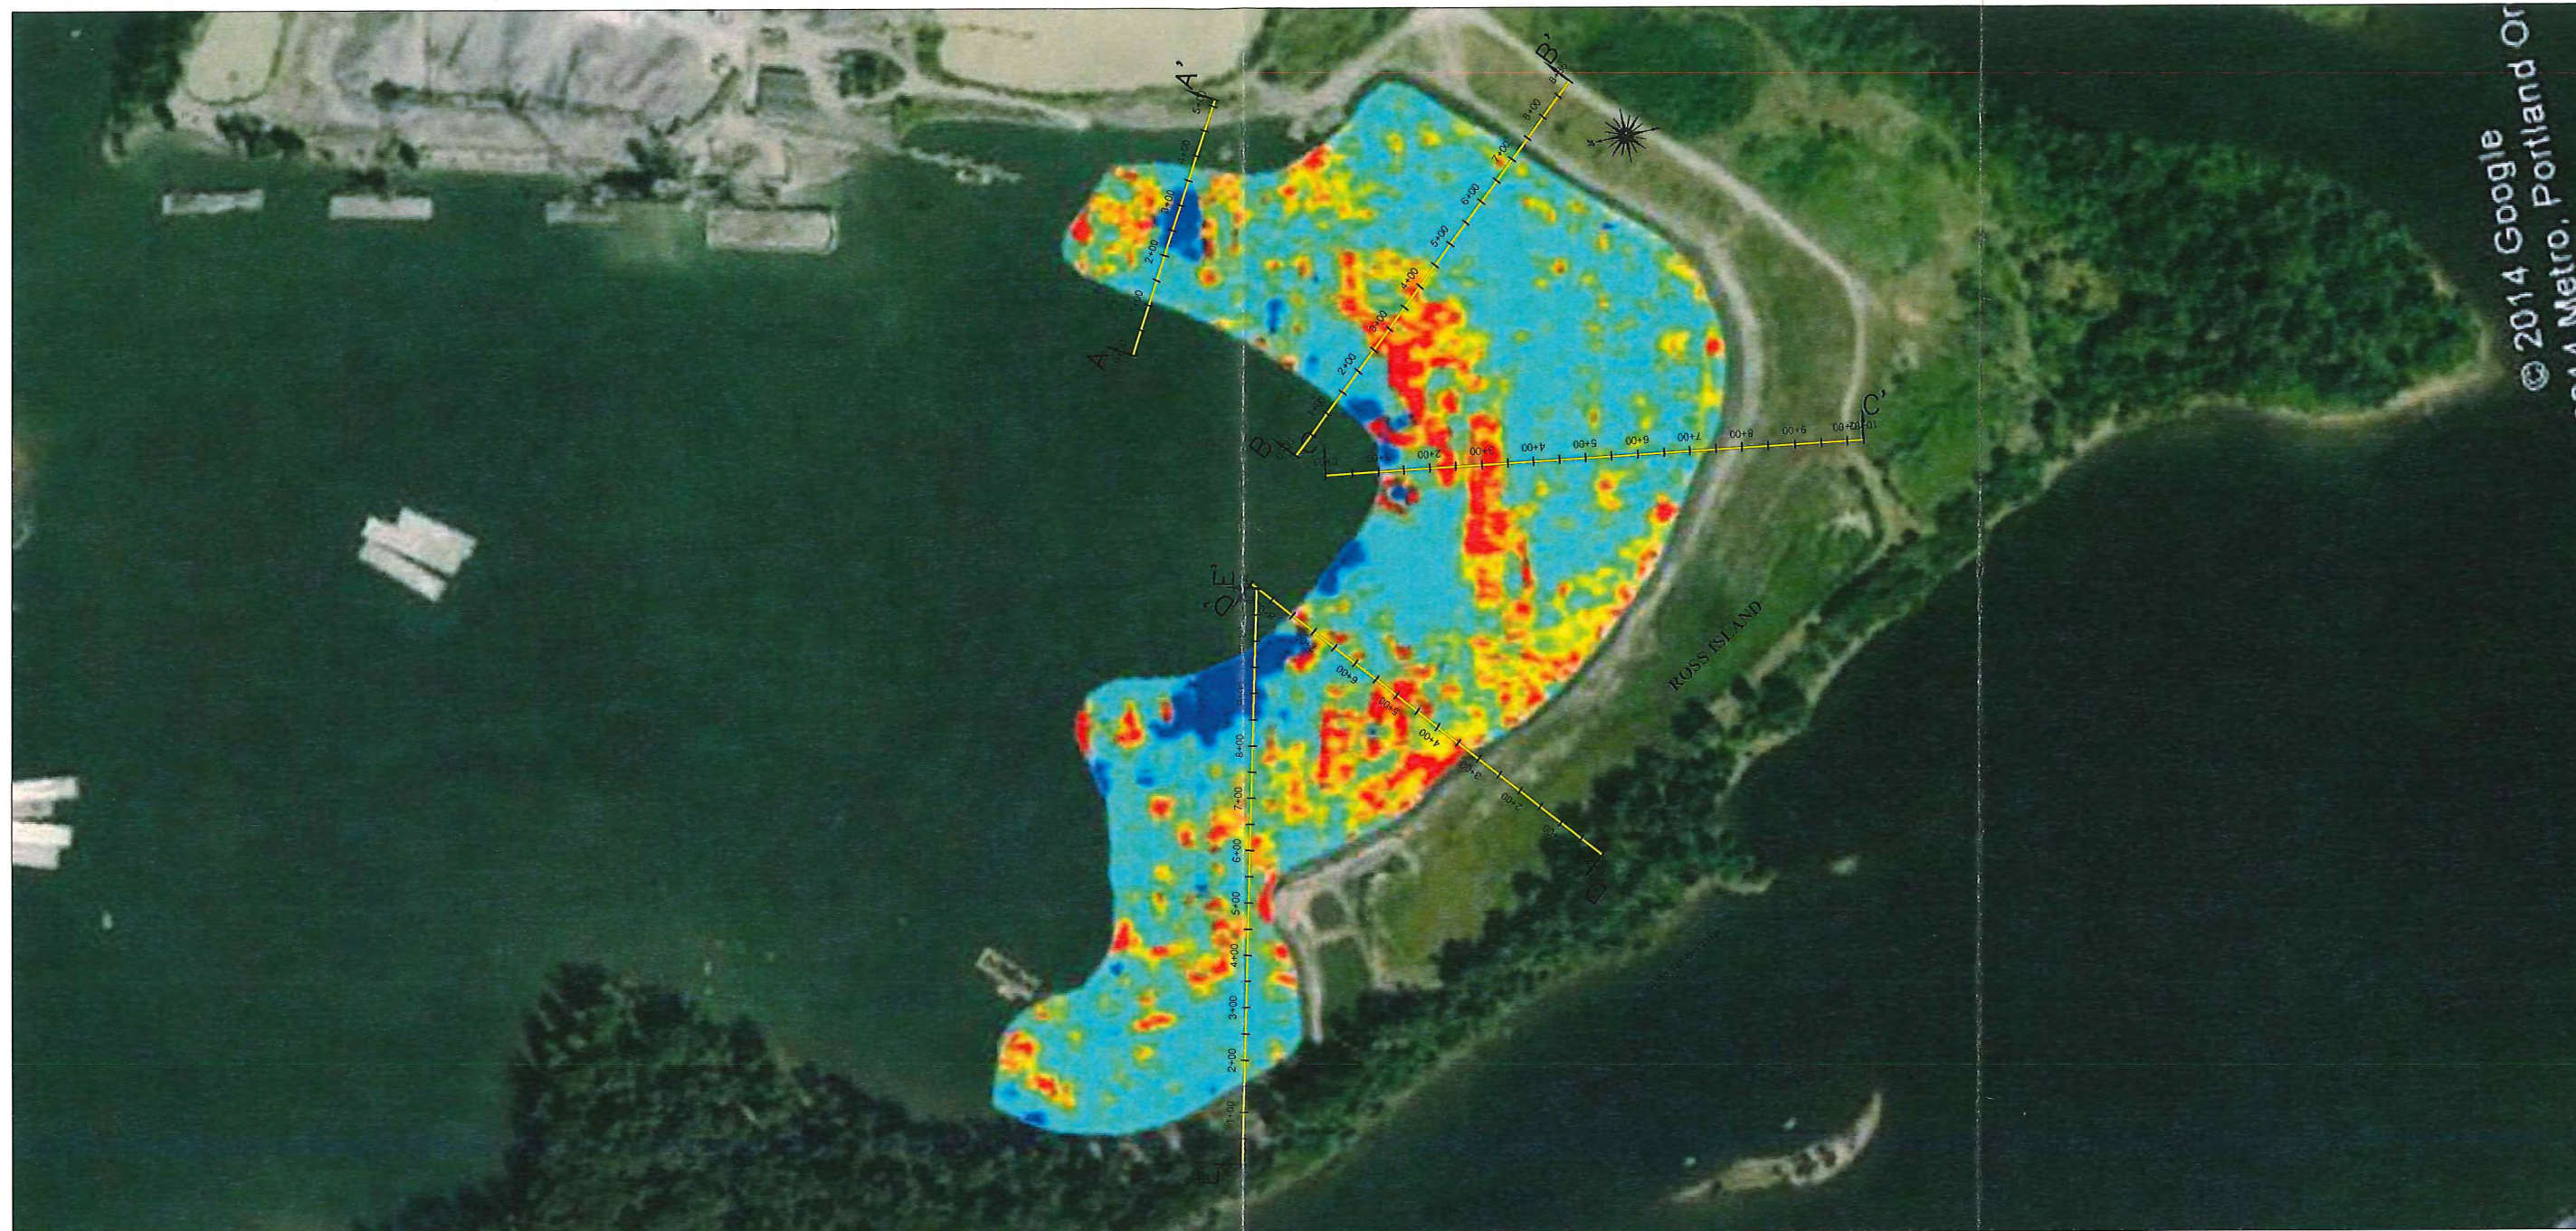
Upon closer inspection of the data, it appears this elevation loss may be attributed to how modeling software interprets and compares the historical and current bathymetric data. Additionally, fill placement activities in this area may have caused surficial sloughing.

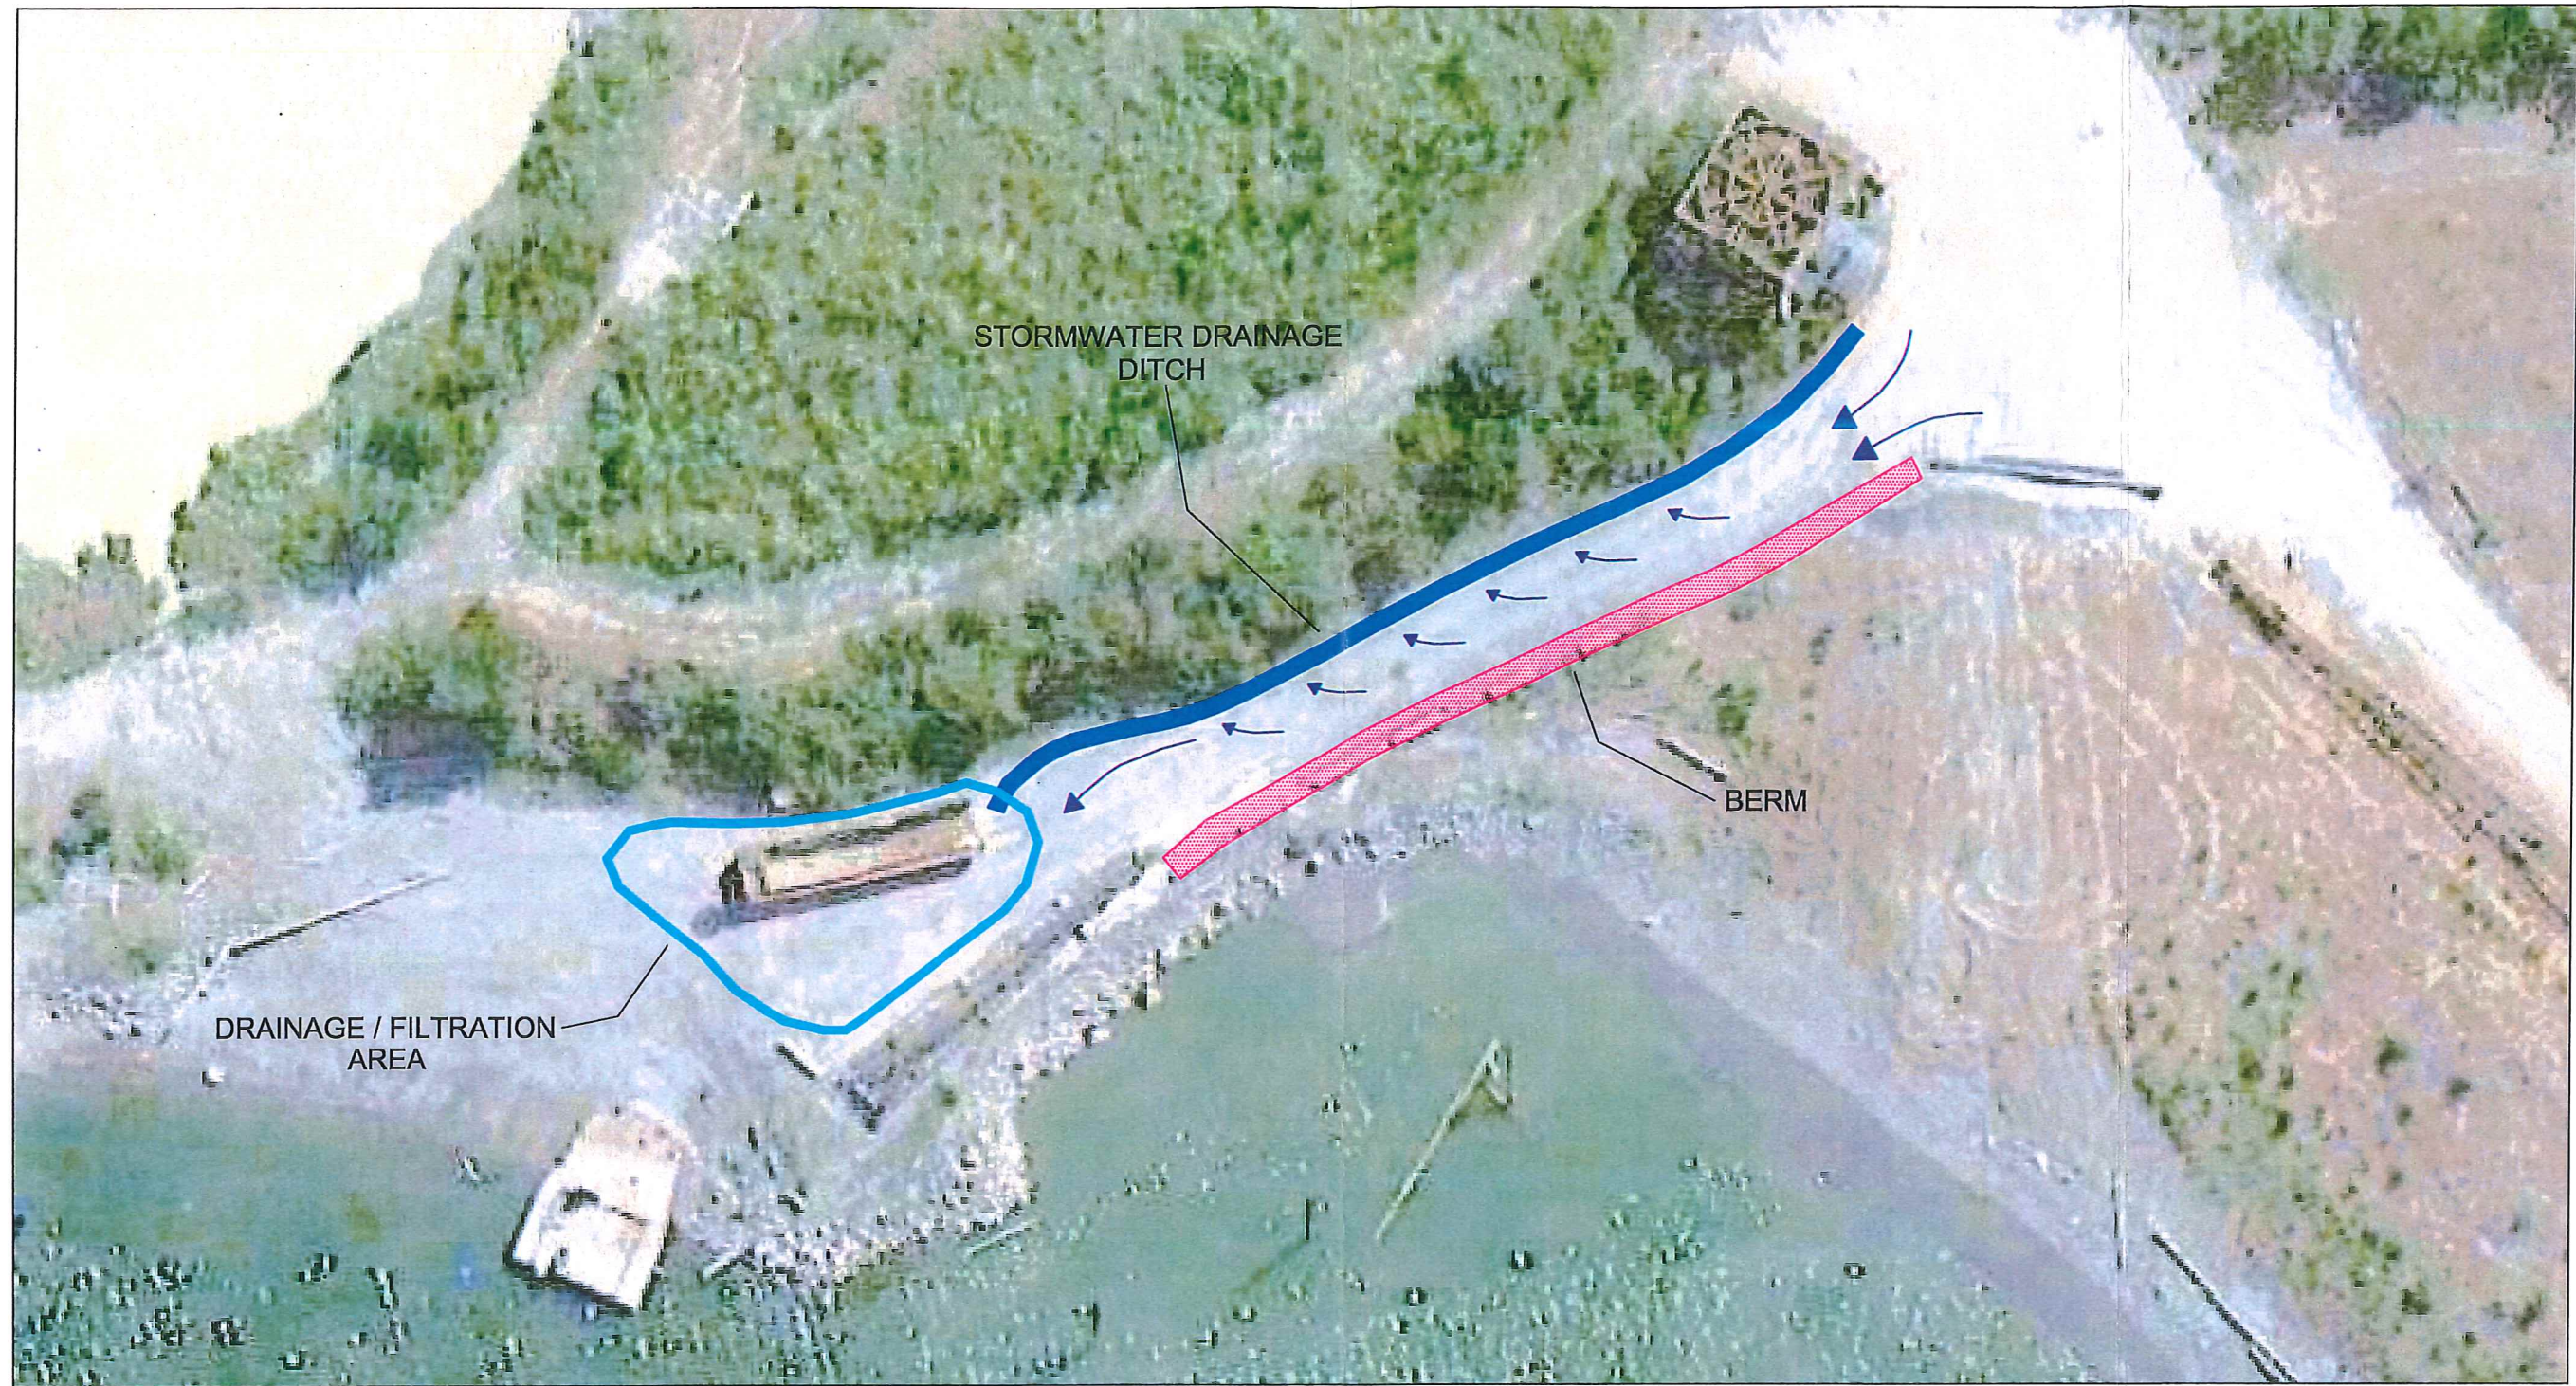
FIGURE 15
Drainage Plan
Sub-Area A2-3

Remedial Action Area A2-1 is a sloped access way that contains drainage berms and trenches to mitigate surface runoff. Drainage berms direct runoff into bio filter bags to the west and towards an existing area of vegetation to the east. This area is covered with crushed stone to reduce surface runoff. Remedial Action Area A2-3 is a gravel covered sloped roadway that includes a runoff trench and a drainage area to detain soil entrained surface runoff. Erosion control methods for A2-3 are shown on Figure 15.

The annual monitoring event for Remedial Action Area Sub-Area A2-1 was conducted by RISG on June 24, 2014. The monitoring included field observation for evidence of rills, ruts, sediment accumulation, sloughing, or damage to improved areas, as well as the condition of bio filter bags, vegetation, and ecology blocks. The monitoring event indicated that the observed BMPs and improved areas were in very good condition and therefore no maintenance or contingency measures were deemed necessary at this time.
