Memorandum

Date: December 16, 2016

SUBJECT: Preliminary Evaluation of Bank Erosion
Potential – Sulzer Pumps, Portland, Oregon

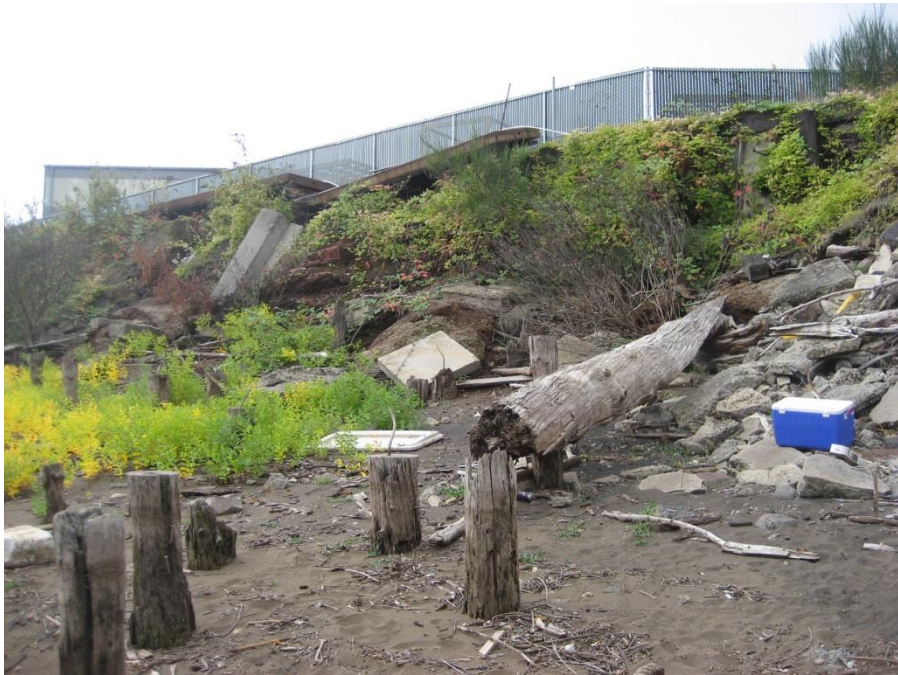
NOT UNDER DOCK

57. End of covered dock. Measurements applied to area downstream and right of pier 57 (not covered by dock)
