OPERATIONS AND MAINTENANCE REPORT  
JANUARY 2022 TO DECEMBER 2022  
MCCORMICK & BAXTER SUPERFUND SITE  
PORTLAND, OREGON

by  
Haley & Aldrich, Inc.  
Portland, Oregon

for  
Oregon Department of Environmental Quality  
Portland, Oregon

File No. 0202315-000  
August 2023

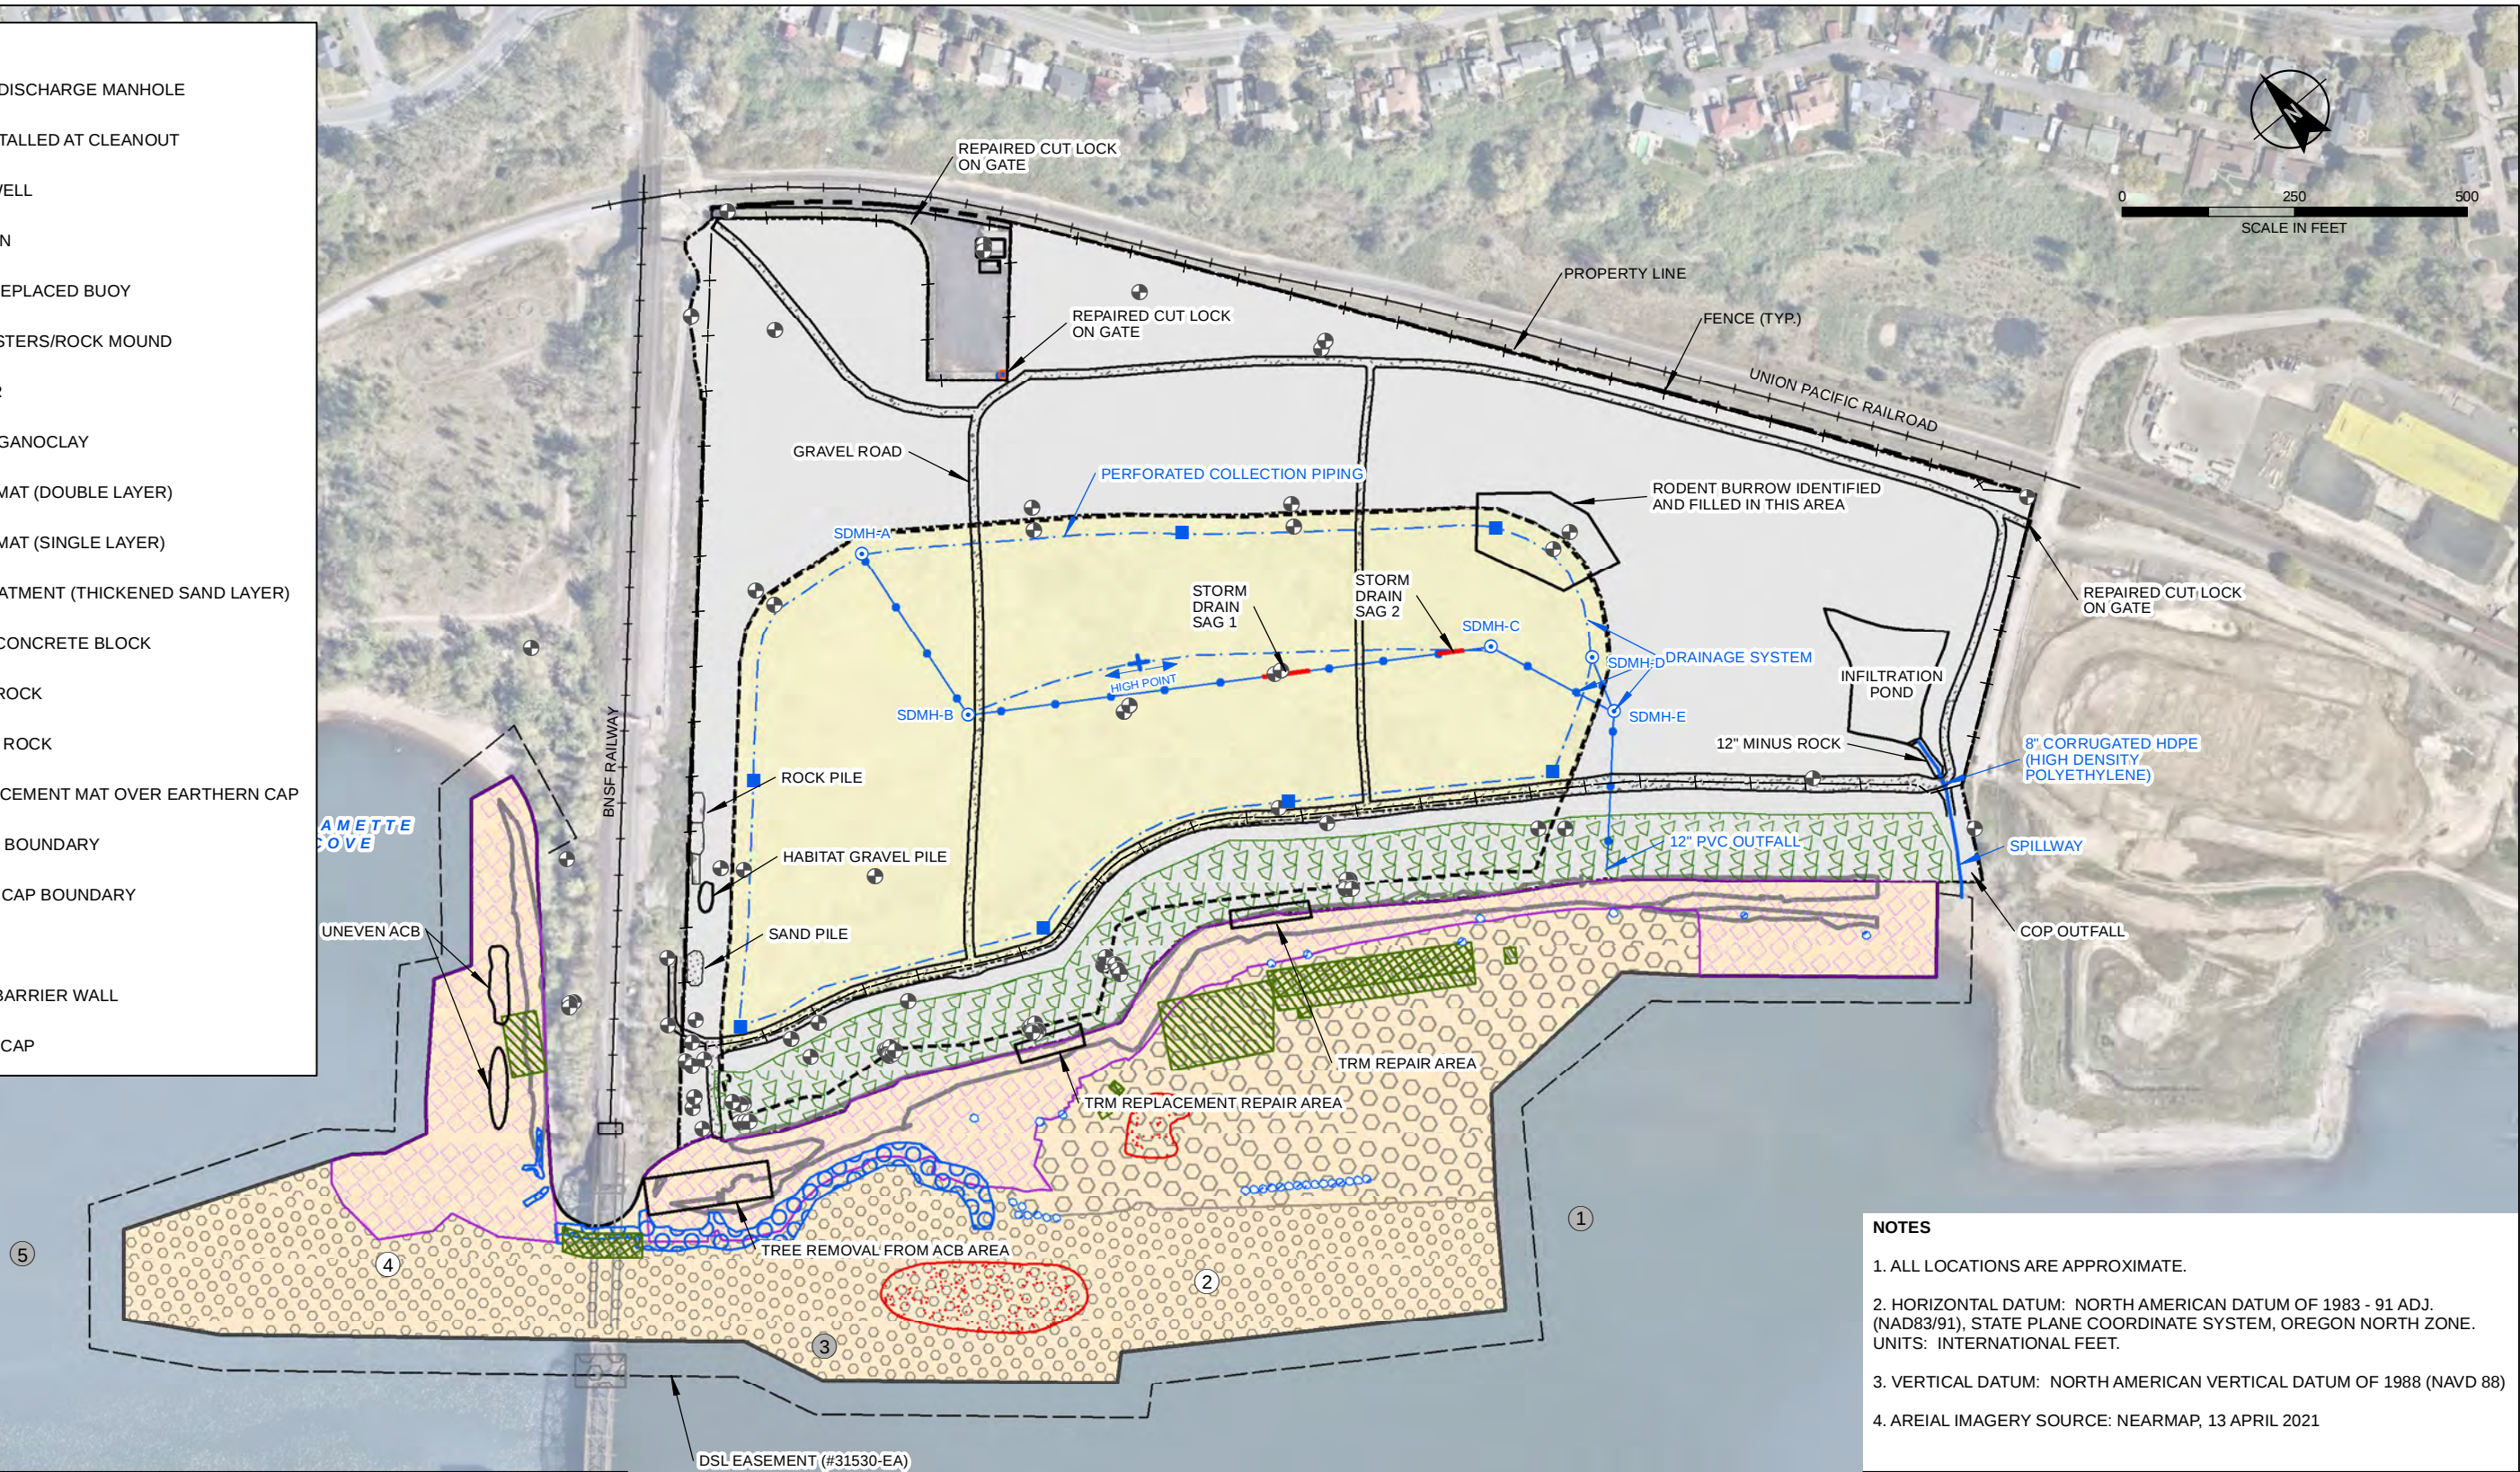
FIGURE 2-1

Soil cap observations were conducted according to the Final O&M Plan. Routine quarterly site inspections were conducted by DEQ, Haley & Aldrich, and GSI on March 2, June 10, September 19, and December 20, 2022. Observations of interest from the routine inspections are summarized on Figure 2-1 and are described in Section 2.2.1. Representative photographs of the Site taken in 2022 are presented

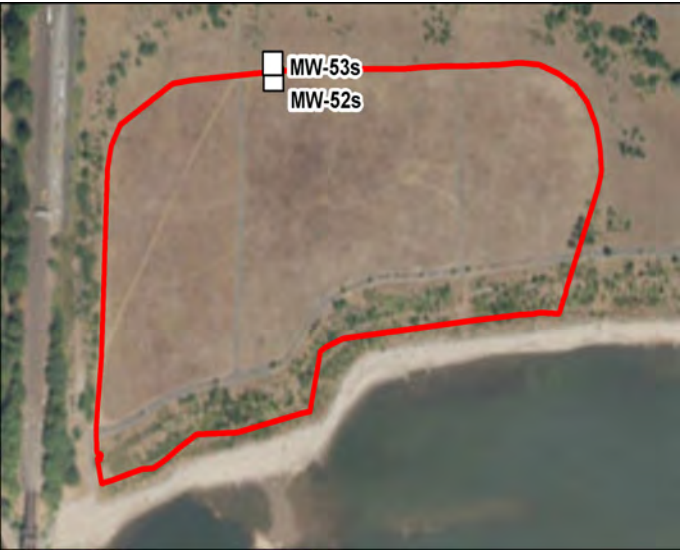
**2022 Groundwater Elevations  
in Monitoring Wells MW-52s and MW-53s**

Due to a pressure transducer failure, there is no data available for MW-53s until 6/17/2022, and there is no data for MW-52s after 08/22/2022. Data gaps in the Willamette River elevation are due to erroneous data.

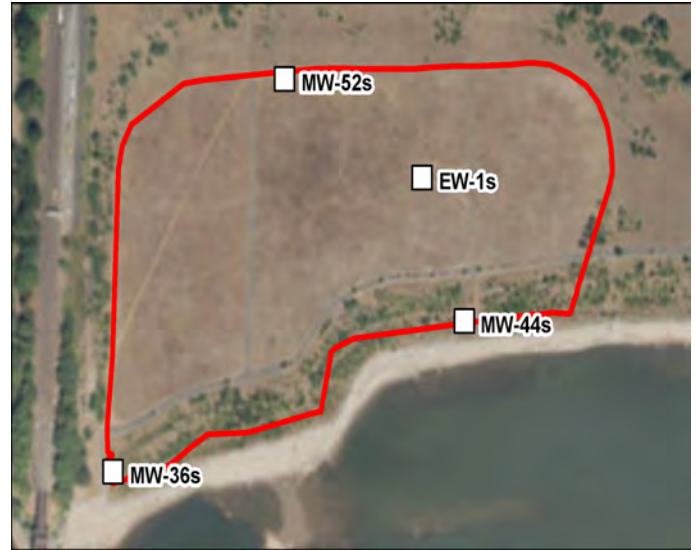
**2022 Groundwater Elevations  
within the Barrier Wall**

Due to a pressure transducer failure, there is no data for MW-52s after 08/22/2022. Data gaps in the Willamette River elevation are due to erroneous data. Data gaps in the Willamette River elevation are due to erroneous data.

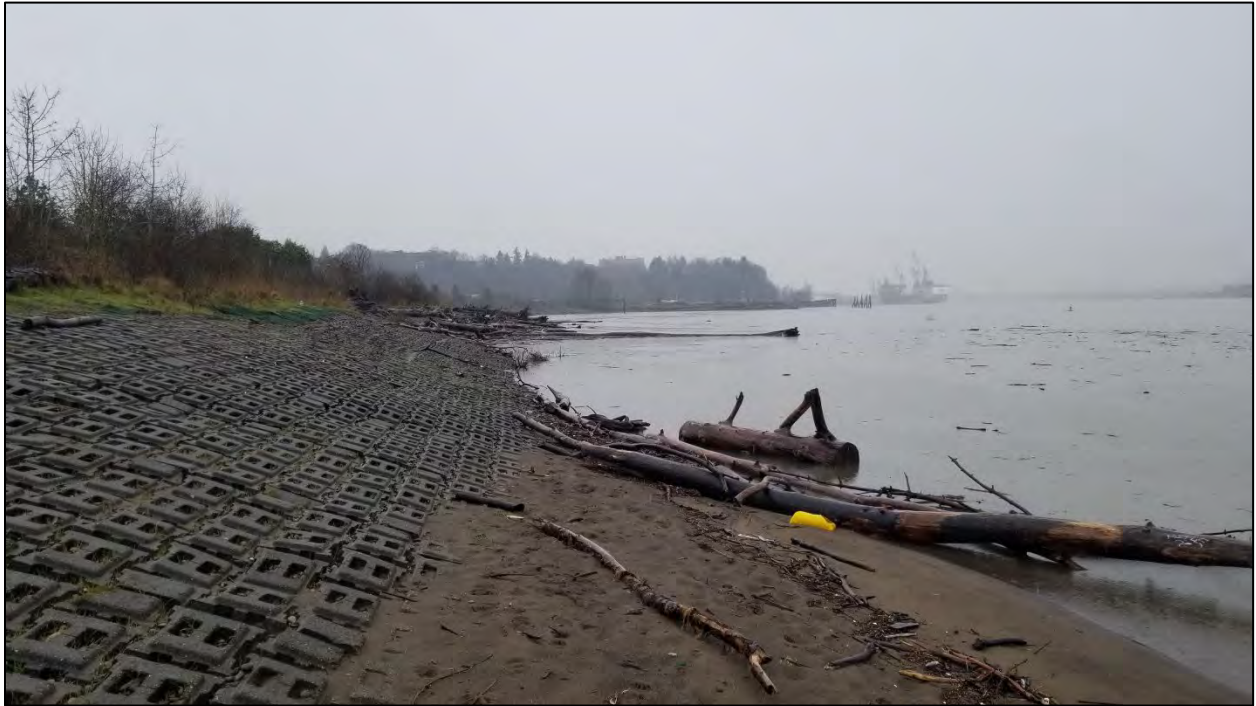
Increased amounts of large logs and woody debris continue to be present at the high tide line and copious amounts of smaller woody debris are present along the Willamette River shoreline (Photographs 1, 2, and 3). Tide levels were high during the site inspection due to the heavy rains that have occurred over the last few days.

Photograph 1: High-river level conditions along Willamette River shoreline. View from northern end of shoreline next to railroad bridge and looking southeast.

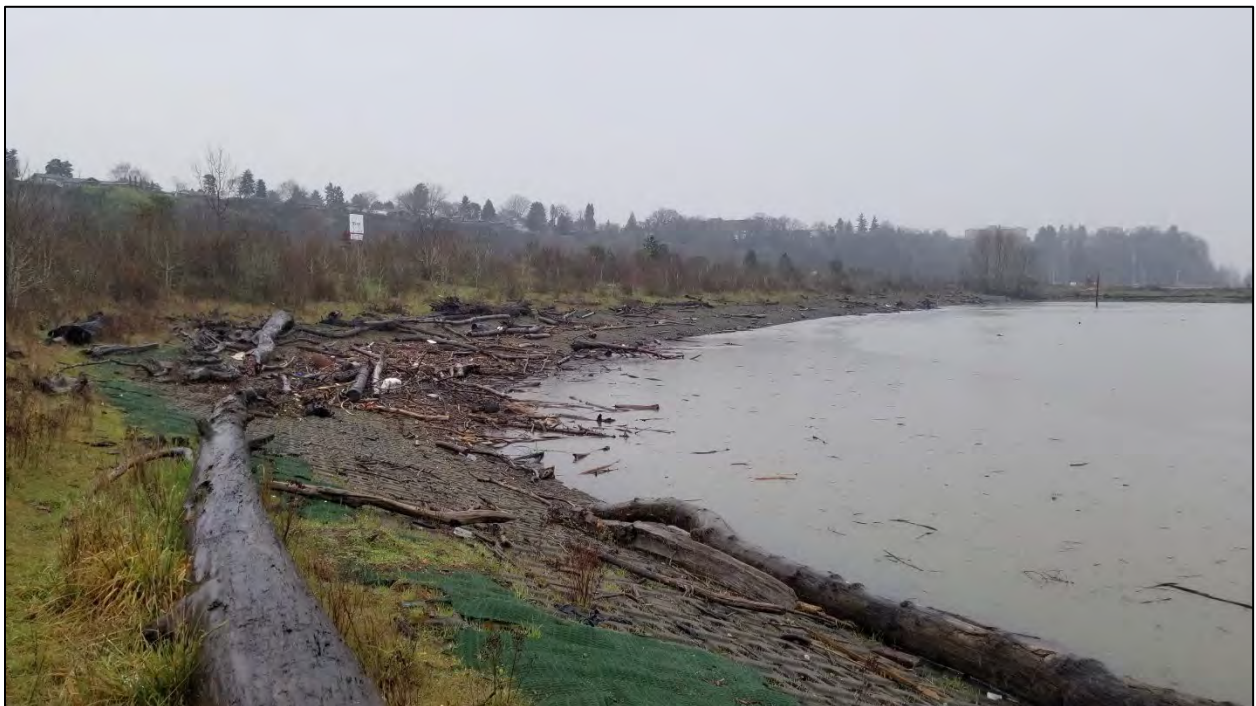
Photograph 2: High-river level conditions along Willamette River shoreline. View from middle section of shoreline at the site and looking southeast.

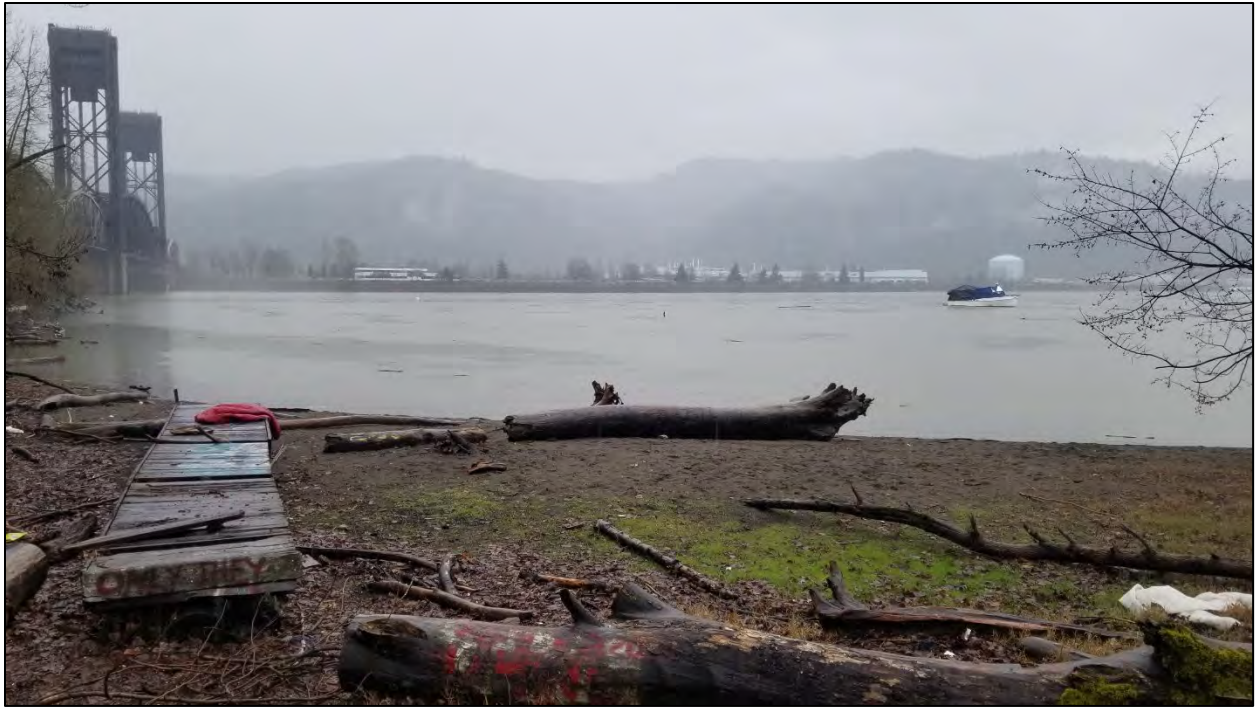
A transient vessel was observed to be anchored in Willamette Cove. The vessel appeared to be anchored off the sediment cap (Photograph 3).

Photograph 3: High-river levels in Willamette Cove. Transient houseboat anchored in the background of frame. View facing southwest.

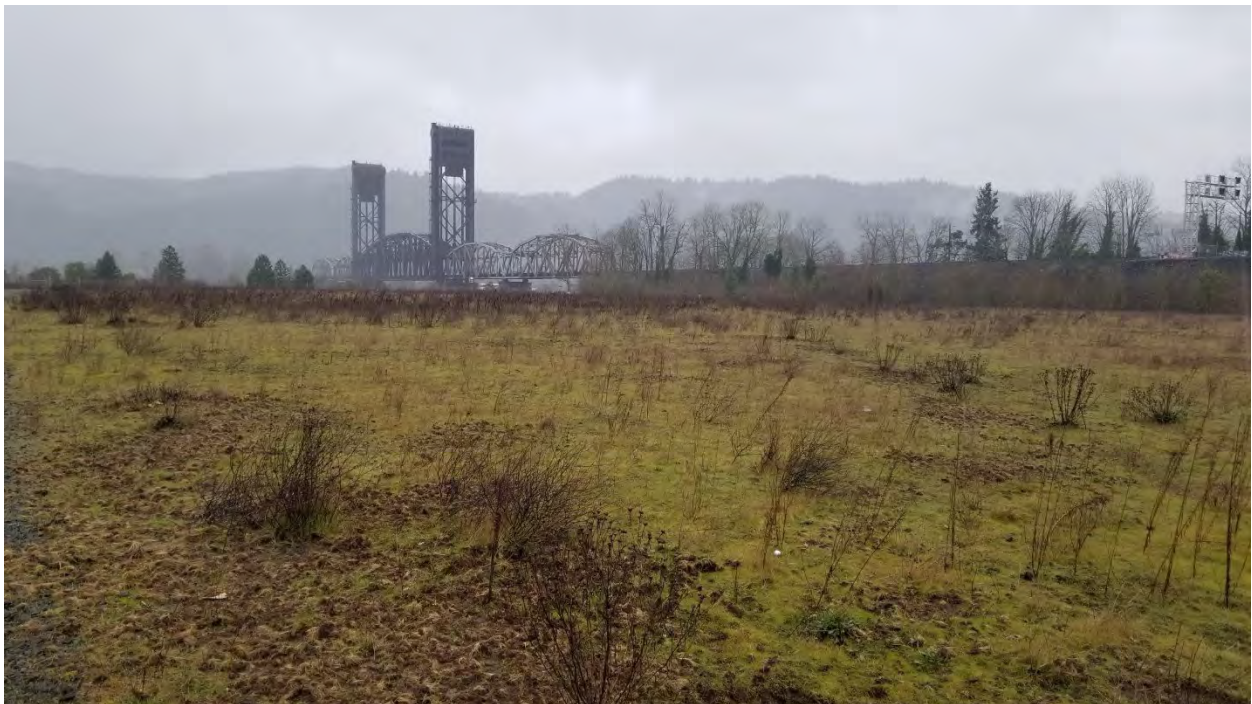
The impermeable cap and soil cap were in good condition (Photographs 6 and 7). Grass vegetation was in stubble and taller shrubs were dormant and bare of leaves. Two geese were observed near the western fence of the upland cap and a murder of crows was observed in the center of the soil cap.

Photograph 6: View of the soil cap from the center of the cap facing west.

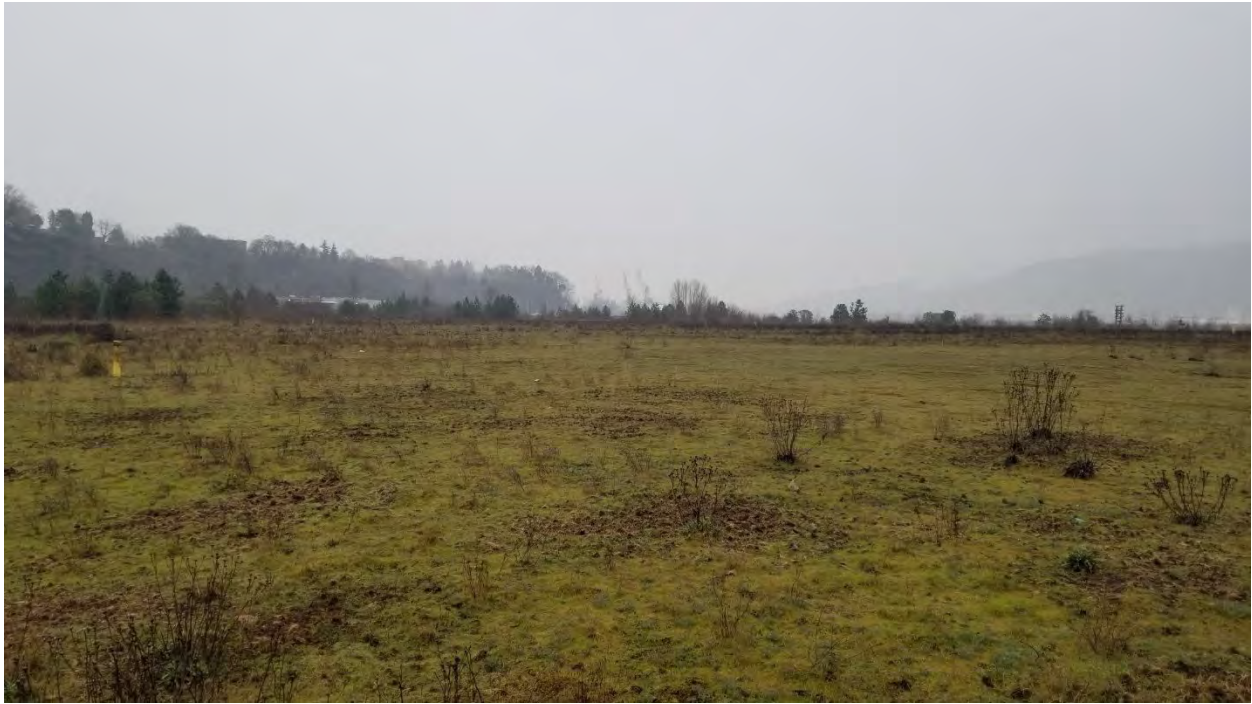
Photograph 7: View of the soil cap from the center of the cap facing southeast.

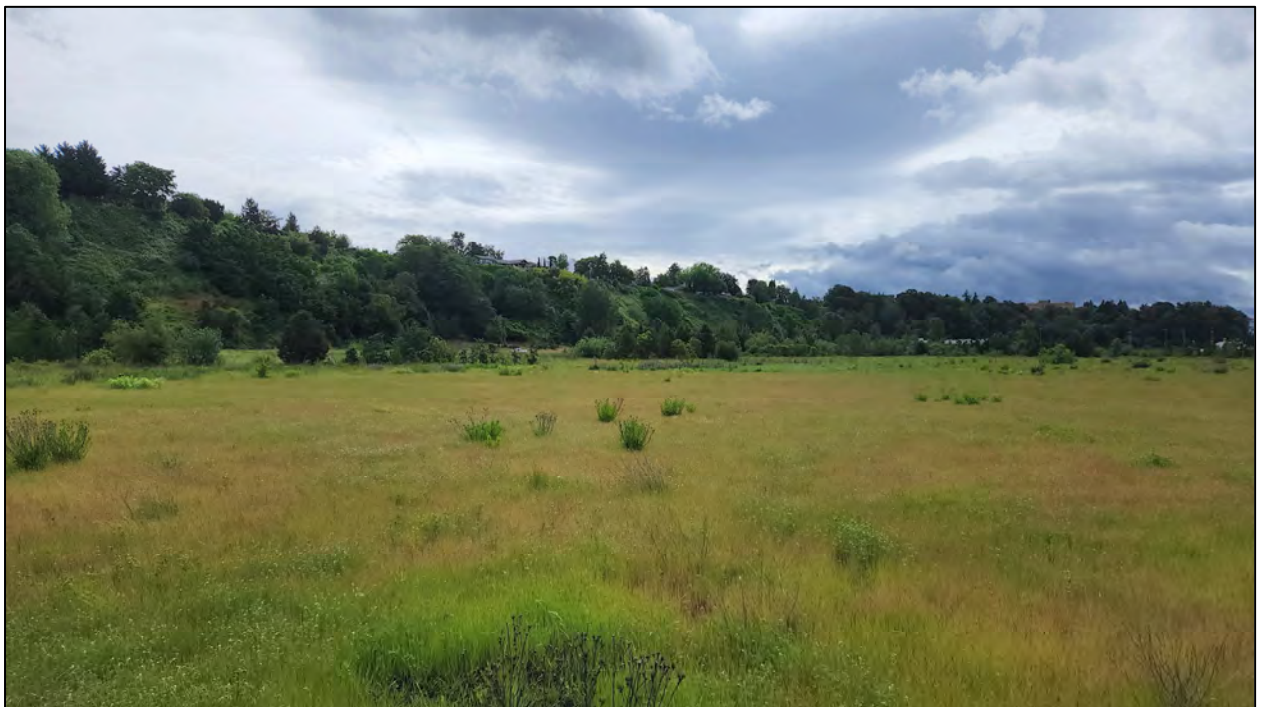
Photograph 2: Impermeable cap conditions with spring grass growth. View facing northeast.

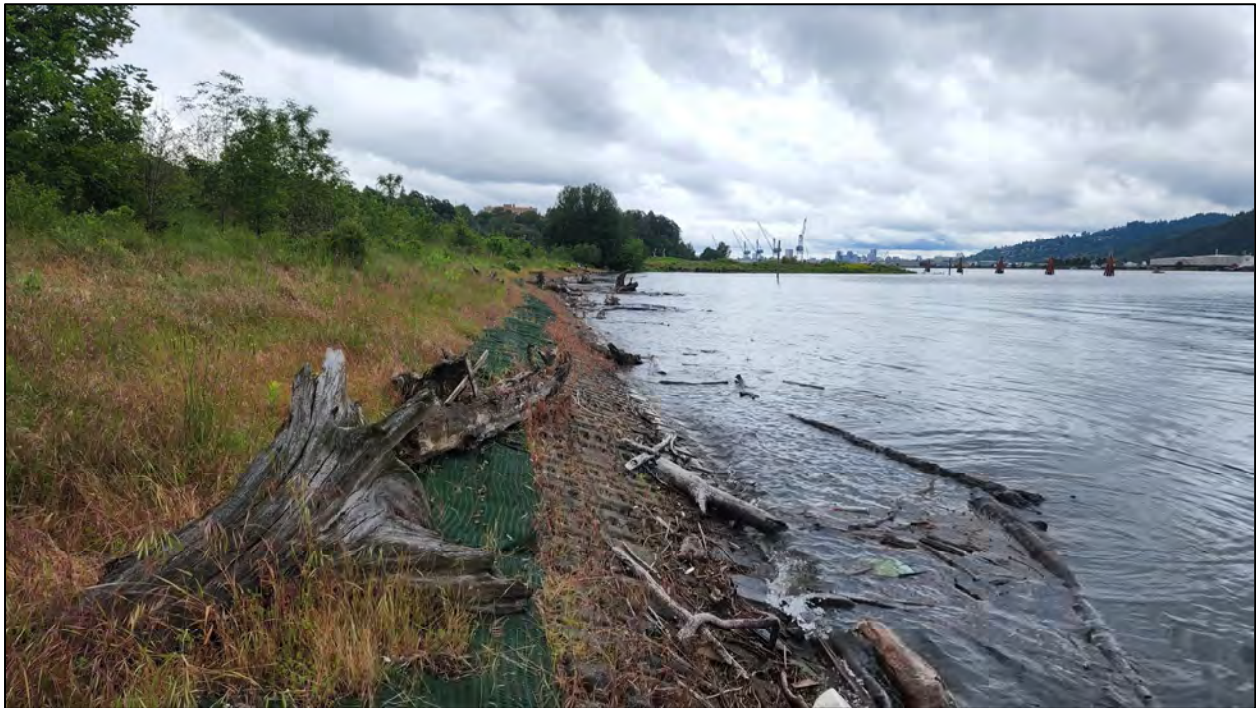
Photograph 4: High-river level conditions along Willamette River shoreline. View facing southeast.

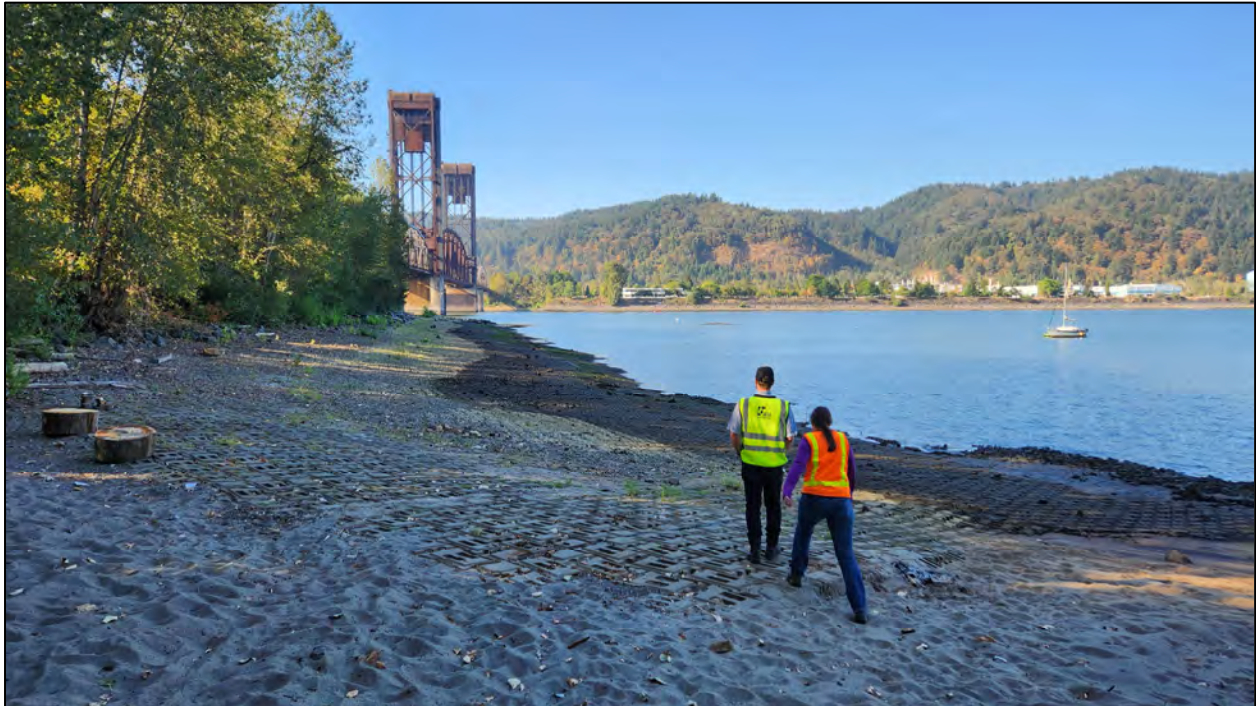
River levels were low during the inspection (Photograph 1). ACB unconformities in Willamette Cove were able to be observed during this site visit. Unconformities were last observed during the third quarter inspection of September 2021 when river levels were also low enough. Unconformities were observed in the same spots (Photographs 2 and 3), however, the degree of potential shifting or sinking relative to the previous inspection was unable to be determined qualitatively based solely on visual observation. Team members discussed potential ways of measuring ACB shifting in a quantitative manner by surveying fixed points on the ACB yearly to measure elevations over time.

Photograph 1: Low-river level conditions along Willamette Cove shoreline. View facing southwest.

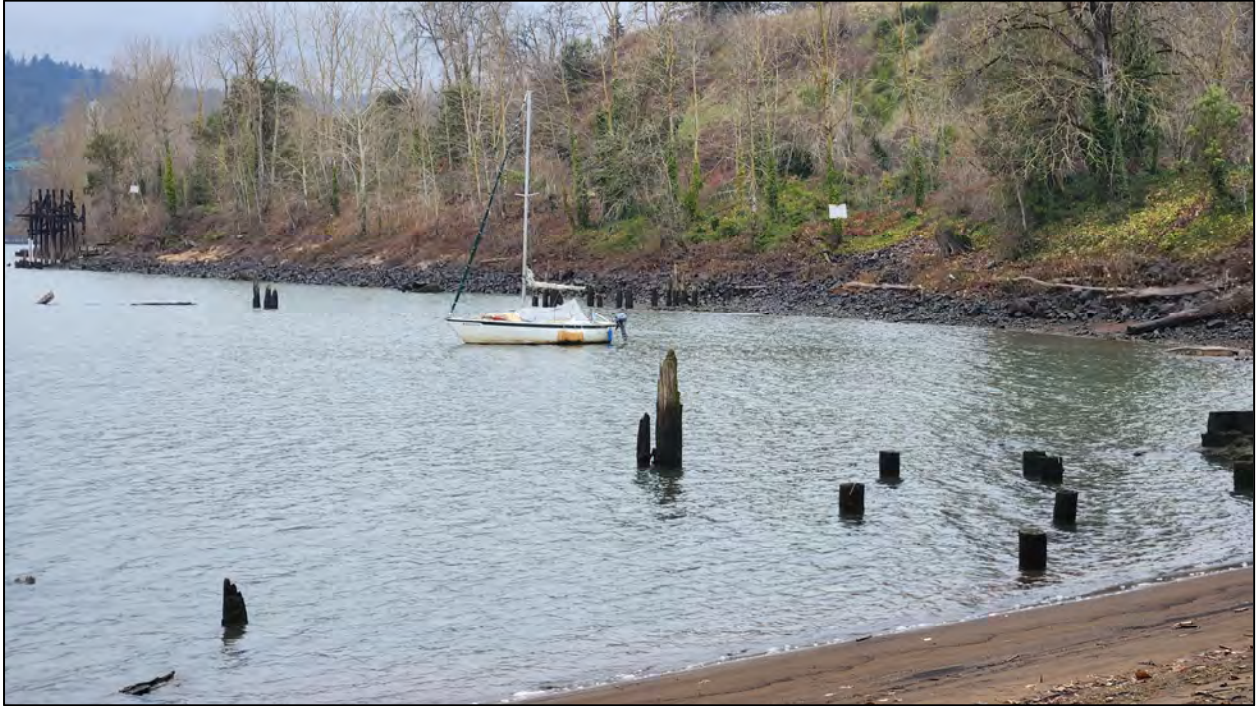
Photograph 1: A vessel anchored in Willamette Cove off of the sediment cap

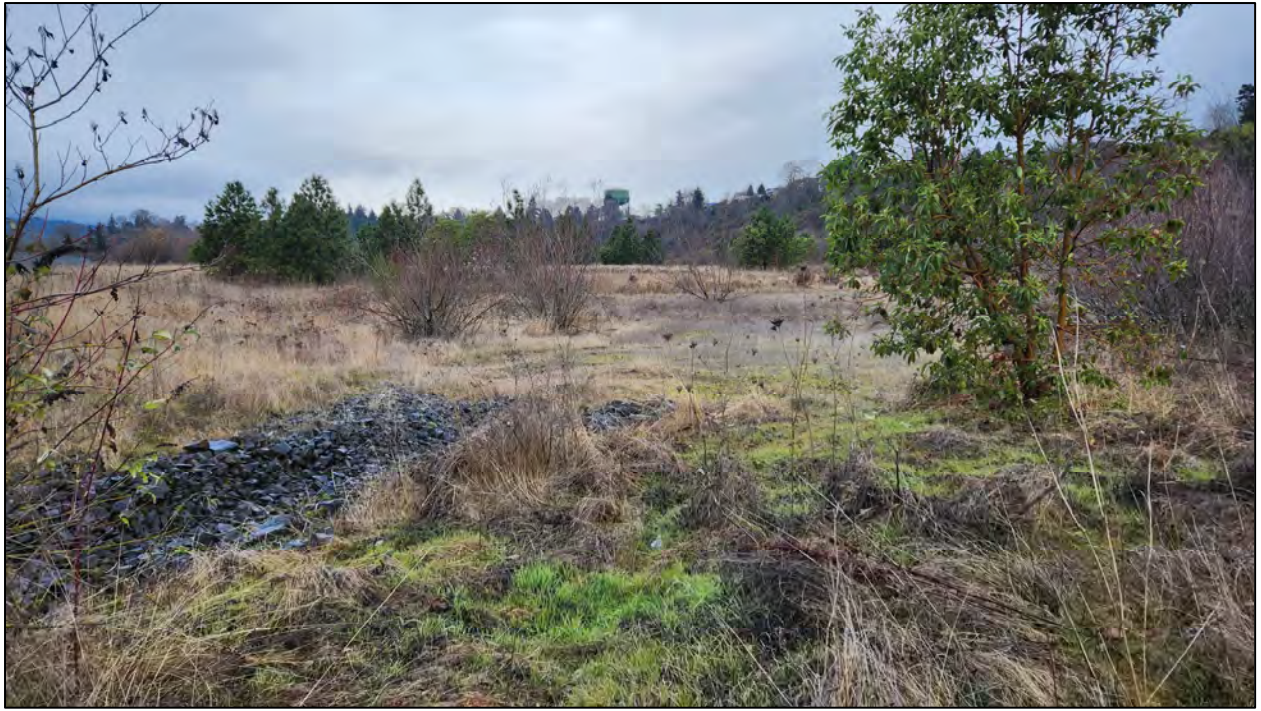
Photograph 5: Drainage basin on southern portion side of the soil cap. View facing north.

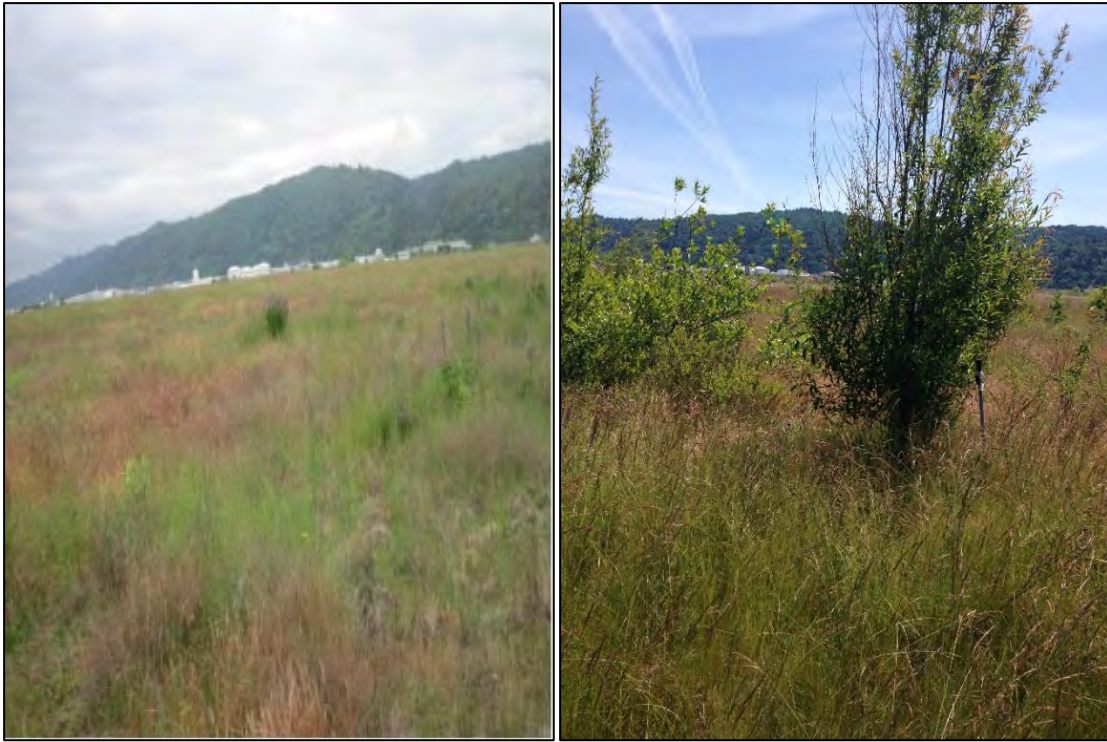
**Photograph C1:** Earthen cap and drainage swale in the foreground with the impermeable cap in the background. Taken looking south from Photograph Station 1 comparing baseline and conditions in 2014. (Left - June 2011, Right – June 2014).

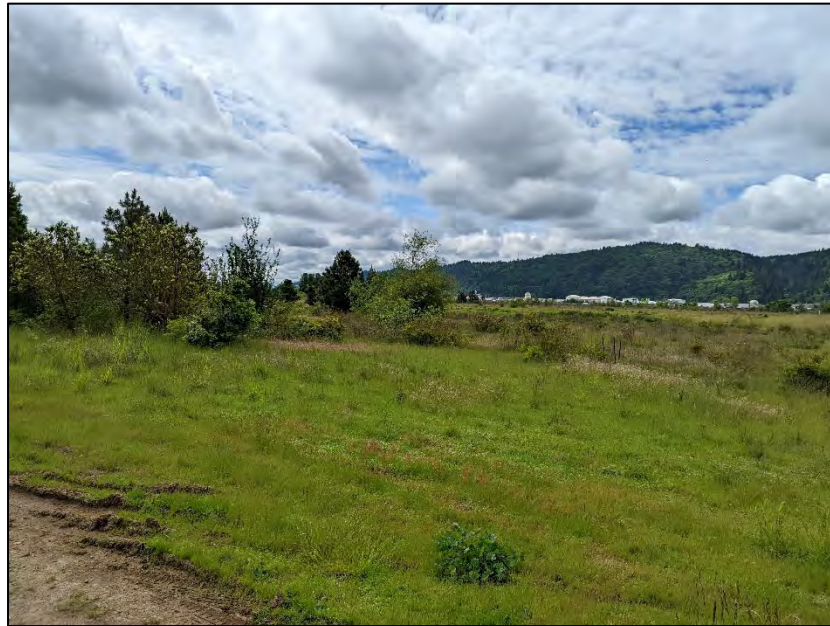
**Photograph C2:** Tree and shrub plantings on the earthen cap. Taken looking southeast from Photograph Station 2 (May 2022).

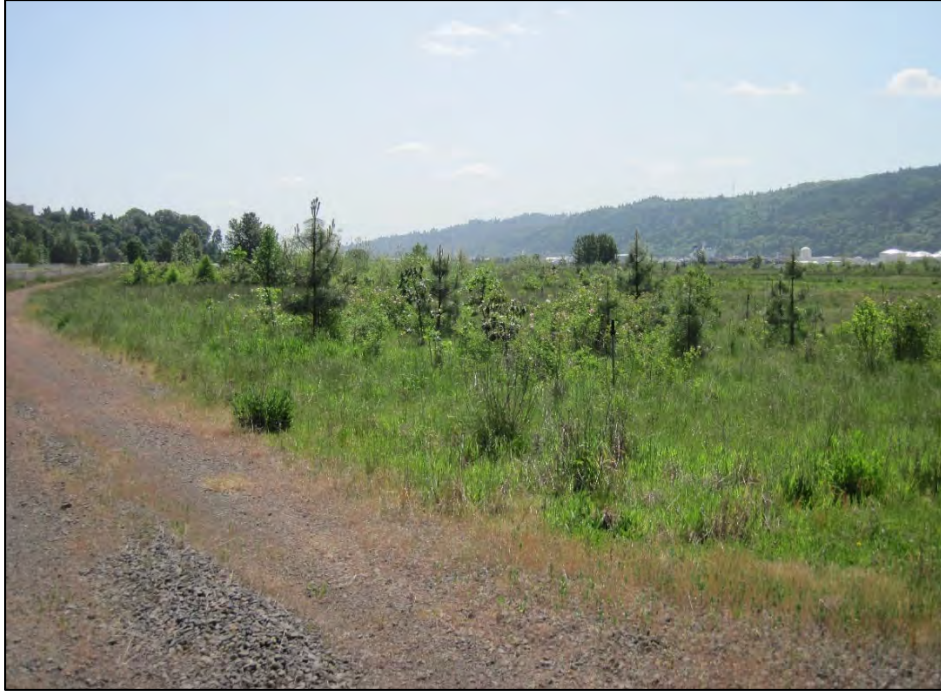
**Photograph C3:** Tree and shrub plantings on the earthen cap are healthy and spreading. Taken from Photograph Station 2 looking southeast (October 2012).

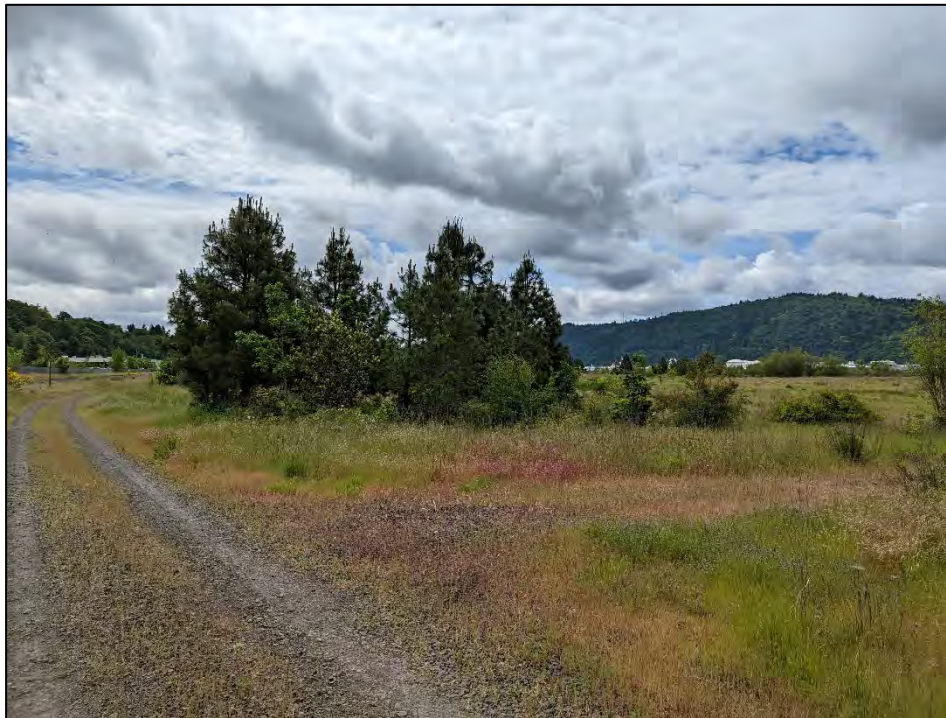
**Photograph C4:** Tree and shrub plantings on the earthen cap are healthy and spreading. Taken from Photograph Station 2 looking southeast (May 2022).

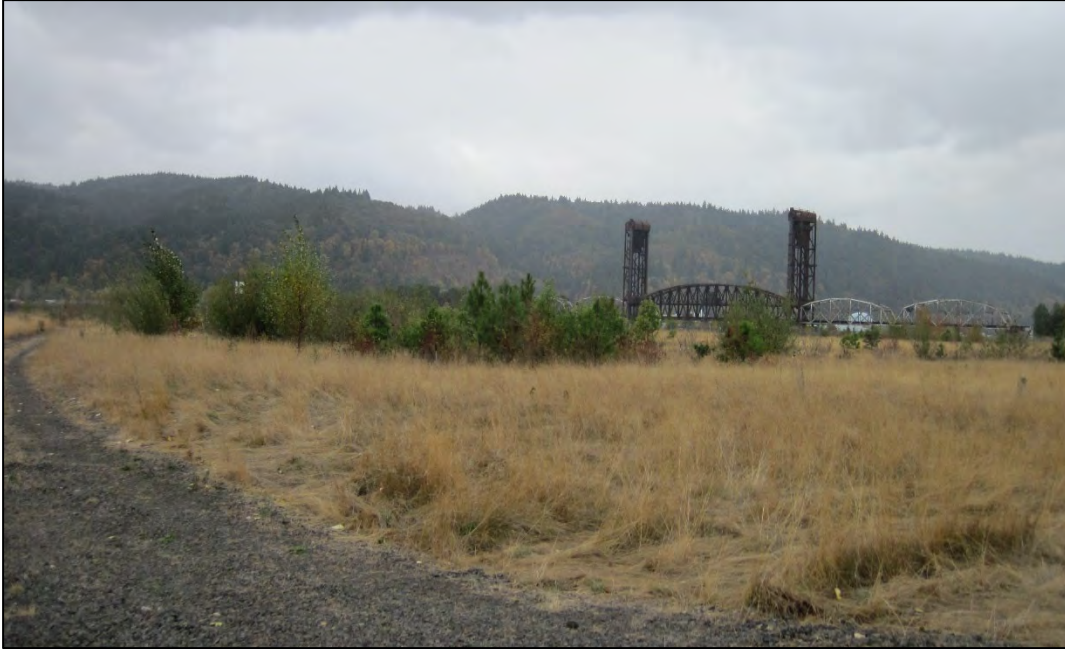
**Photograph C5:** Eastern edge of the earthen cap with perimeter road in foreground. Taken from Photograph Station 3 looking west (October 2012).

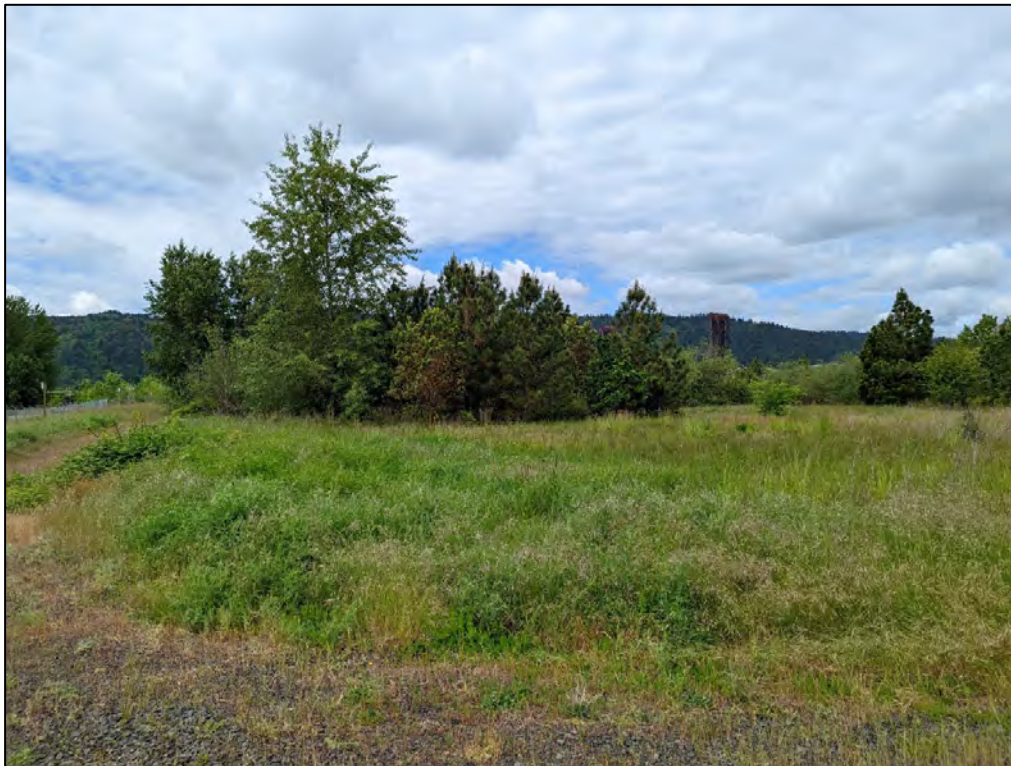
**Photograph C6:** Eastern edge of the earthen cap with perimeter road in foreground. Taken from Photograph Station 3 looking west (May 2022).

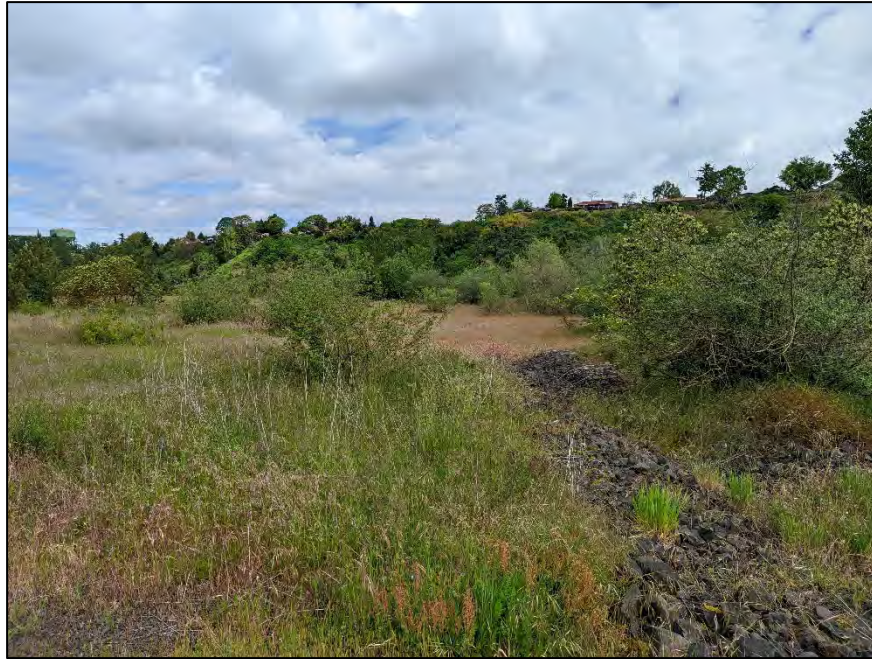
**Photograph C7:** Stormwater pond dominated by willow and alder. Taken from Photograph Station 4 looking northeast (October 2012).

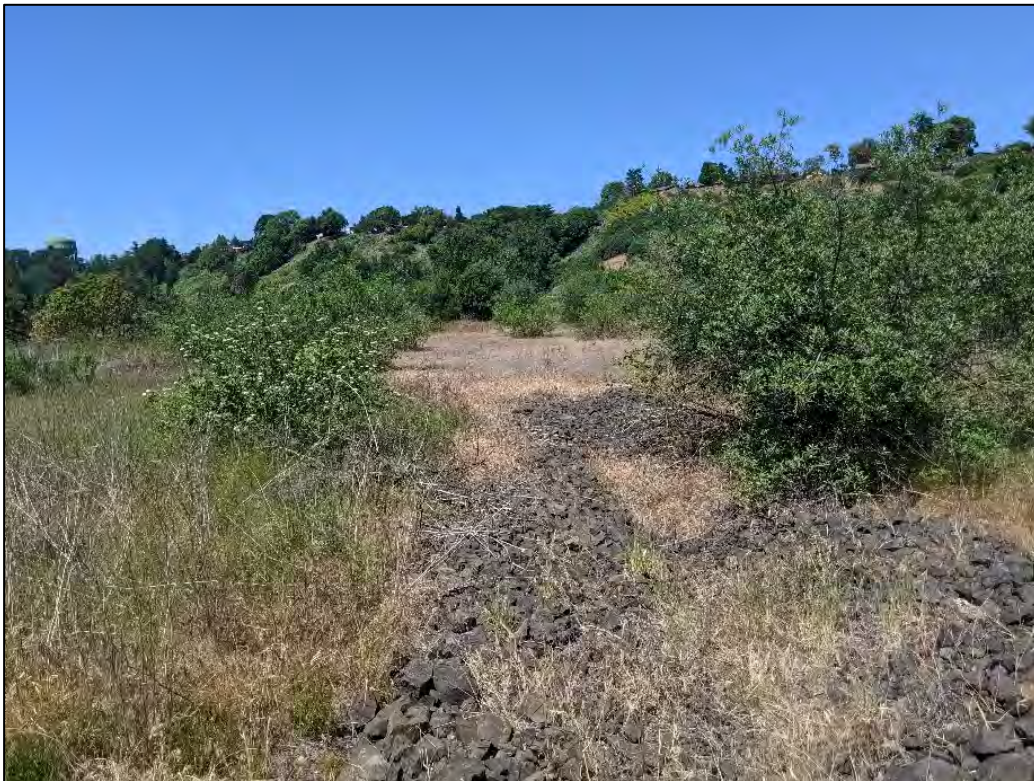
**Photograph C8:** Stormwater pond dominated by willow and alder. Taken from Photograph Station 4 looking northeast (May 2022).

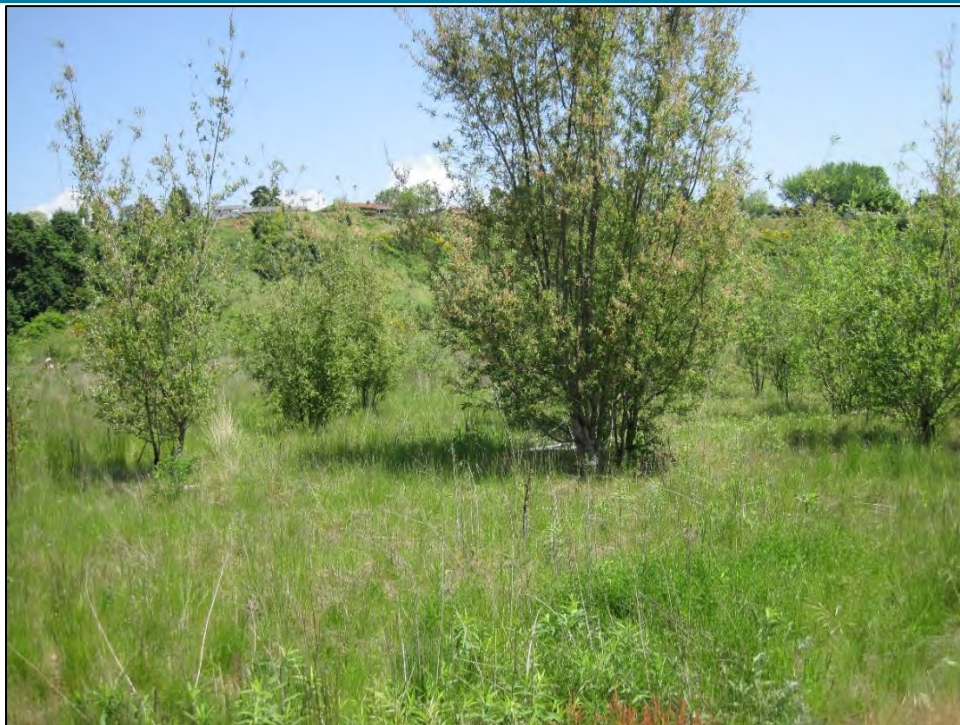
**Photograph C9:** Willow plantings on the earthen cap. Taken from Photograph Station 5 looking northeast (October 2012).

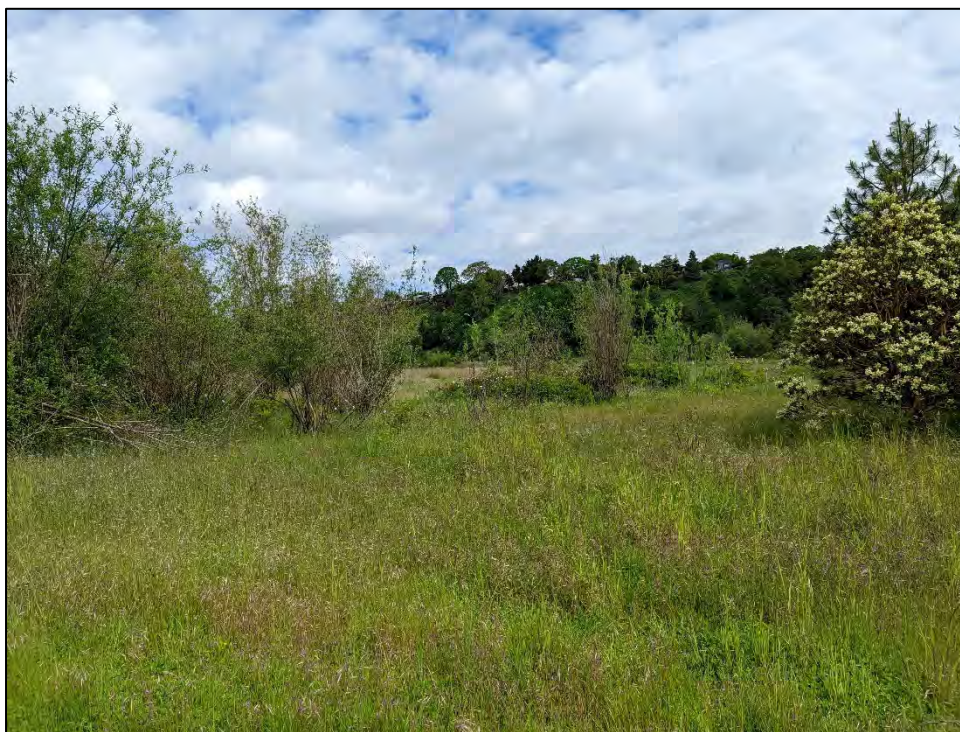
**Photograph C10:** Willow plantings on the earthen cap. Taken from Photograph Station 5 looking northeast (May 2022).

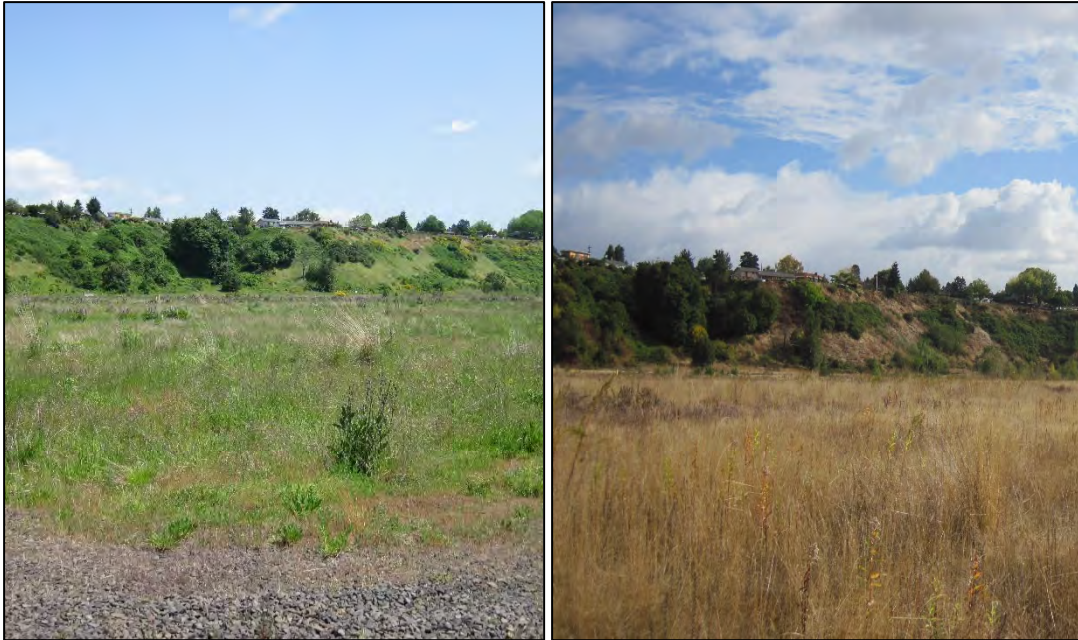
**Photograph C11:** Impermeable cap dominated by grasses and herbaceous vegetation in the early summer (left) and fall (right). Taken from Photograph Station 6 looking east (Left – May 2012; right – October 2012).
