OPERATIONS AND MAINTENANCE REPORT  
JANUARY 2022 TO DECEMBER 2022  
MCCORMICK & BAXTER SUPERFUND SITE  
PORTLAND, OREGON

by  
Haley & Aldrich, Inc.  
Portland, Oregon

for  
Oregon Department of Environmental Quality  
Portland, Oregon

File No. 0202315-000  
August 2023

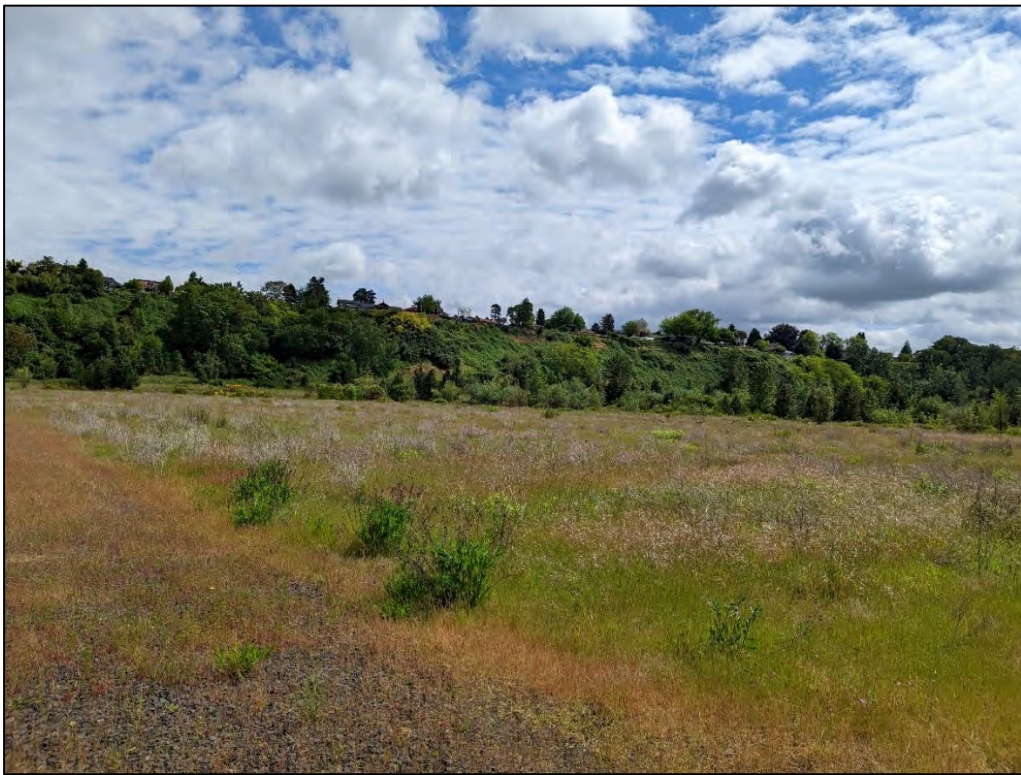
**Photograph C12:** Impermeable cap dominated by grasses and herbaceous vegetation. Taken from Photograph Station 6 looking east (May 2022).

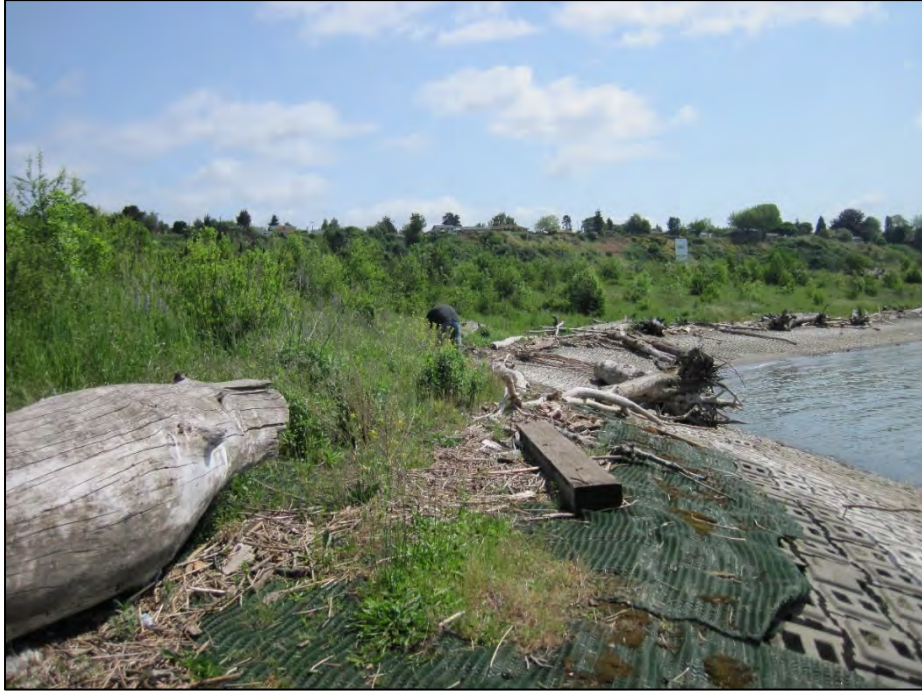
**Photograph C13:** Vegetation growth within the lower riparian component. Taken from Photograph Station 7 looking south (May 2012).

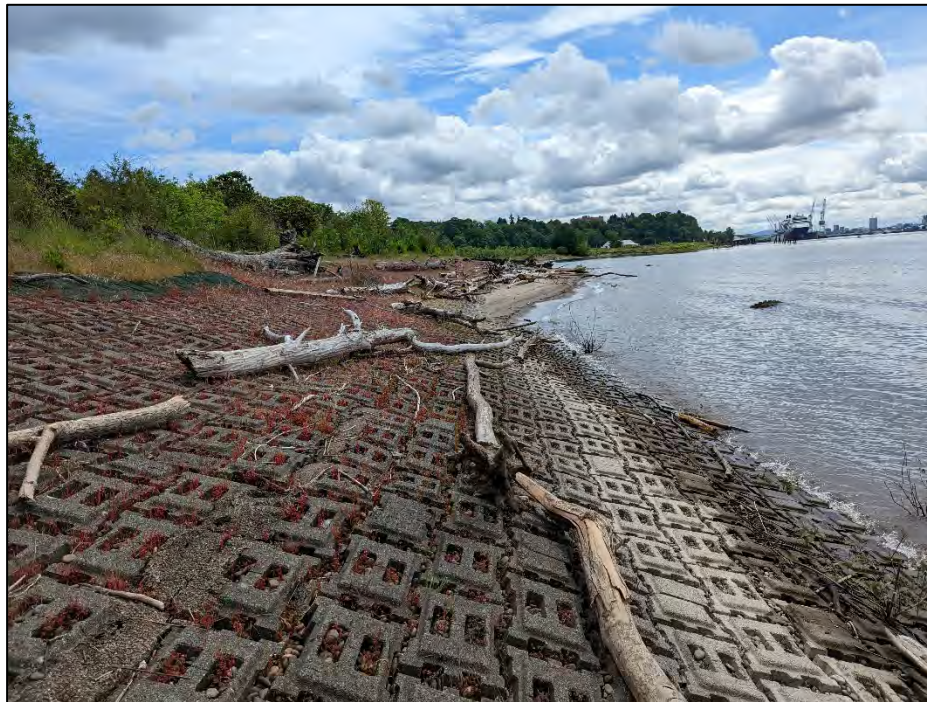
**Photograph C14:** Vegetation growth and wood debris within the lower riparian component and along the shoreline. Taken from Photograph Station 7 looking southeast (May 2022).

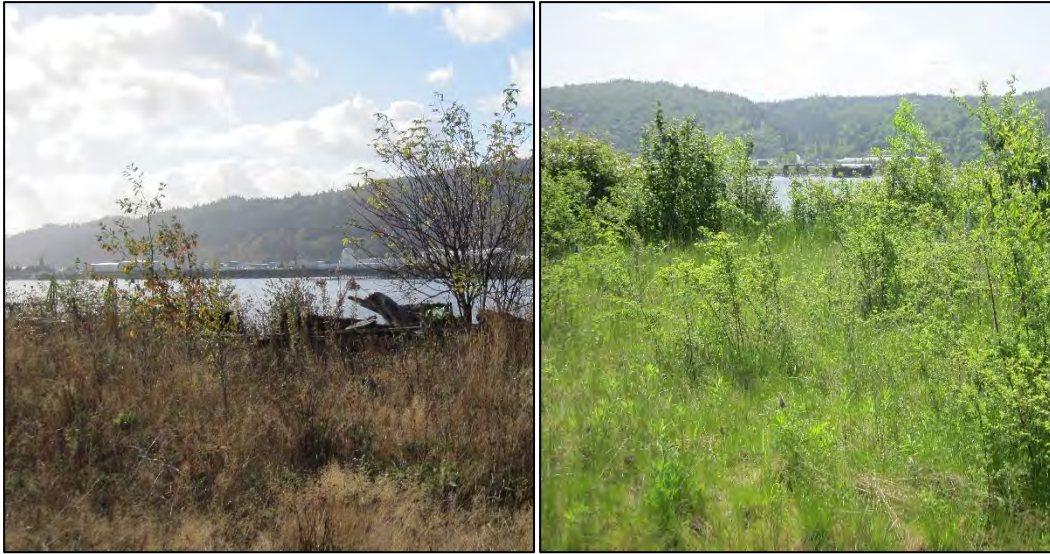
**Photograph C15:** Upper riparian component with trees, shrubs, and herbaceous plants. Taken from Photograph Station 8 looking southwest (Left – May 2012; right – October 2012).

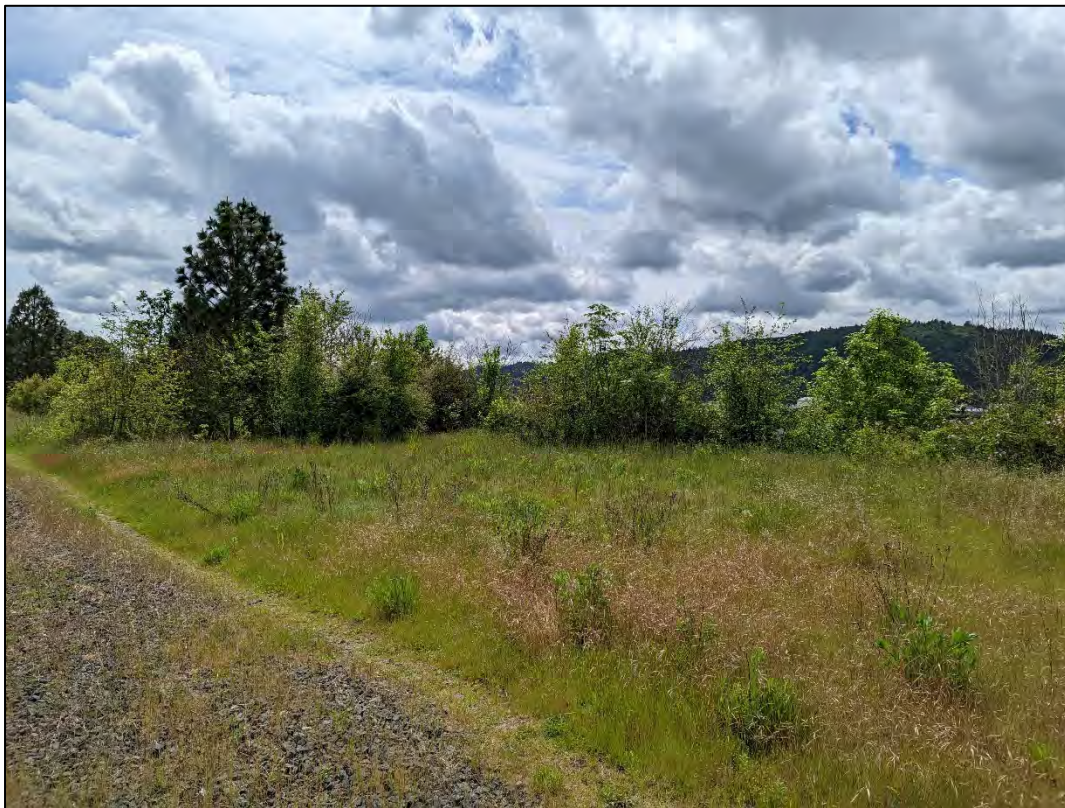
**Photograph C16:** Upper riparian component with trees, shrubs, and herbaceous plants. Taken from Photograph Station 8 looking southwest (May 2022).

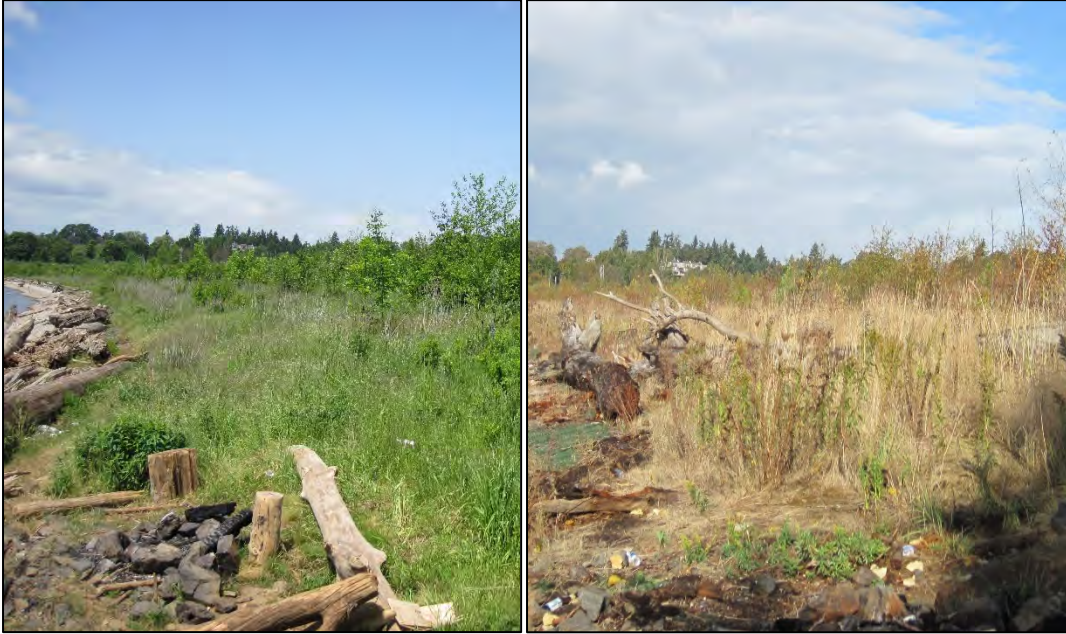
**Photograph C17:** Lower riparian component with large wood along the edge. Taken from Photograph Station 9 looking northwest (Left – May 2012; right – October 2012).

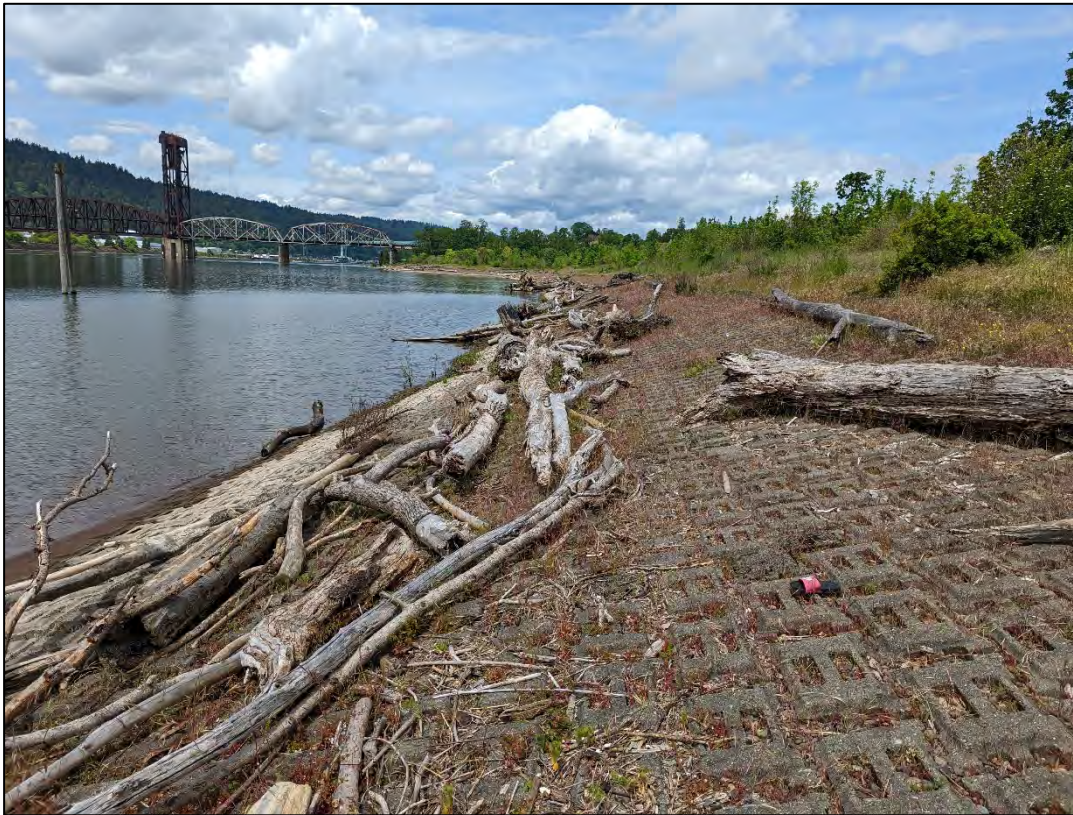
**Photograph C18:** Lower riparian component with large wood along the edge. Taken from Photograph Station 9 looking northwest (May 2022).
