### MARINA ADVISORY COMMITTEE

February 26, 2024 at 2pm

HDR was retained by the City of Warrenton to perform an evaluation of the Warrenton Marina to assess general condition of the docks, identify any recommended repairs and/or replacement of the docks, and provide guidance on prioritization of upgrades and maintenance.

# **Underwater Condition Assessment of Warrenton Marina**

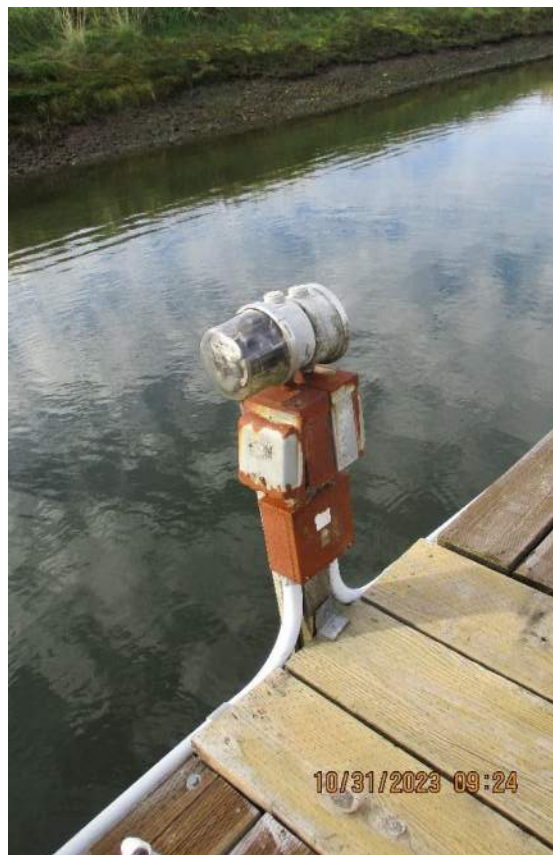
Power and water are available at all slips. Both systems are in poor condition and appear to have been pieced together over time. Electrical conduit and cabling that was once fastened to the side of the dock has fallen off and is in the water in multiple locations as shown in Photo 20. A utility drop near Dock N is in the water (see Photo 21). Action should be taken to get all live electrical circuits out of the water. The meter pedestals (Photo 22) appear to be very old units, with significant corrosion present.

**Photo 22:**  
Typical utility pedestal.

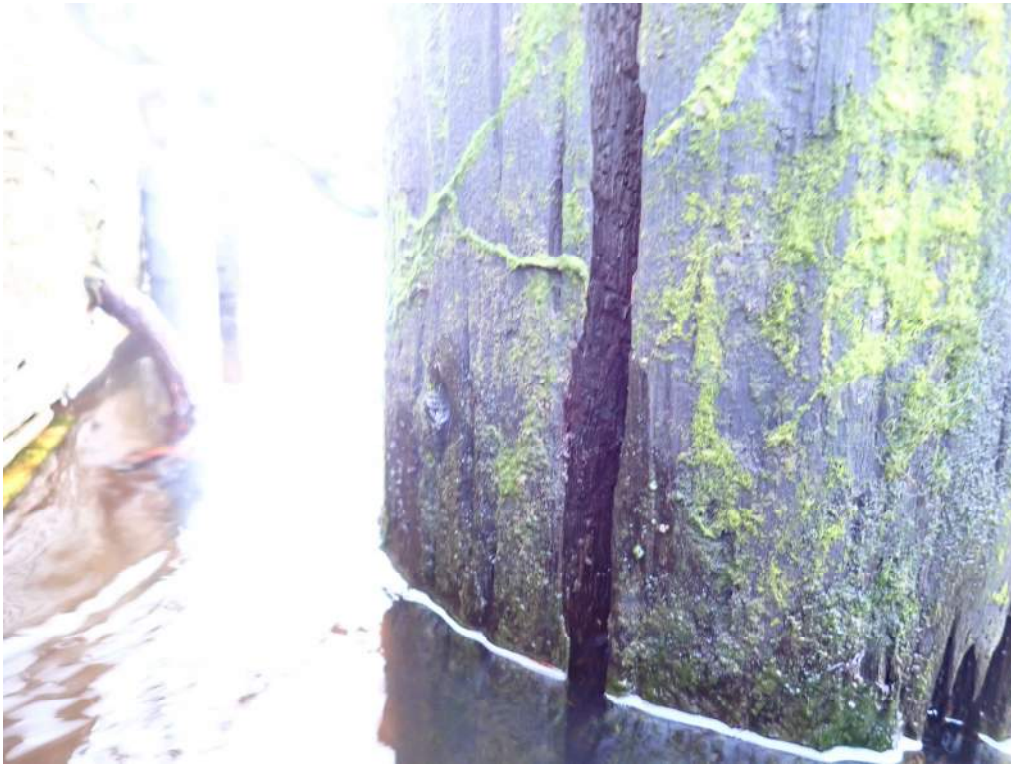
Photograph 27– Typical Check in Timber Piles

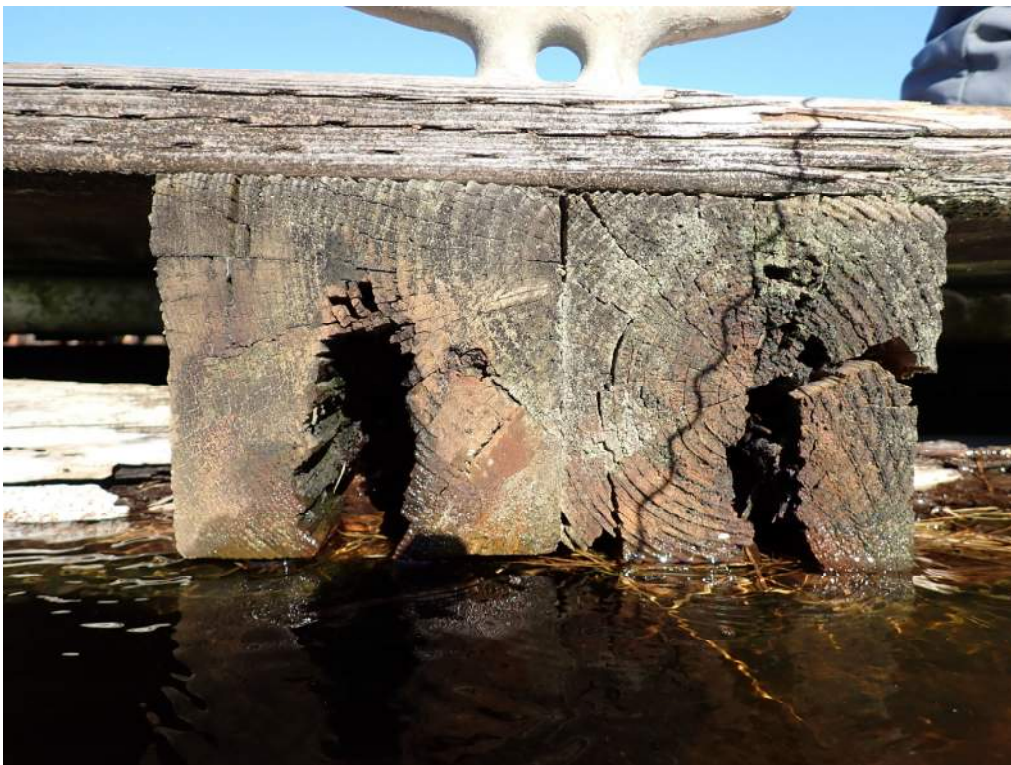
Photograph 28– Typical Section Loss in Timber Transverse Supports

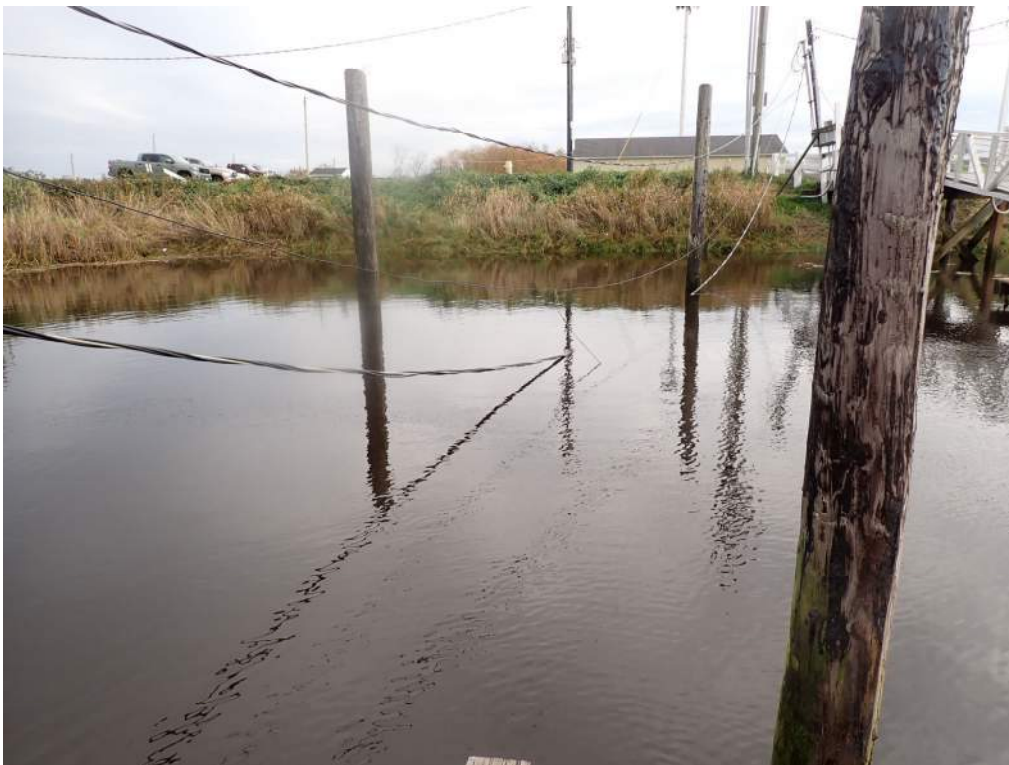
Photograph 32– Submerged Utility Line Near Northwest Marina Entrance
