# River Mile 13.5 Year 7 Isolation Cap Inspection Report

Portland General Electric Company (PGE)

February 9, 2024

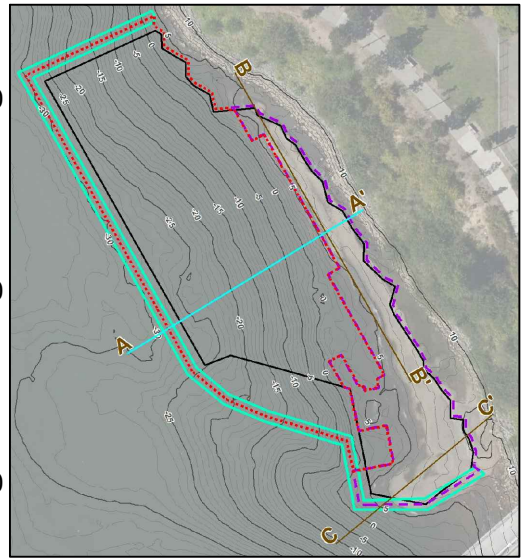
**FIGURE 5 - RM 13.5 CAP SECTION A - A'**

Evaluation of time series survey data (Figures 5–7) indicates continued but limited leveling and smoothing of localized areas of mounded capping material (high spots) that remained following construction of the cap in 2015. This is consistent with the 2019 and 2022 inspection findings, although the 2023 survey results indicate a substantial reduction in material movement and almost no material loss. The 2023 elevations are essentially the same as the 2022 elevations. No new areas of concern were identified as part of the Year 7 Investigation. Previous areas of concern that were evaluated in the Year 3 and Year 5 evaluations are shown on Figure 9, along with the 2017 cap maintenance area. Those areas were evaluated again during this inspection, as discussed below.

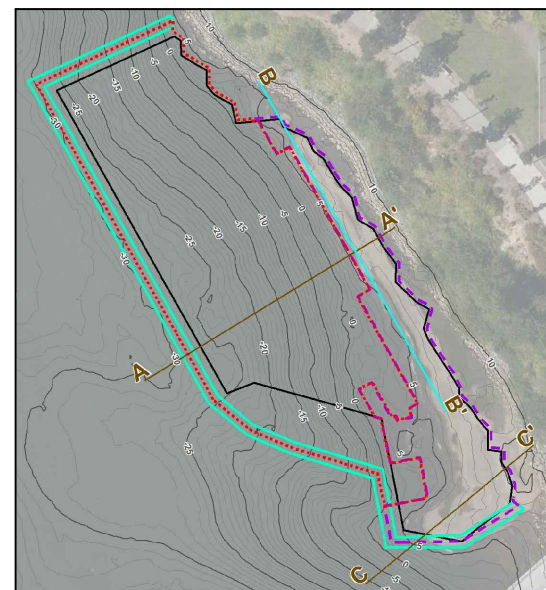
**FIGURE 6 - RM 13.5 CAP SECTION B - B'**

- The area along the shoreline, as portrayed in Figure 6 (cross section B-B'), has experienced transitory movement of armor materials since cap construction, primarily materials being pushed shoreward by wave action. This is also the area where the 2017 cap maintenance took place. The recent data suggest similar, limited ongoing material movement, but no new material loss. This may indicate a stabilization of the cap profile; however, the area will continue to be evaluated during future monitoring events. A discussion on remaining cap thickness and protectiveness is provided below.

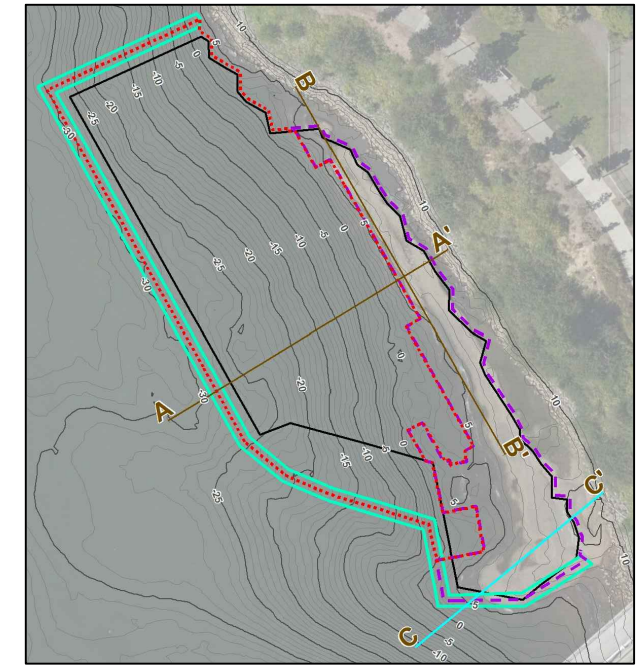
**FIGURE 7 - RM 13.5 CAP SECTION C - C'**

- The area in the southeastern corner of the cap, as portrayed in Figure 7 (cross section C-C'), has experienced the most elevation loss (approximately 1.7 feet) since 2015. The eastern-most portion of the cap was built up in a hump, which has been pushed shoreward by wave action. The visual inspection noted that armor material was still present in this area, so it is unclear what material has been displaced. Settlement of underlying cap materials may partially explain the elevation loss. Importantly, no additional material loss was identified between the 2022 and the 2023 surveys. This area will continue to be evaluated during future monitoring events. A discussion on remaining cap thickness and protectiveness is provided below.

- The area in the southwest corner of the cap, as portrayed in Figure 7 (cross section C-C'), that experienced greater than 1 foot of erosion between the 2016 and 2023 surveys (Figure 3) appears to have stabilized, with no additional notable erosion between the 2022 and 2023 surveys (Figures 4 and 7). This area was a high spot that has likely been leveled off due to wave action. This is primarily an area of toe armor; the current profile suggests sufficient toe armor remains to maintain slope stability, and there is no risk to the integrity of the cap. This area will continue to be evaluated during future cap inspections. As this area is outside of the required isolation cap footprint, there is no impact on environmental protectiveness.

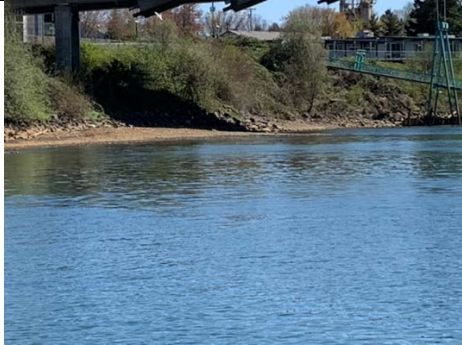
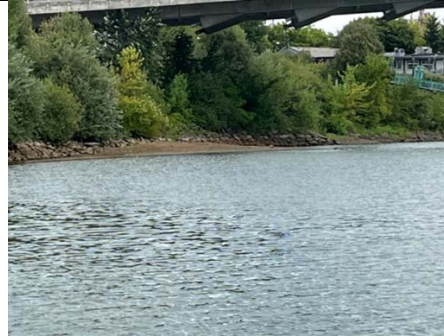
*Observed camping activities by unhouse people along walking path during both inspections on April 12, 2021.*

*Photos taken from Springwater Trail above cap and riprap area due accessibility issues to the river level on August 9, 2023.*

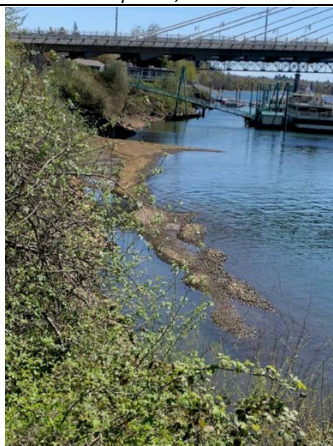
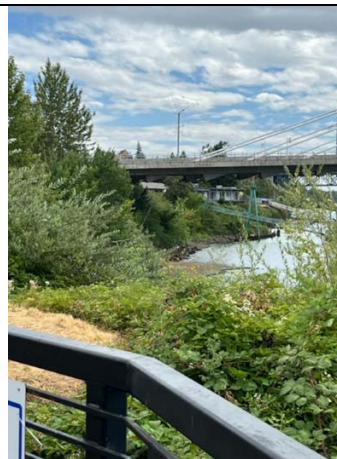
*Photos taken looking north to south at the RM 13.5 shoreline from the OMSI Submarine Dock.*
