River Mile 13.1 Year 3 Isolation Cap Inspection Report

ESCI #5249

Portland General Electric Company, (PGE)

September 21, 2021

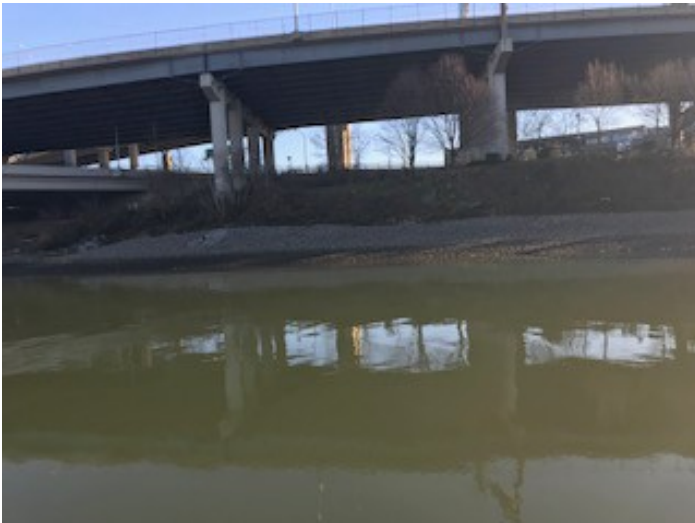
<p>Photo No.1</p>	<p>Date: 1/31/2019</p>

<p>Direction Photo Taken:</p> <p>South to north</p>		
<p>Description:</p> <p>Looking at the RM 13.1 sediment cap from the public dock</p>		
<p>Photo No.2</p>	<p>Date: 4/21/22</p>

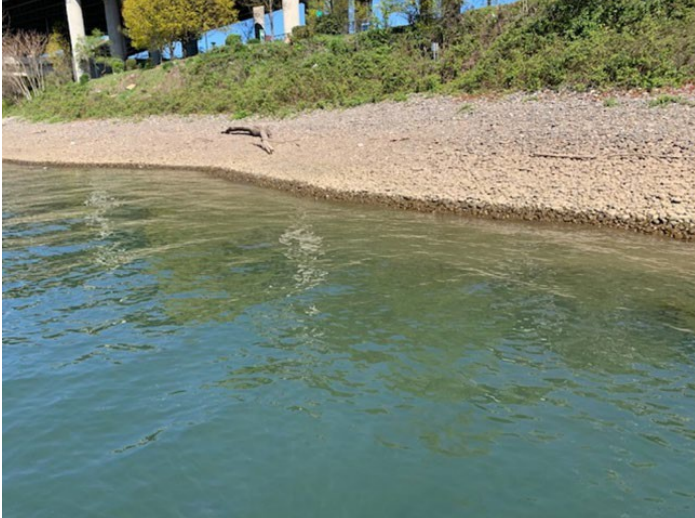
<p>Direction Photo Taken:</p> <p>South to north</p>		
<p>Description:</p> <p>Looking at the RM 13.1 sediment cap from the public dock</p>		
<p>Photo No.3</p>	<p>Date: 1/31/2019</p>

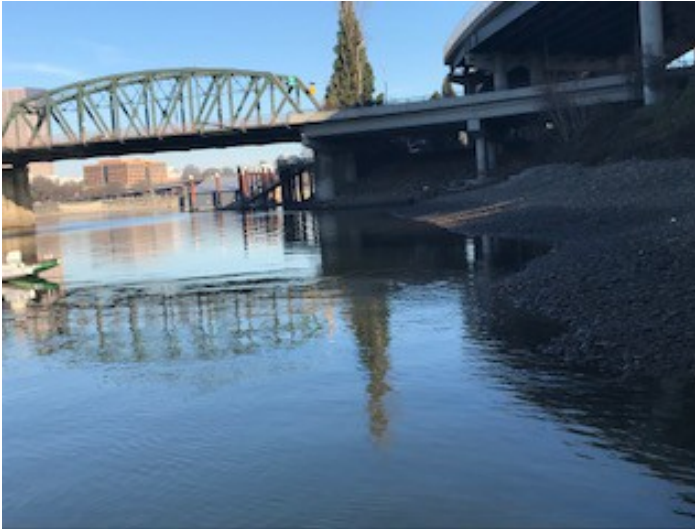
<p>Direction Photo Taken:</p> <p>South to north</p>		
<p>Description:</p> <p>View of the riprap/shoreline from the public dock</p>

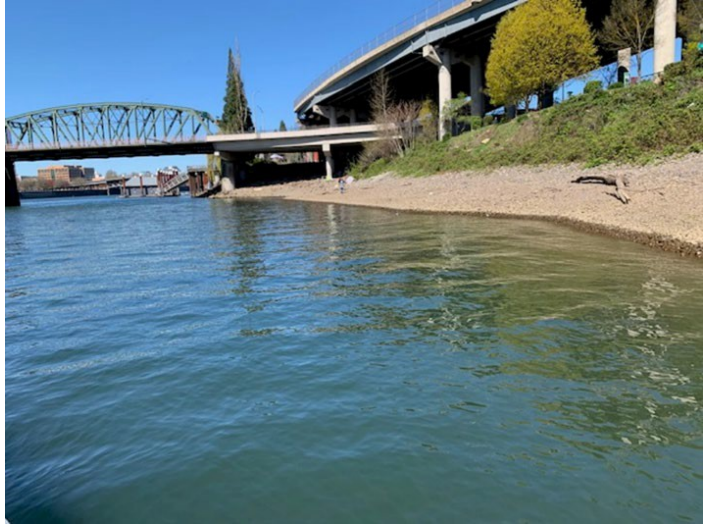
<p>Photo No.4</p>	<p>Date: 4/12/2021</p>

<p>Direction Photo Taken:</p> <p>South to north</p>		
<p>Description:</p> <p>View of the riprap/shoreline from the public dock</p>		
<p>Photo No.5</p>	<p>Date: 1/31/2019</p>

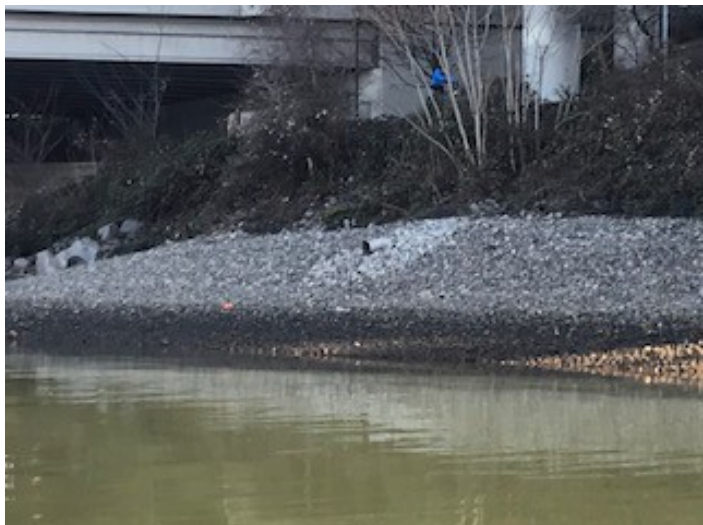
<p>Direction Photo Taken:</p> <p>South to north</p>		
<p>Description:</p> <p>Another view at the riprap/shoreline from the public dock</p>		
<p>Photo No.6</p>	<p>Date: 4/12/2021</p>	 
<p>Direction Photo Taken:</p> <p>South to north</p>		
<p>Description:</p> <p>Another view of the riprap/shoreline from the public dock</p>

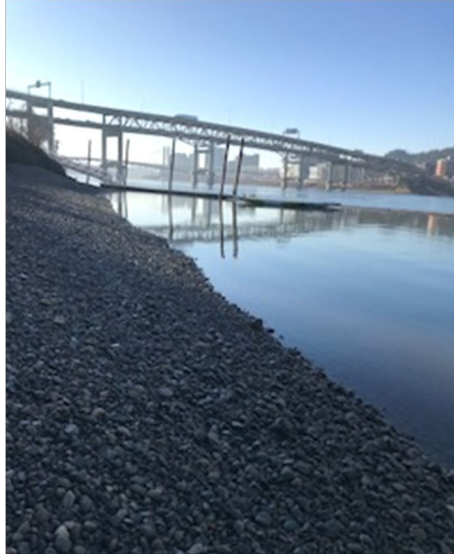
<p>Photo No.7</p>	<p>Date: 1/19/2019</p>

<p>Direction Photo Taken: North to south</p>		
<p>Description: Looking at RM 13.1 from the riprap/shoreline</p>		
<p>Photo No.8</p>	<p>Date: 4/12/2021</p>

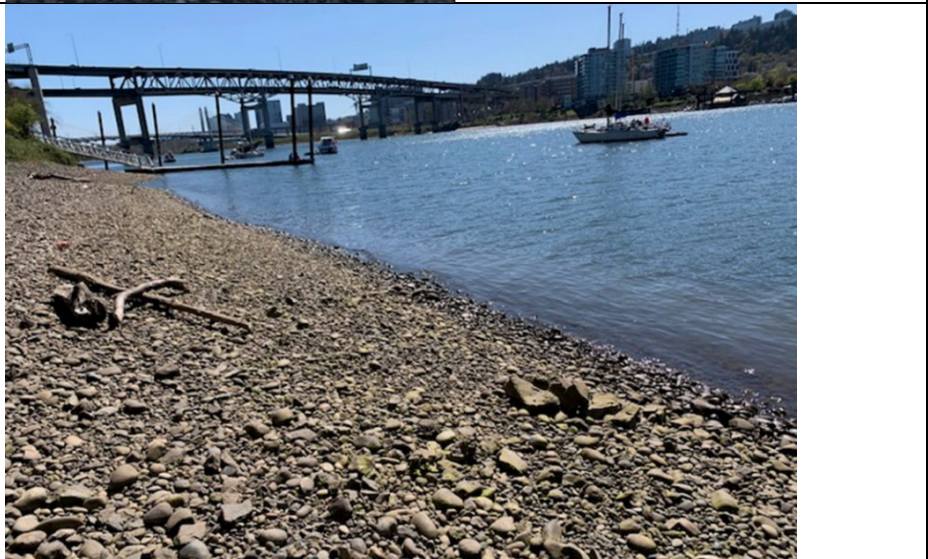
<p>Direction Photo Taken: North to south</p>		
<p>Description: Looking at RM 13.1 from the riprap/shoreline</p>		
<p>Photo No.9</p>	<p>Date: 1/31/2019</p>

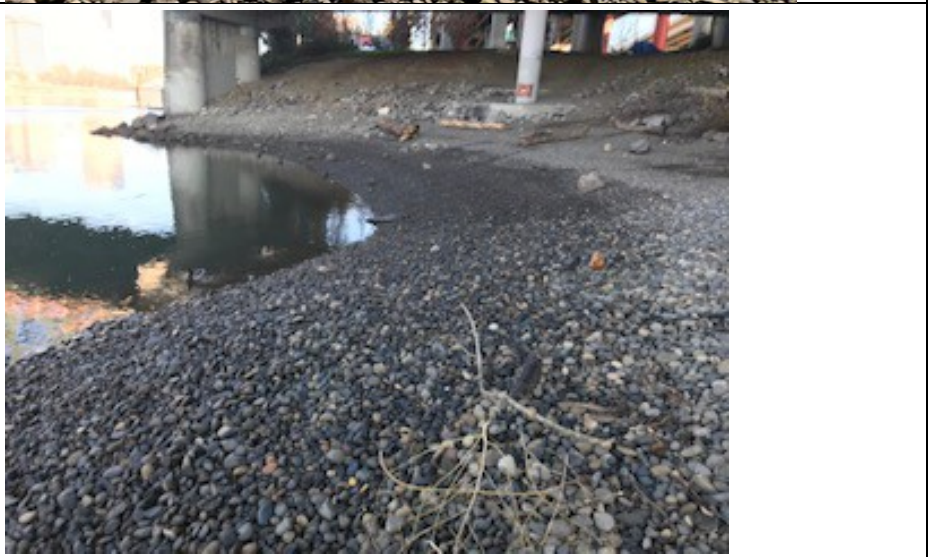
<p>Direction Photo Taken: South to north</p>		
<p>Description: Looking at RM 13.1 from the riprap/shoreline</p>

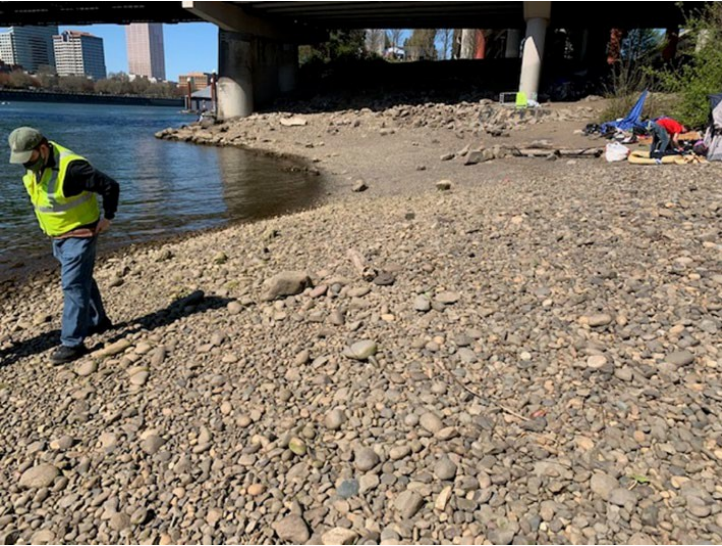
<p>Photo No.10</p>	<p>Date: 4/12/2021</p>

<p>Direction Photo Taken:</p> <p>South to north</p>		
<p>Description:</p> <p>Looking at RM 13.1 from the riprap/shoreline</p>		
<p>Photo No.9</p>	<p>Date: 1/31/2019</p>

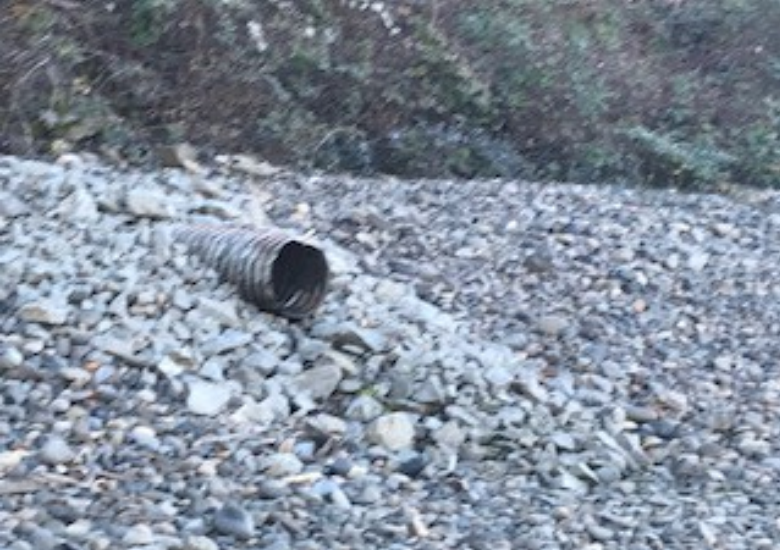
<p>Direction Photo Taken:</p> <p>West to east</p>		
<p>Description:</p> <p>Looking at the City of Portland water pipe looking up from river shoreline</p>		
<p>Photo No.9</p>	<p>Date: 4/12/2021</p>

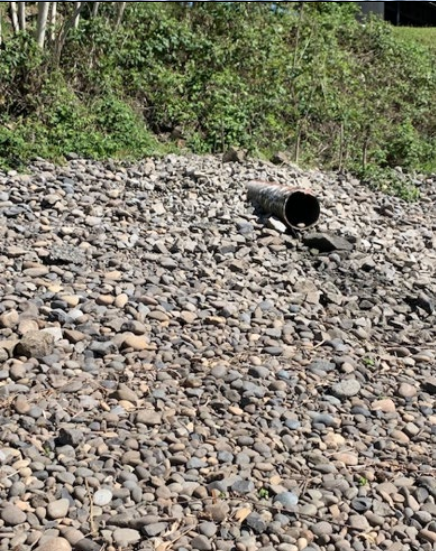
<p>Direction Photo Taken:</p> <p>West to east</p>		
<p>Description:</p> <p>Looking at the City of Portland water pipe looking up from river shoreline</p>
