ST HELENS FIBERBOARD FACILITY UPLAND REMEDY

Fourth Quarter 2022 Progress Report

UPLAND CAP INSPECTION FORM

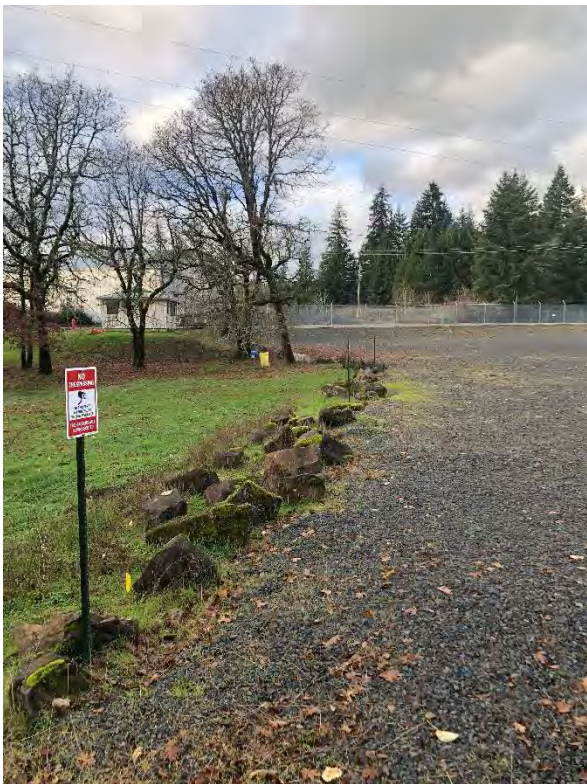
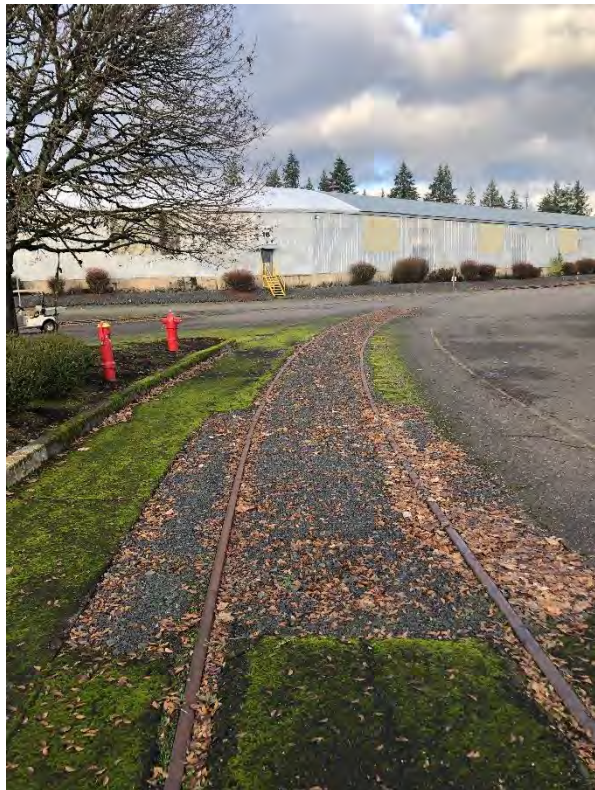
Cap Inspection Area 1 – Soil and Gravel Cap (cont.)

Condition: The condition of the gravel cap remains good in all portions of cap inspection area 1, but invasive weeds have established in some areas of the cap, particularly along the Upland/Lowland Boundary.

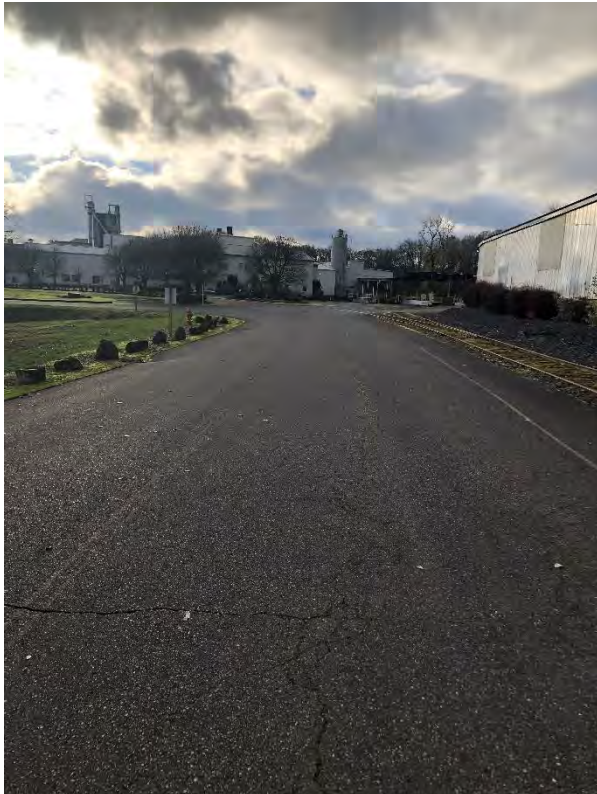
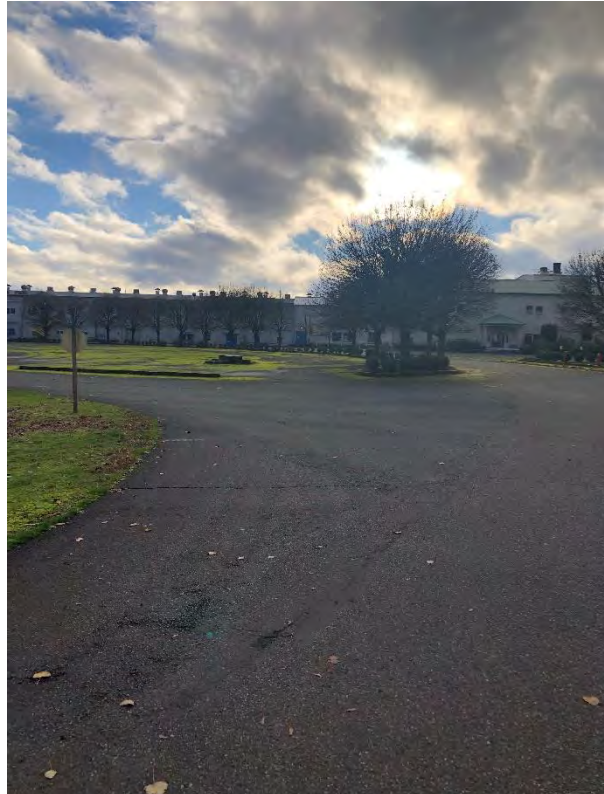
Cap Inspection Area 1 – Asphalt and Concrete Pavement

None taken. Cracks in existing pavement continue to be monitored. Cracks do not appear to have changed since monitoring began in 2019, and do not yet warrant repair.

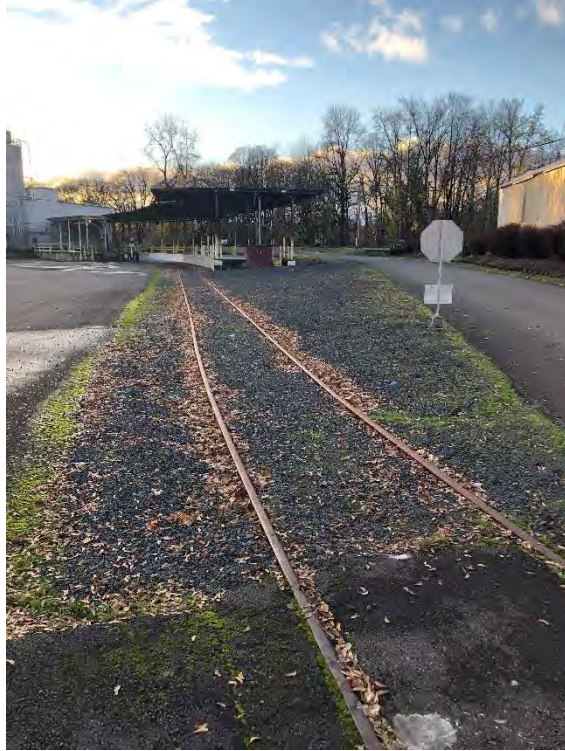
Cap Inspection Area 2 – Soil and Gravel Cap

Condition: Native and invasive weeds continue to be present in upper few inches of gravel throughout the cap, and particularly along the Upland/Lowland boundary.
