# AMCCO REMEDIAL ACTION CONSTRUCTION COMPLETION REPORT

ASTORIA MARINE CONSTRUCTION COMPANY  
ECSI NO. 1898

ASTORIA, OREGON  
*January 25, 2024*  
*Project No. M1653.01.002*

*Prepared by*  
*Maul Foster & Alongi, Inc.*  
*3140 NE Broadway Street, Portland, OR 97232*

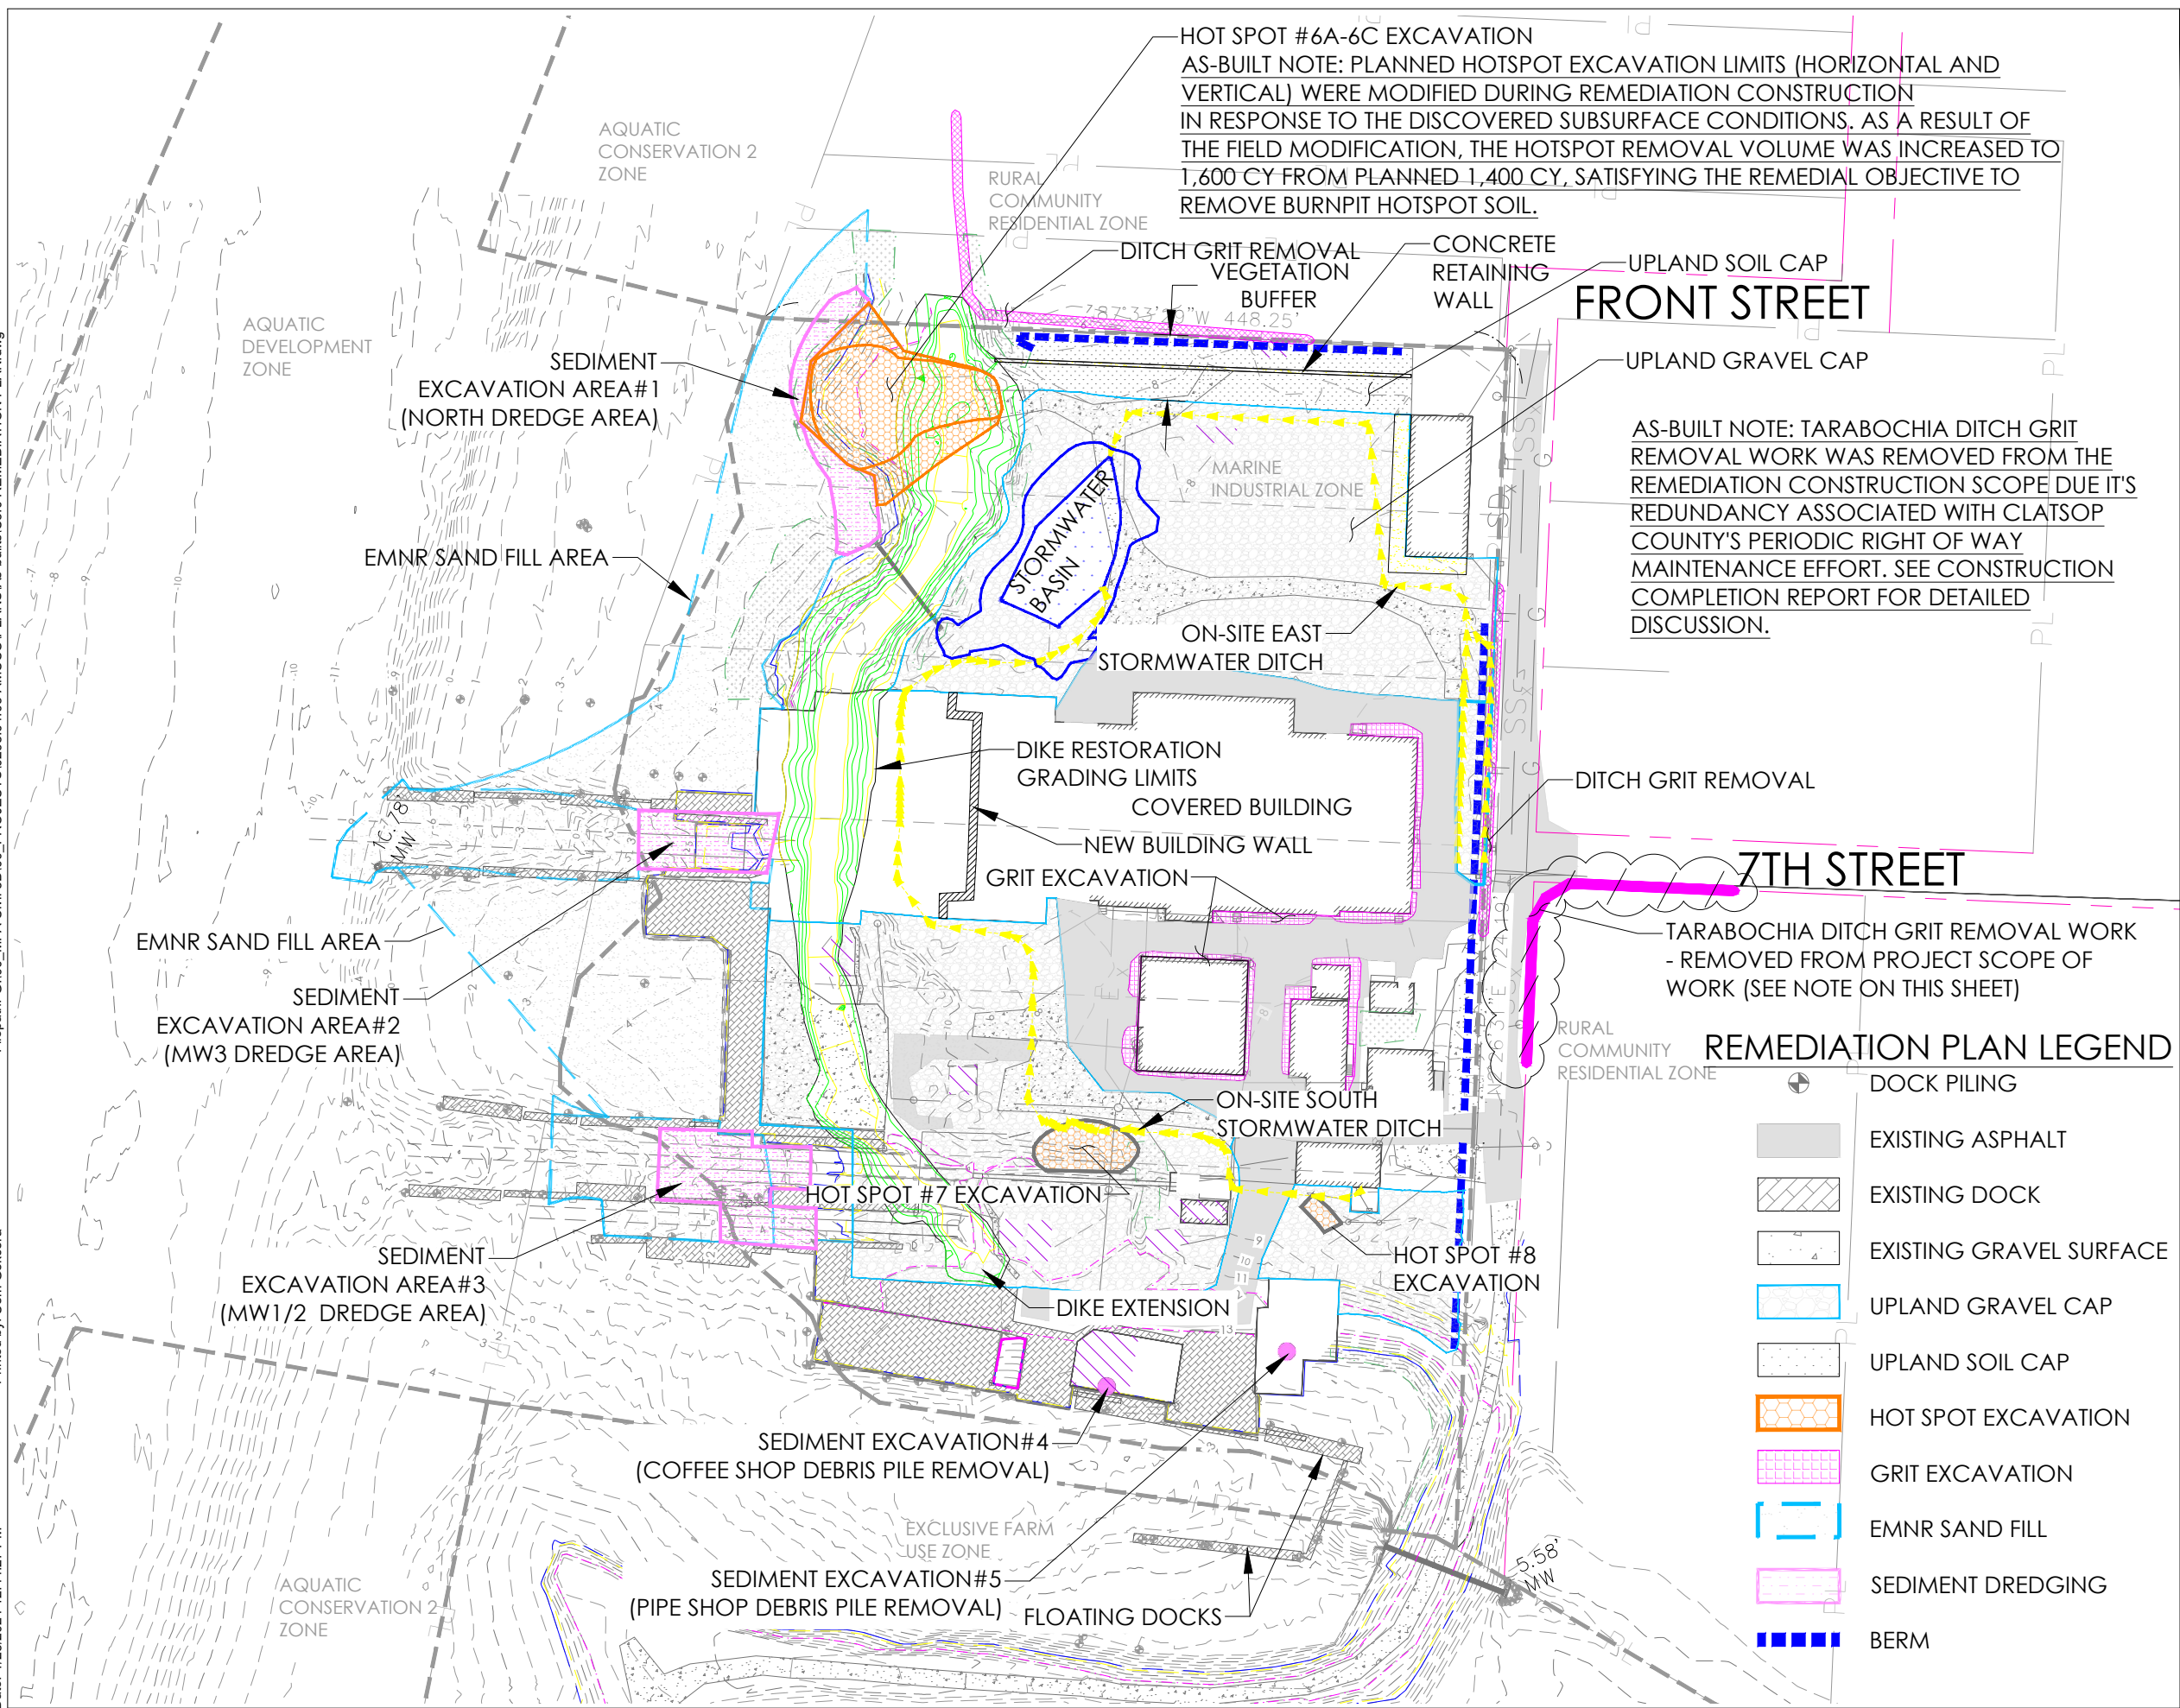
**Figure 1-3  
Master  
Remediation  
Plan**

demolition of the pipe shop and partial demolition of the coffee shop, the debris piles were removed and staged in an upland area that was located directly over Hot Spot #8 (See Figure 1-3 for locations of sediment and upland soil hot spot excavation areas).

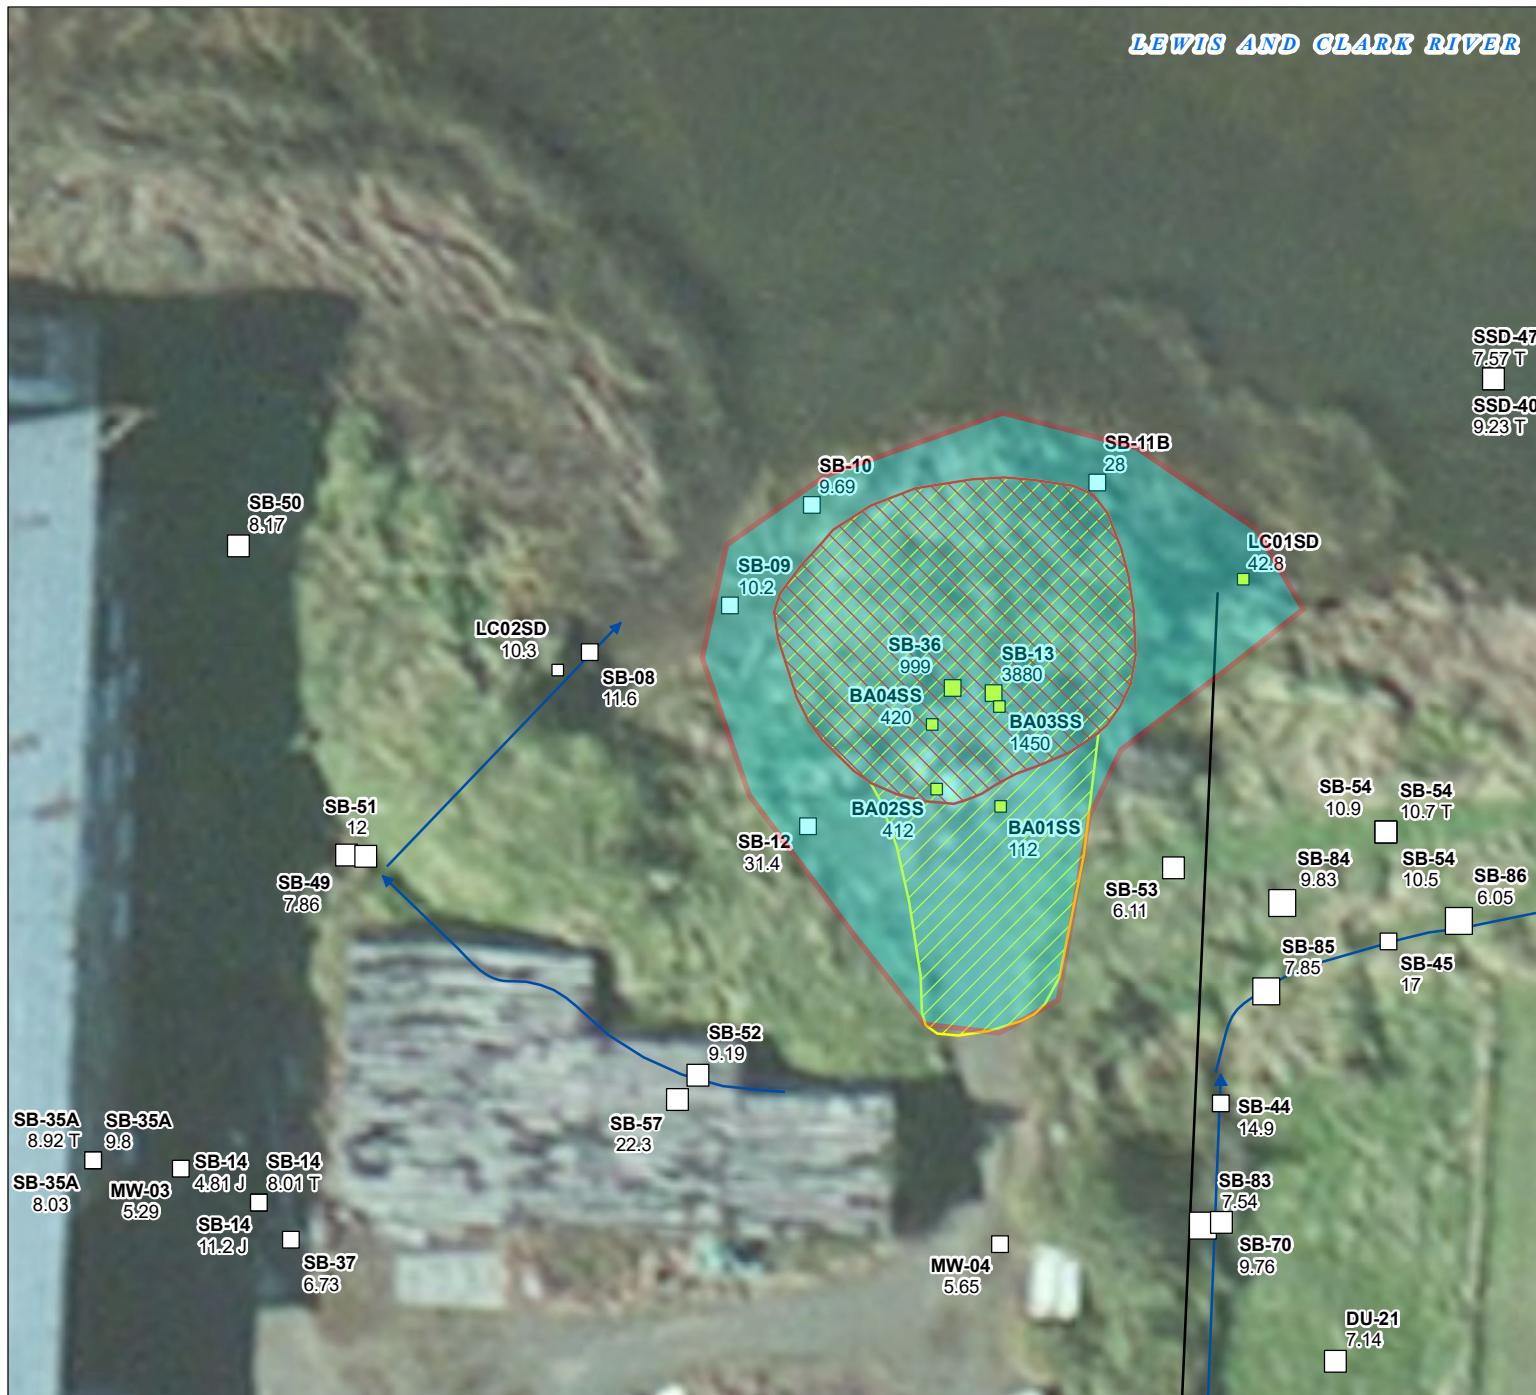
**FIGURE 3-3**

The source control risk for copper was considered as the basis for design regarding the shallow (2-foot) excavation boundary, as shown by the yellow boundary in Figure 3-2. The red boundary identifies a much smaller area where arsenic exceeds source control or hot spot criteria (see Figure 3-3 for arsenic details in shallow soil). Remedial investigation sampling results for these upland samples were screened against the sediment cleanup levels. The pathway of concern is the erosion of soil directly to the Lewis and Clark River sediment.
