PHASE 1 ENVIRONMENTAL SITE ASSESSMENT

**OCHOCO LUMBER COMPANY
200 SE COMBS FLAT ROAD
TAX LOTS: TOWNSHIP 15S, RANGE 16E,
SECTION 4B - 7200, 7300, 7101, SECTION 4C - 2900
PRINEVILLE, CROOK COUNTY, OREGON 97754**

Project Number O002-1

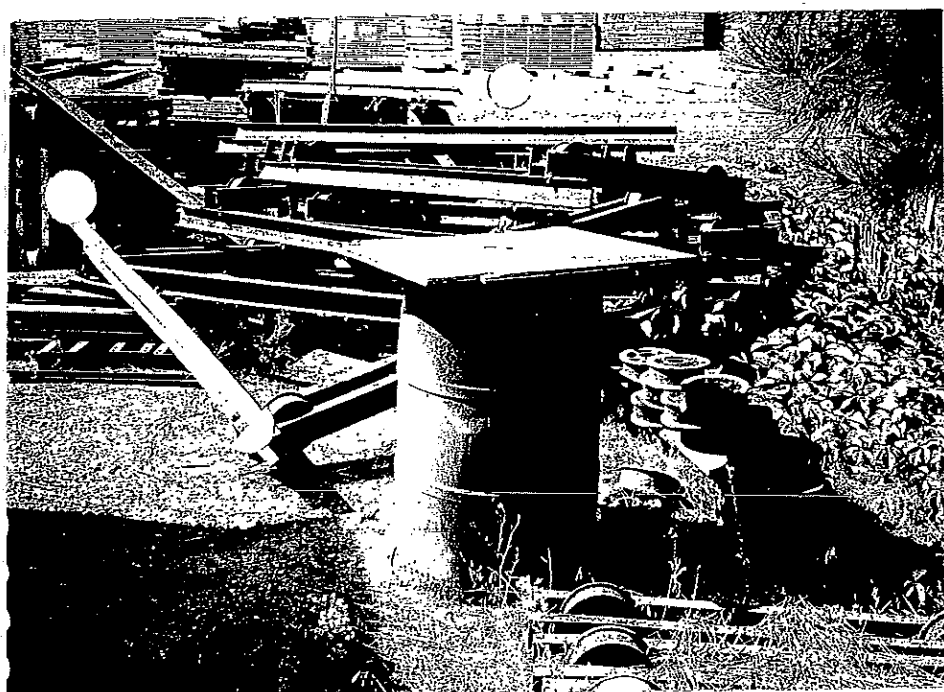
The first area we asked to inspect was the truck shop. On the way to the truck shop I saw a single drum (reference photograph 1 Appendix A) sitting next to a small shed. The drum was covered with a piece of plywood and was determined to contain approximately 5 gallons of used oil. The drum was not labeled in any manner. State and federal regulations set forth in OAR 340-111-032 and 40 CFR 279.22(c); require generators of used oil to label containers with the words "used oil." Ochoco Lumber failed to label a container of used oil in the yard next to a small shed between the office and the truck shop with the words "used oil."

- Photo #1 Drum of used oil between office and truck shop;
- Photo #2&3 Approximately 150 gallons of used oil stored outside the truck shop (July 16, 1997);

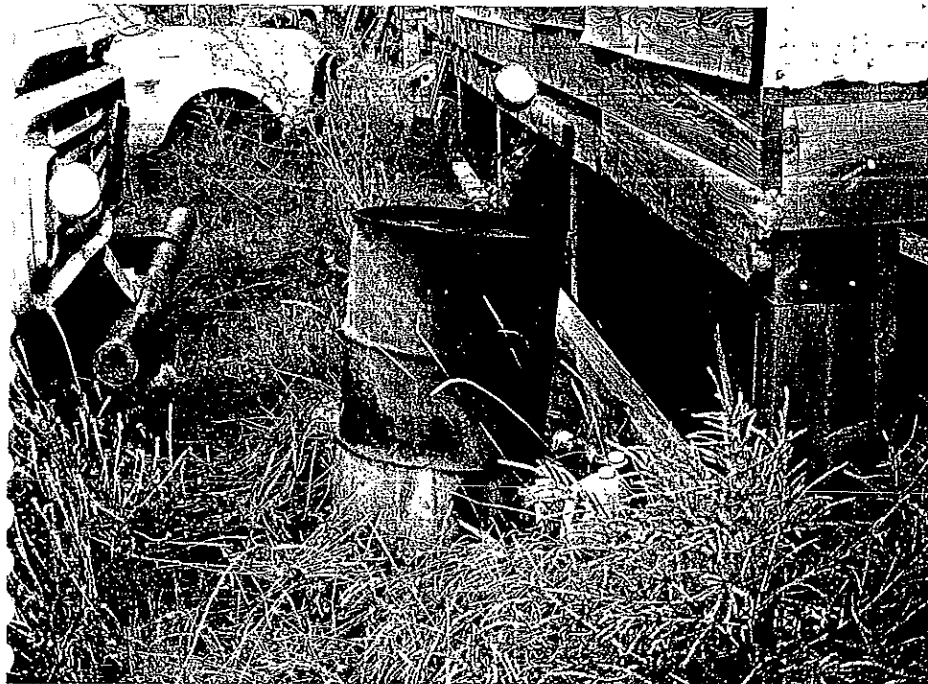
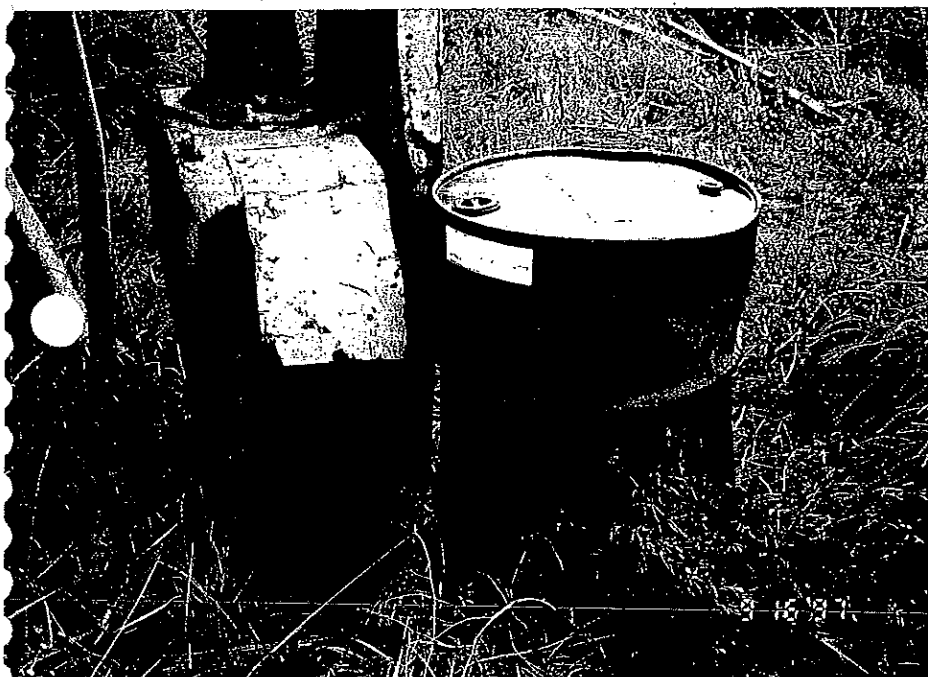
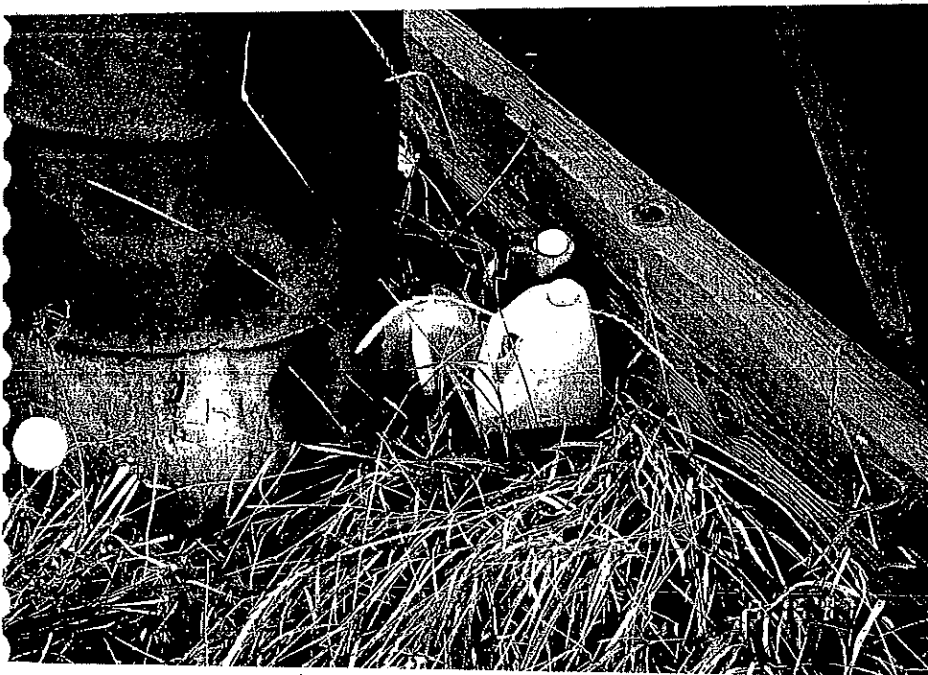
- Photo 4A-4C Used oil stored outside the truck shop away from primary storage area photo taken September 16, 1997, seven weeks after photograph 4.
- Photo 5 Abandoned batteries outside the old truck shop next to the batteries was a vent pipe for an unregistered underground storage tank;

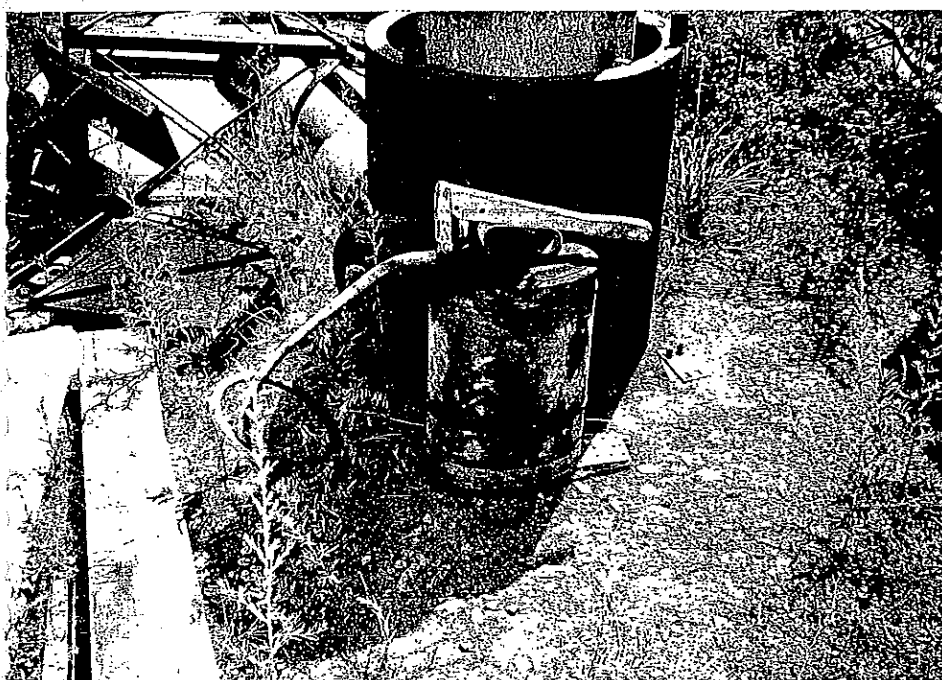
Photo #6

Also next to the old truck shop was a small grease container (reference photograph 6 Appendix A). The container was about half full of an unknown liquid. Mr. Lyon agreed that it did not contain grease and said he would determine what was in the container. State and federal regulations pursuant to OAR 340-102-011 and 40 CFR 262.11 require generators of solid wastes to determine if their solid wastes are hazardous wastes. Ochoco Lumber failed to make a hazardous waste determination on the contents of a grease gun located in their boneyard near the old truck shop. As of my visit on September 16, 1997 nothing had been done to determine the content of this container.

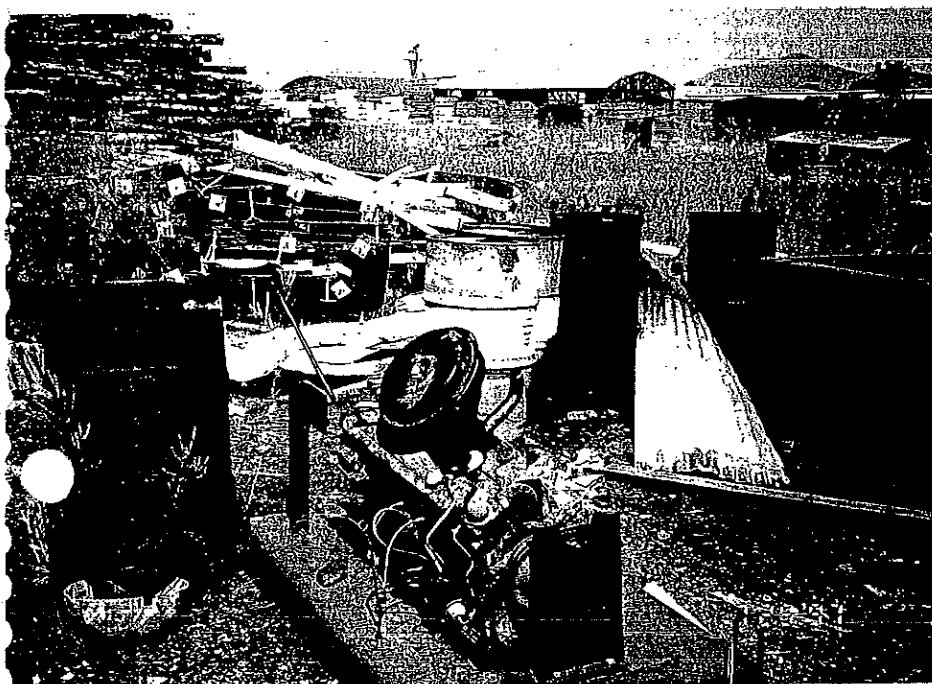
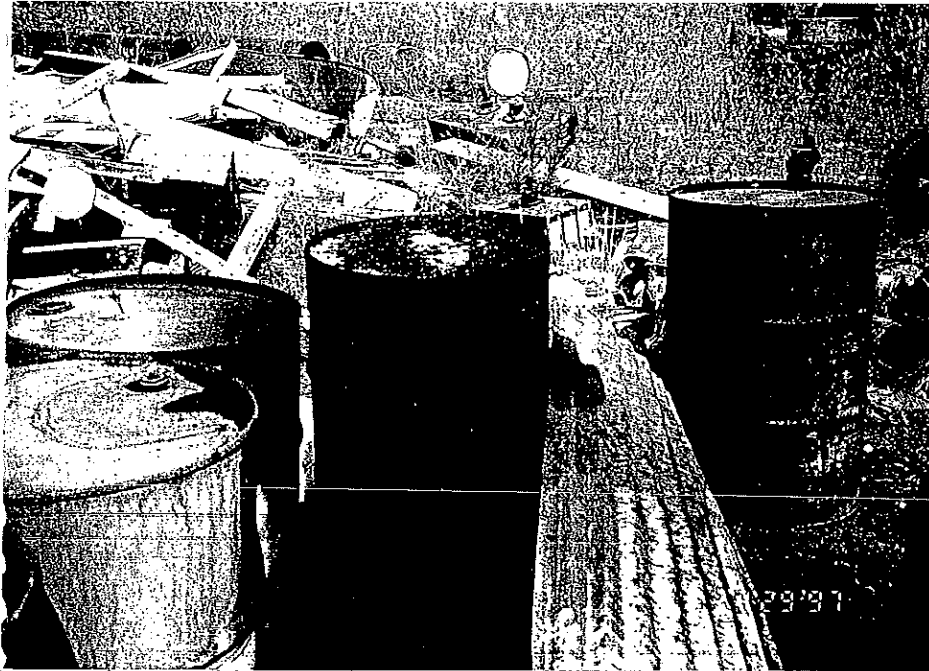
In the center of the boneyard there were several 55 gallon drums of unknown liquid (reference photograph 7 and 8 Appendix A). After opening the drums it appeared that they contained used oil or

- ~~Photo 6 Container of unknowns in a grease container in the boneyard;~~
- Photo 7&8 Drums of what appeared to be used oil abandoned in the center of the boneyard;

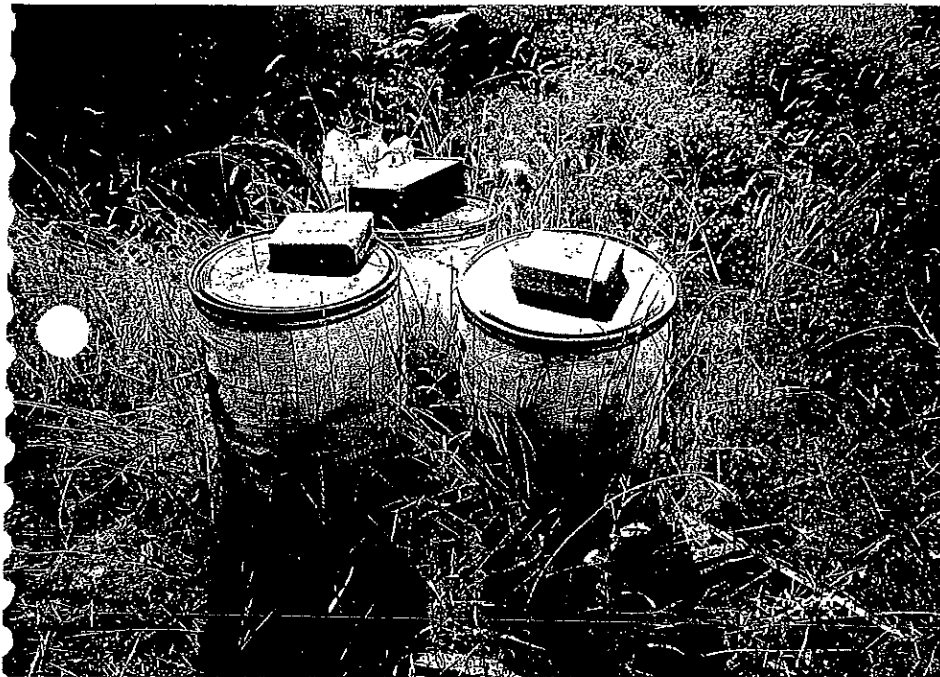
I next observed 3 cardboard/paper drums stored at the north end of the boneyard (reference photograph 9 Appendix A). Mr. Lyon could not for sure say what was in the drums but he did feel that the material had something to do with boiler maintenance. It was later determined that the drums contained alum. A chemical that at one time was used in boiler maintenance. It was determined that this material could be disposed of at the Crook County Landfill.

- Photo #9 Photograph of three drums of what turned out to be boiler chemicals abandoned in the boneyard the material was determined to be alum.
- Photo 10&11 Transformers observed in the boneyard no PCB labels and leaks were evident around each transformer;

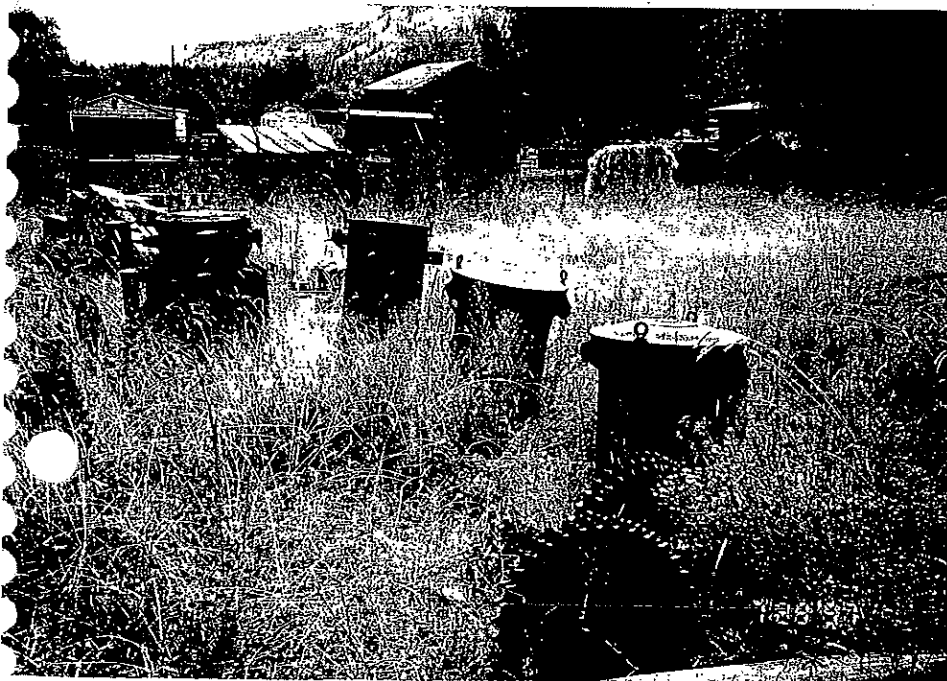
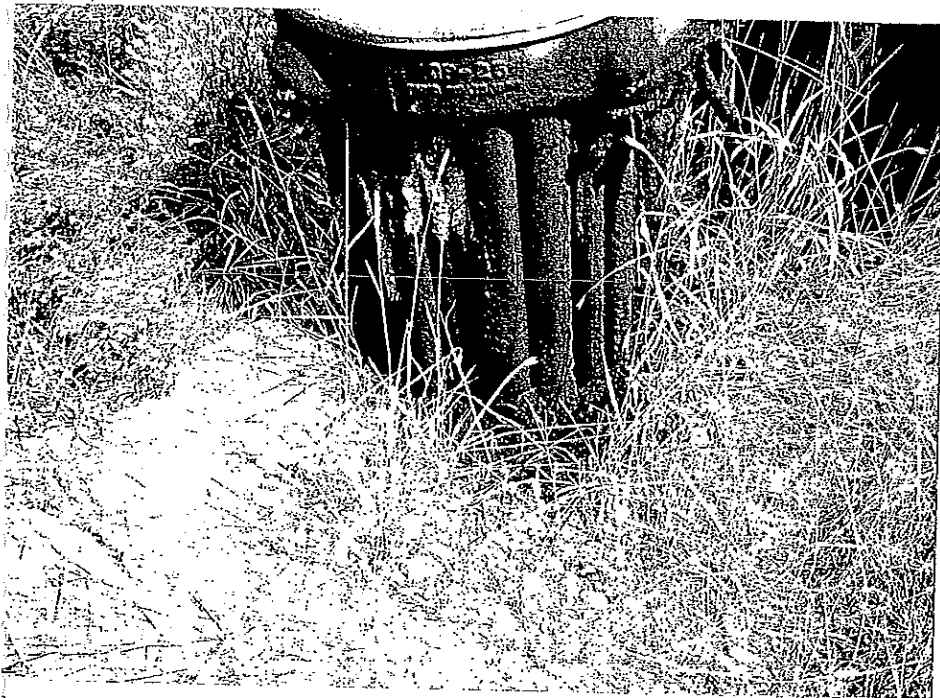
Just west of the alum containers I noticed 4 transformers (reference photograph 10 Appendix A). The transformers were not labelled in any manner and visible releases were evident around all four transformers (reference photograph 11 Appendix A). The State is not authorized for the PCB portion of EPA Toxic Substance Control Act (TSCA). However, I did inform Mr. Lyon that transformers that have not been tested or are not labelled must be assumed to be PCB transformers and must be stored in containment and covered. Following the inspection I contacted Mr. Dan Hyster, Oregon's EPA Operations Office, and explained what I had found. I explained that if the transformers were determined to contain PCBs that I would be referring this case to EPA.

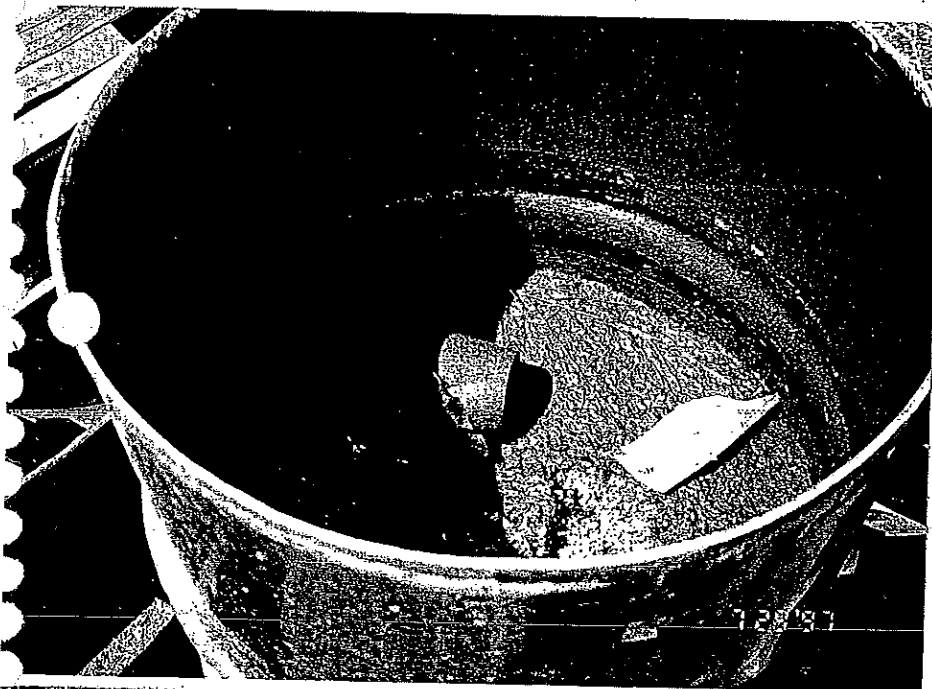
Photo #16

- Photo 12-15 Photographs of the sampling activity in and around the 4 transformers soils were sampled around 3 of the 4 transformers;
- Photo 16 Photograph of one of several abandoned drums of material in the boneyard;

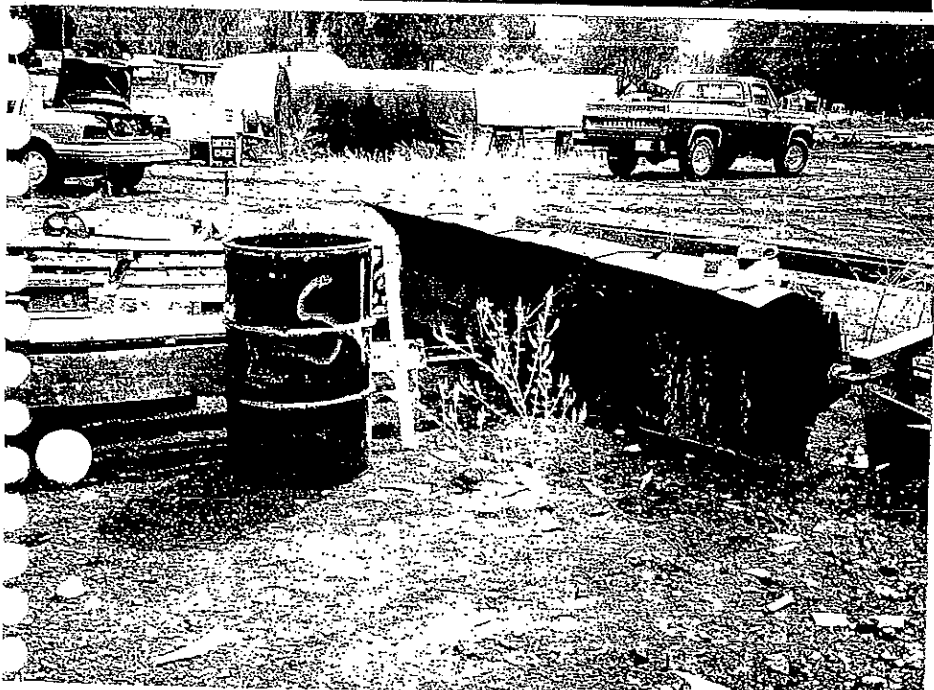
Photo #17

- Photo 17 Photograph of another drum of unknown material abandoned in the boneyard the contents of this drums was sampled July 30, 1997;
- Photo 18-20 Photograph of the sampling activity of the drum shown in photograph 17;

* Unknown wastes were observed in the boneyard. Several containers in the boneyard contained waste that you could not identify. You need to identify the contents of those containers and properly manage the material in the containers. You must provide the department a summary of what was determined to be in the drums stored in the boneyard. The summary should include the contents of the cardboard drums, the contents of the small grease container near the locked up old truck shop, and the contents of several 55 gallon drums in the center of the boneyard. The summary should also include how you intend or how you did manage the material in the drums.

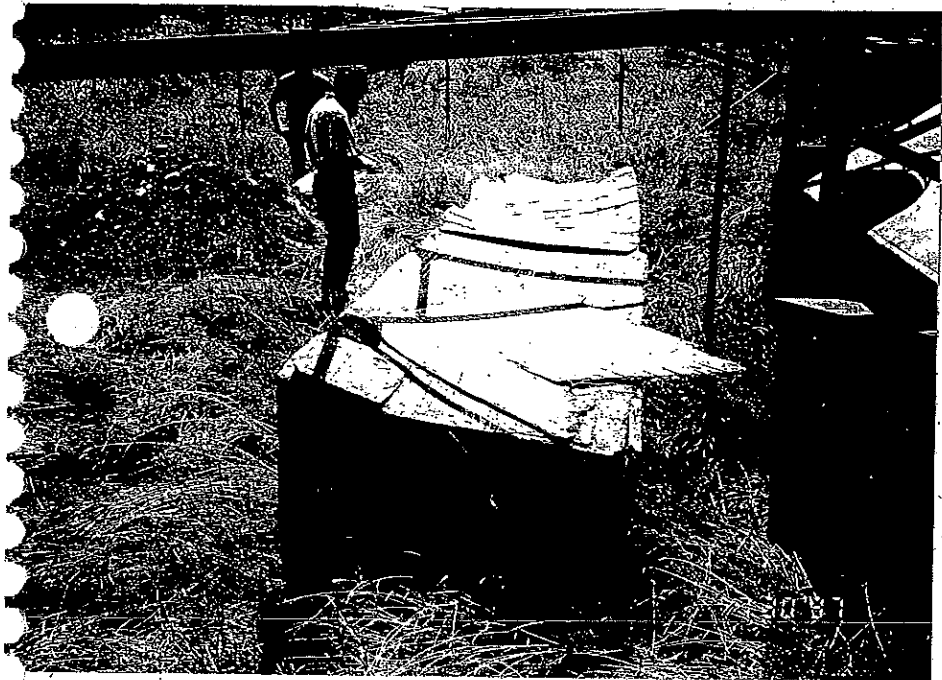
- Photo 21&22 Photographs of the wooden container in the boneyard that contained asbestos materials;

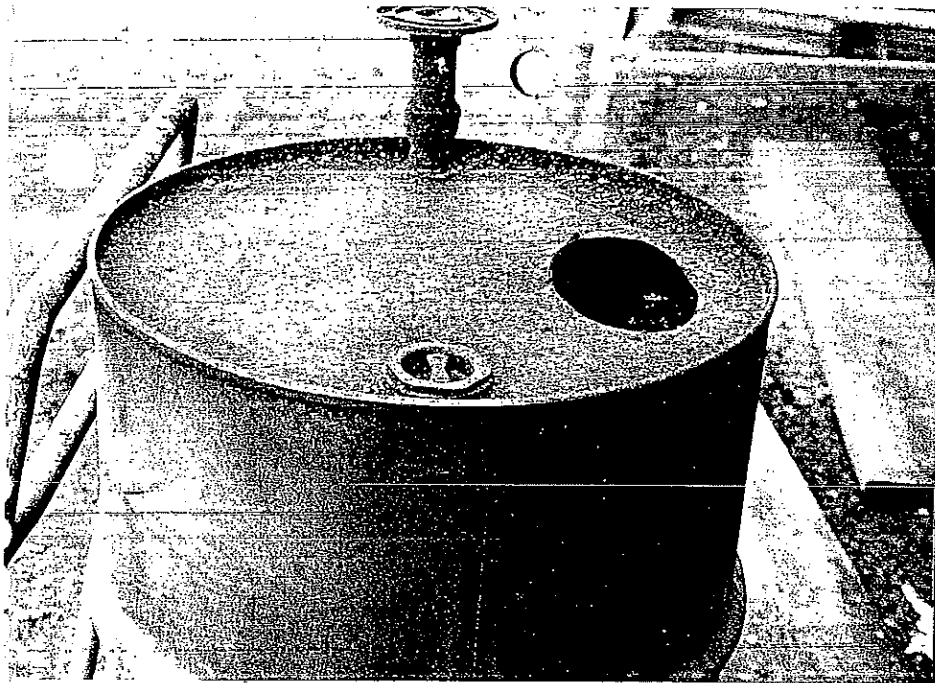
Photo #32

I next inspected the small logmill. Behind the small logmill I observed several drums (reference photograph 32 Appendix A). The drums were all empty drums except for one of the drums. That drum contained what Mr. Lyon and the logmill maintenance foreman Kenny said was used oil. The drum was not labelled in any manner, was open as it had a hole in the top of the drum, and visible releases were observed around the container (reference photograph 33 Appendix A). State and federal regulations set forth in OAR 340-111-032 and 40 CFR 279.22(c) and (d); require generators of used oil to label containers with the words "used oil," and to clean up any releases of used oil. State regulations set forth in OAR 340-111-032(2), require containers, used to store used oil, to be closed, covered, or located under cover to prevent rainwater from coming in contact with the used oil. Ochoco Lumber Company failed to label a 55 gallon drum of used oil located behind the small logmill with the words "used oil," failed to clean up visible releases of used oil from that drum, and failed to keep the container covered so that rain water could not get into the container.

- Photo 23-28 Photographs of sampling activity surrounding the blocks of material in the wooden box in the boneyard;
- Photo 29&30 Photographs of outfalls from the boiler room into the log floating pond;
- Photo 31 Photograph of a spill of hydraulic oil at the debarker;
- Photo 32 Photograph of several empty drums against the wall of the small logmill the one drum set away from the wall contained used oil;
- Photo 33 Photograph of the drum shown in photograph 32 that is set away from the wall showing that it contained used oil and was full and open;
- Photo 34 Photograph showing product storage at the small log mill;
- Photo 35 Photograph of the blade shop in the small logmill the blade shops in both the large and small log-mills the facility did not use any caustic cleaners.

* The containers of used oil observed at the truck shop, behind the small sawmill and in the boneyard must be in good condition and closed or covered in such a manner that rainwater cannot enter the container.

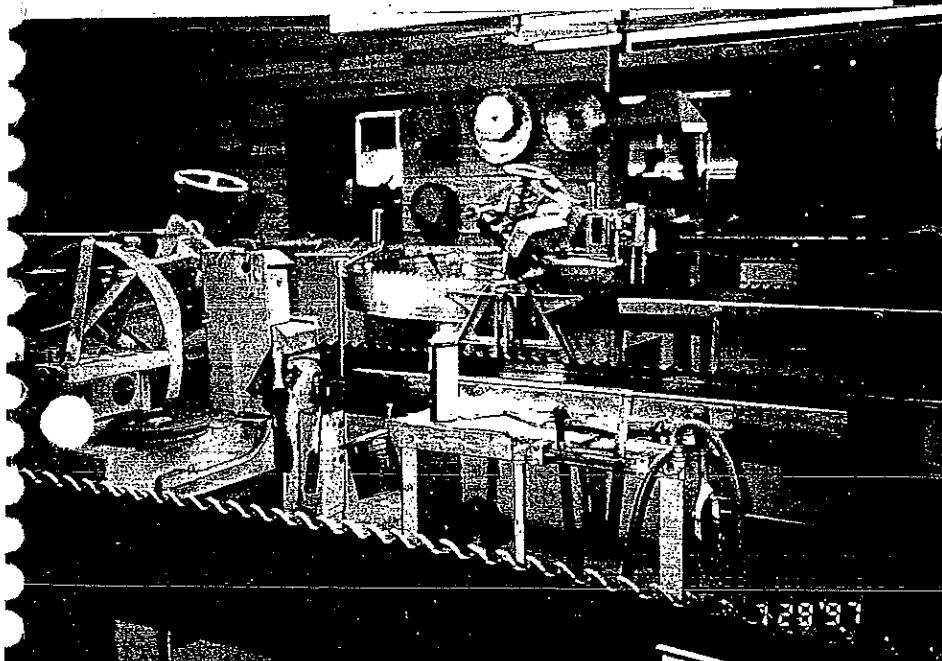
Photo
#34

Just inside the small logmill there is an area used for product storage (reference photograph 34 Appendix A). Drip pans are used to catch any of the product drippage and the drippage is collected and placed in the drum outside the building. The small logmill shop was also the home of Ochoco Lumber's second degreasing station. There was massive confusion as to who manages this unit. At first Mr. Lyon said Safety-Kleen managed the unit; however, we could find no paperwork to verify that claim. Following the

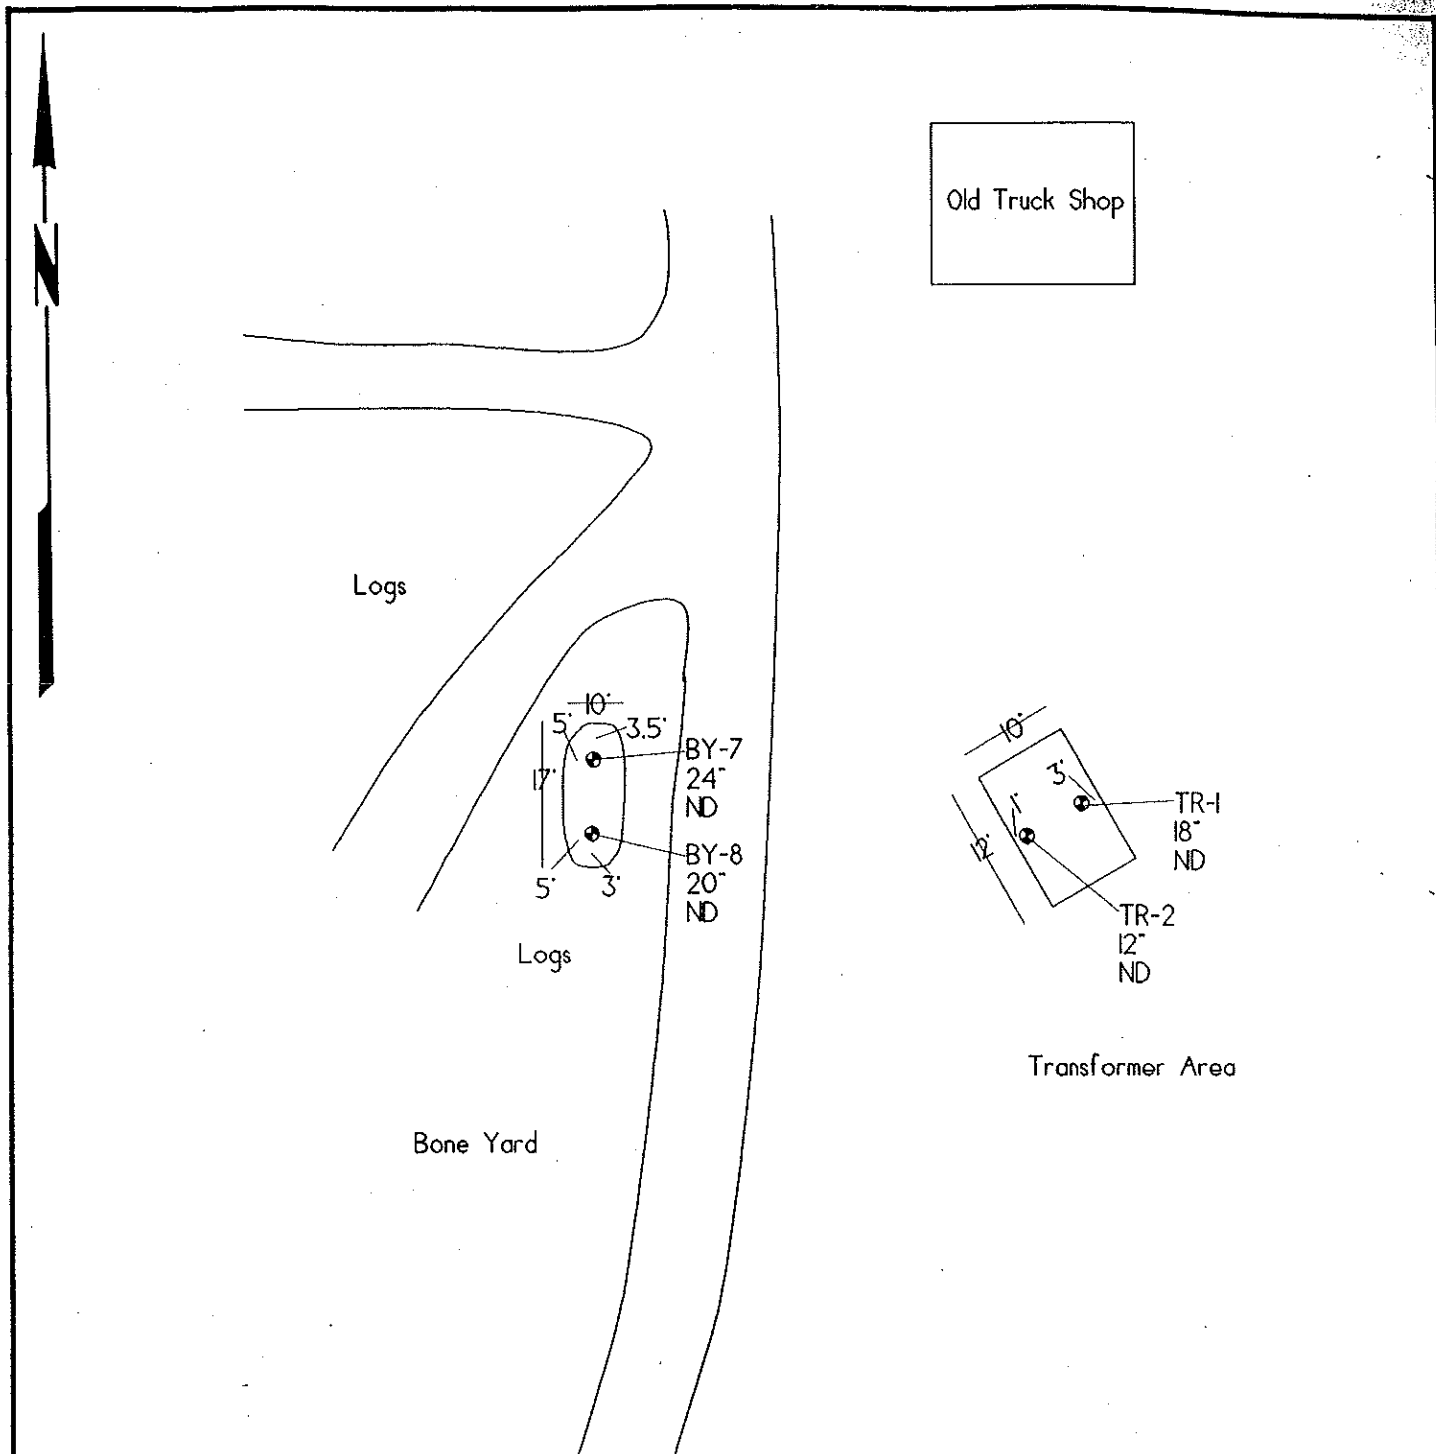
Transformer and Bone Yard Area

On January 14, 1998, Ochoco excavated visibly contaminated soil from the boneyard area. Before excavation, scrap metal and drums were removed from the area of stained soil. The ground surface in the boneyard area is covered with large crushed rock (three-inch minus) to a depth of approximately one foot. Soil beneath the crushed rock is dark brown sandy silt. The cleanup excavation measured approximately ten by 17 feet and had a maximum depth of 24 inches. No TPH was detected in two cleanup verification samples taken from the bottom of the excavation. Soil sample locations are shown on Figure 3.
