Seismic Vulnerability Assessment  
Phase 1

Phillips 66 Terminal  
Portland, Oregon

File No. 20545-035-02  
May 30, 2024

# WILLAMETTE RIVER TERMINAL: MARINE FACILITY STRUCTURAL CONDITION ASSESSMENT

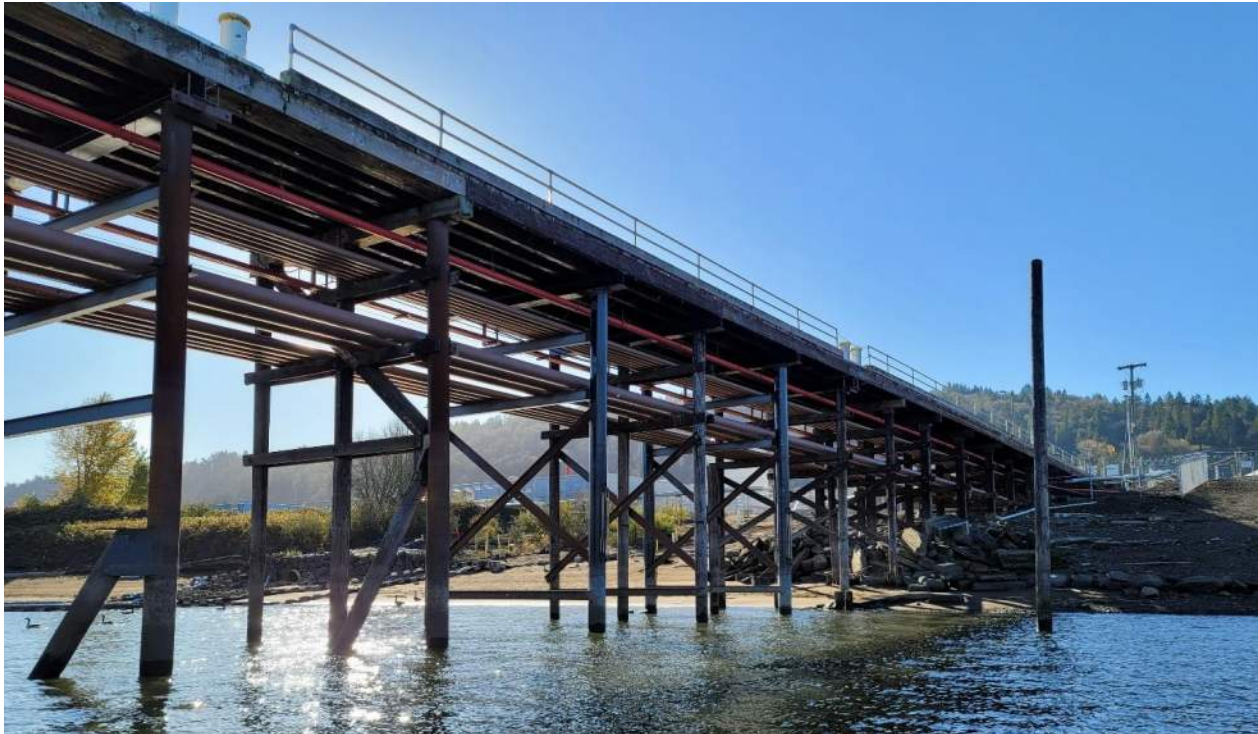
Picture 3. Pier approach from the downstream side. Note the combination of steel piles and bracing with the original timber elements.

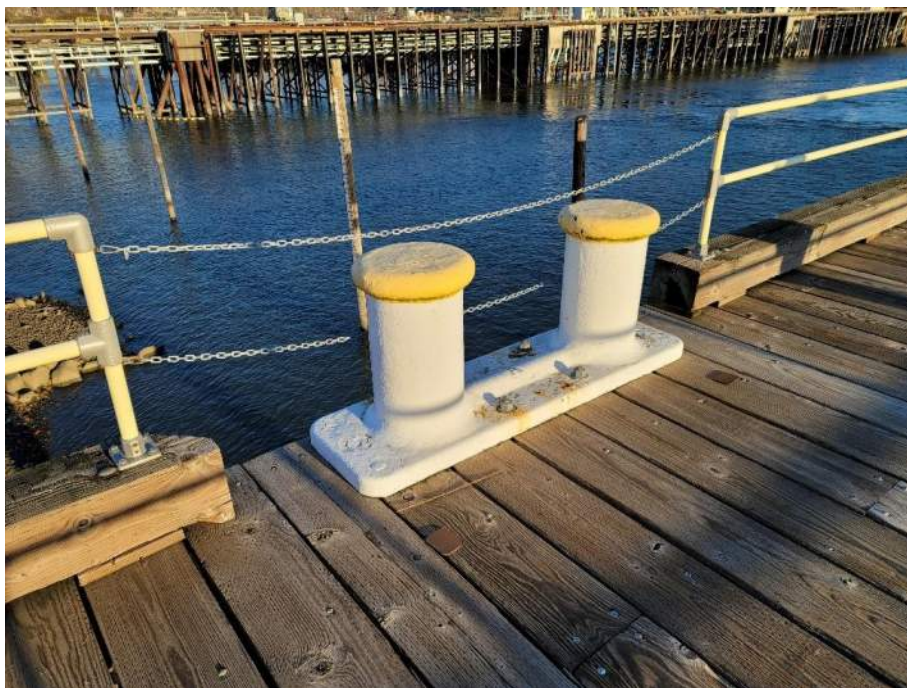
Picture 18. Bollard 'A', deck, handrails along approach. It does not appear to see regular use.

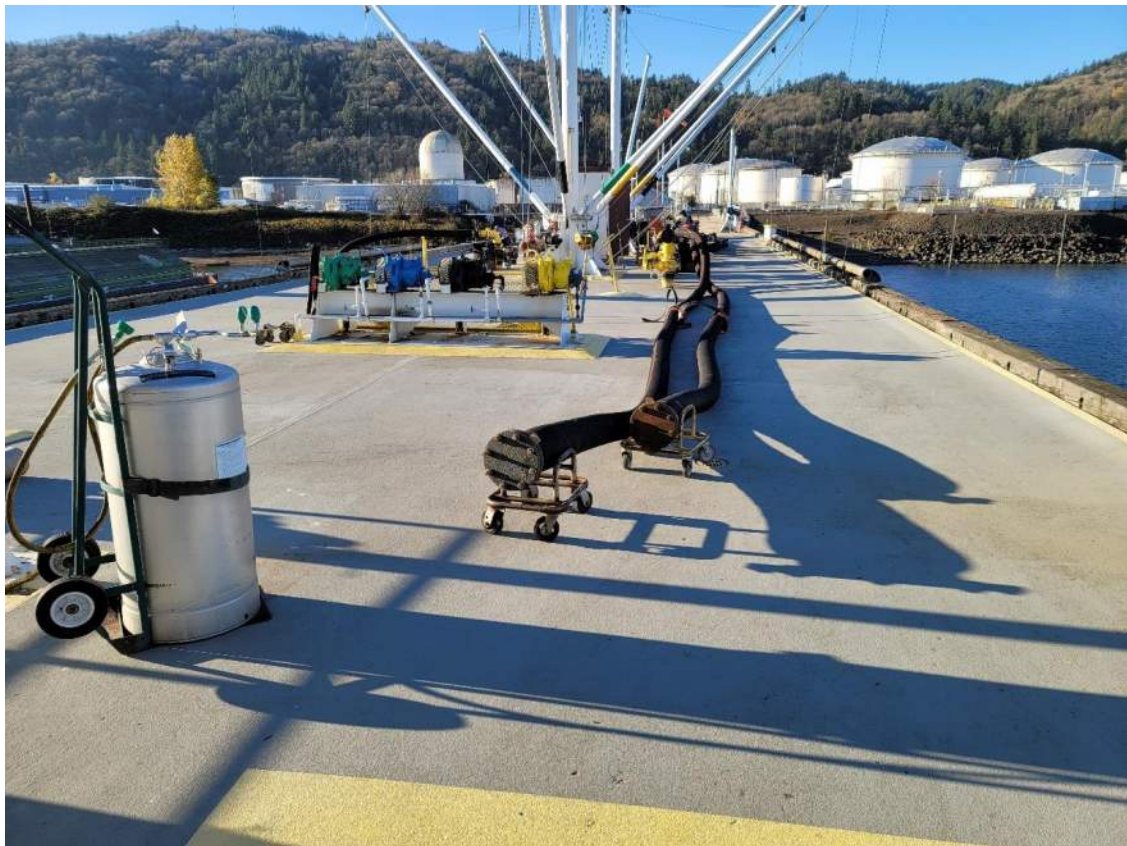
Picture 24. Service area. Note good condition of concrete surface.

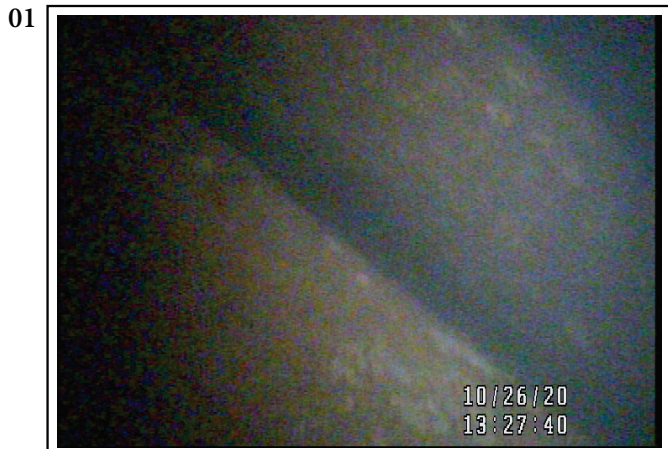
Typical Dolphin Cluster Pile Condition.

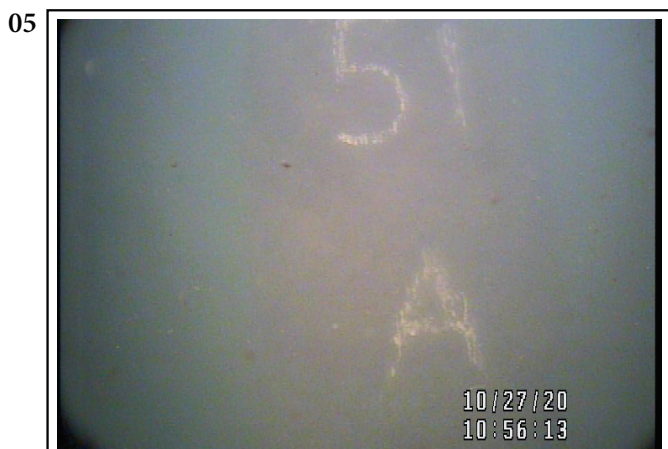
Pile 51 A - Loose at top.

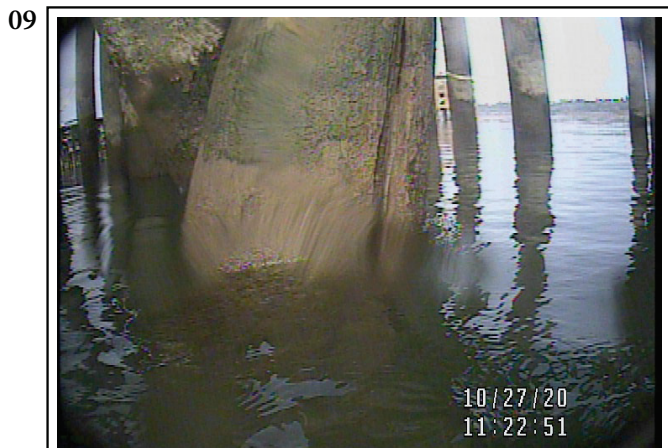
Pile 50 B - Splitting observed.

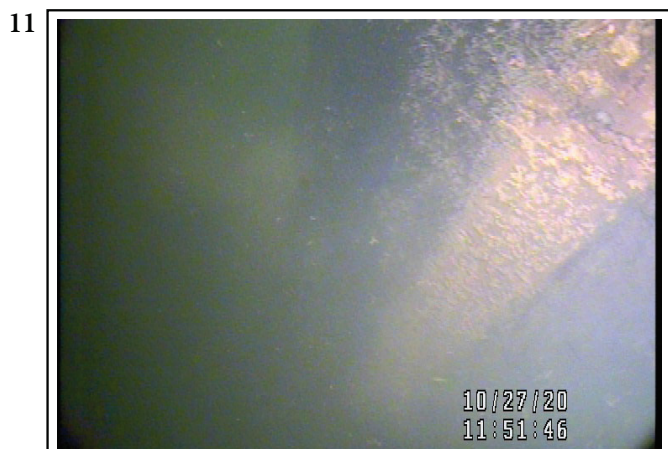
Pile 49 - Minor corrosion sighted.

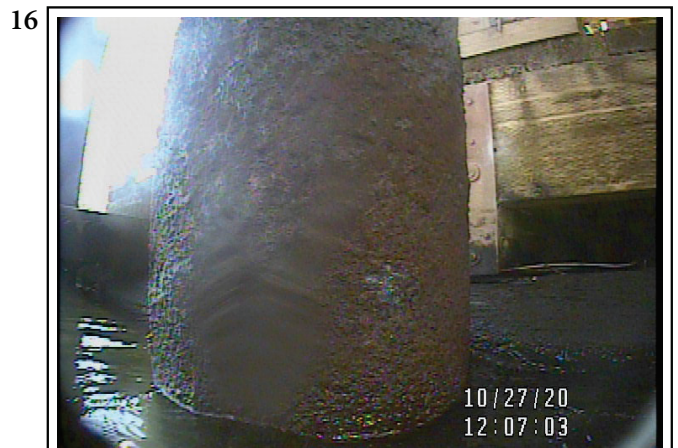
Fender Pile 47 - Minor corrosion sighted.

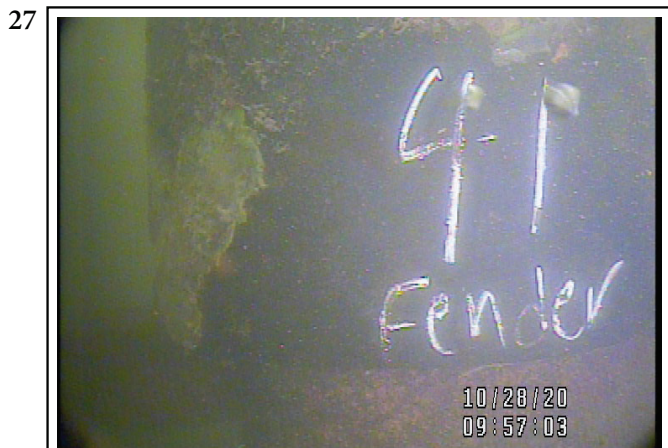
Fender Pile 41 - Minor corrosion sighted.

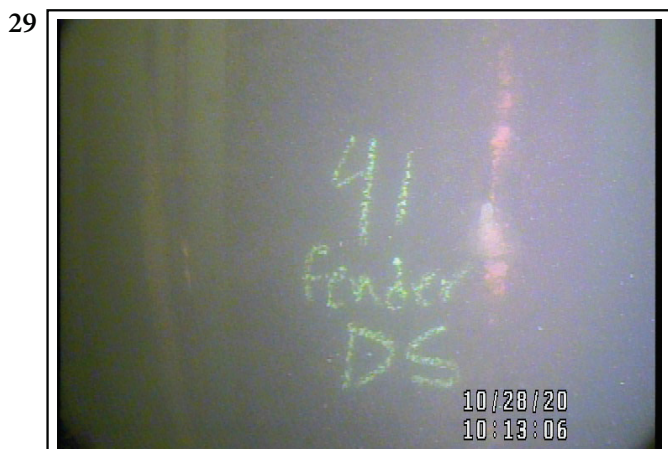
Fender Pile 41 Downstream side - Minor corrosion sighted.

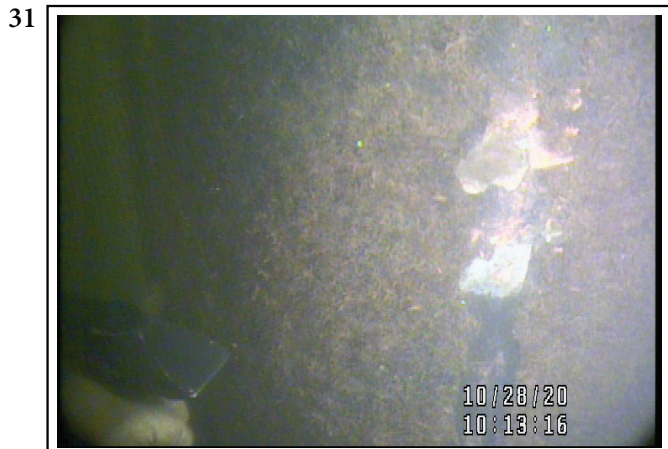
Pile 41 B - Loose at top.

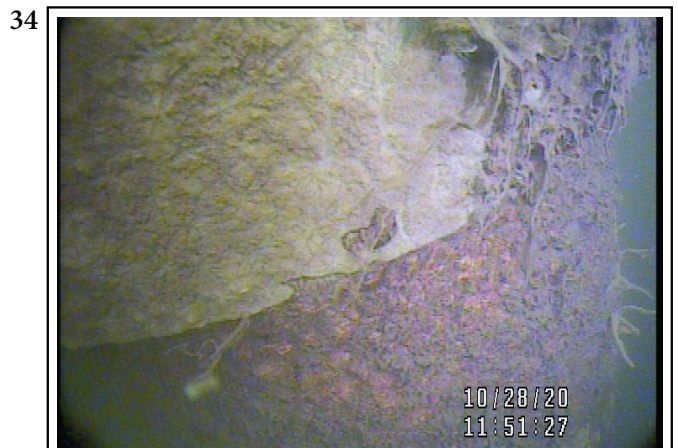
Fender Pile 38 - Minor corrosion sighted.

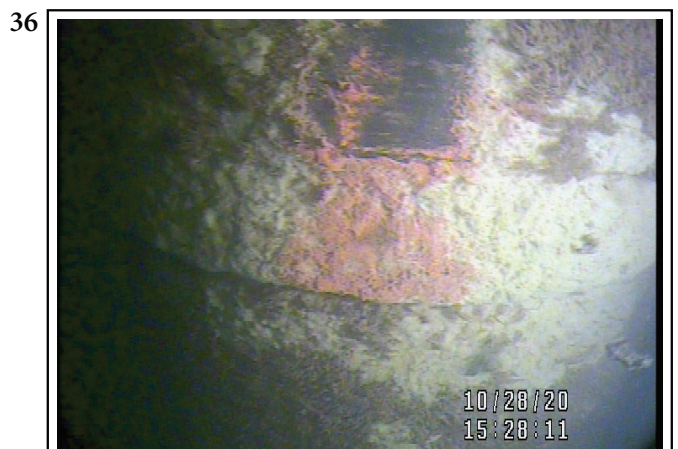
Fender Pile 33 - Minor corrosion sighted.

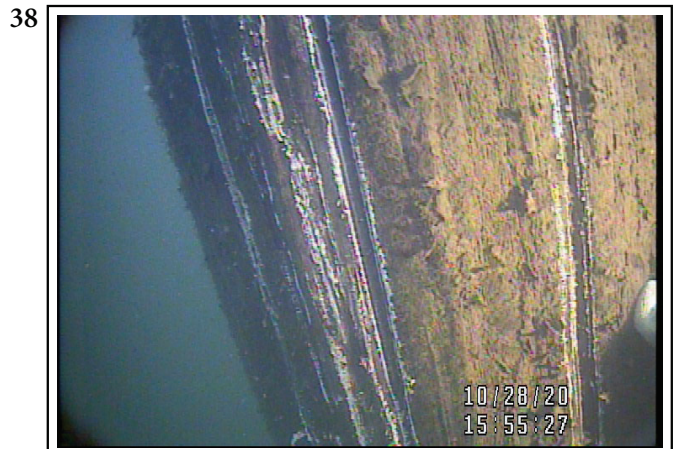
Pile 32 D - Splitting observed.

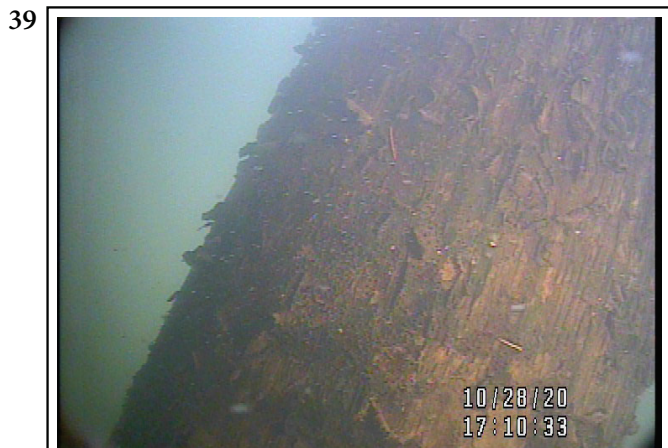
Pile 32 D - Weather checking observed.

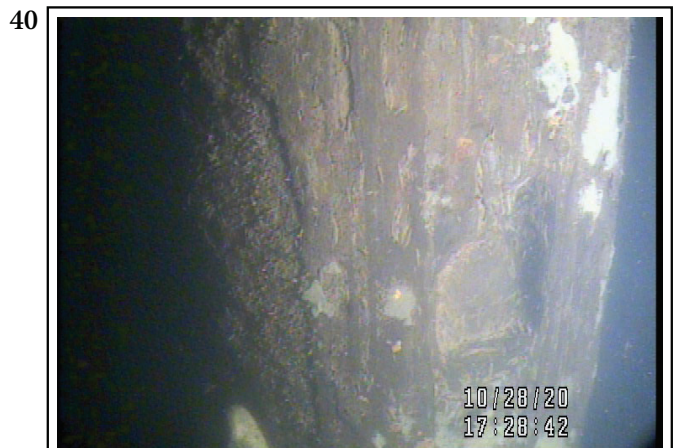
Pile 32 D - Pocket of wood missing observed.

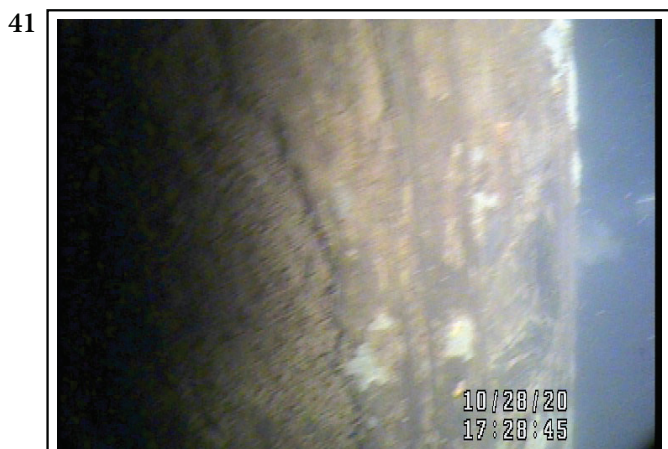
Pile 32 D - Pocket of wood missing observed.

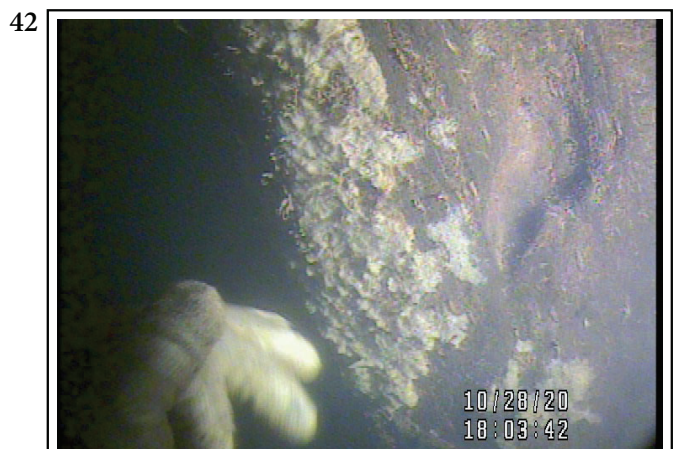
Pile 32 D - Pocket of wood missing observed.
