Oregon Department of Environmental Quality

Operations and Maintenance Report January 2023 to December 2023

McCormick & Baxter Superfund Site Portland, Oregon ECSI No. 74

August 14, 2024

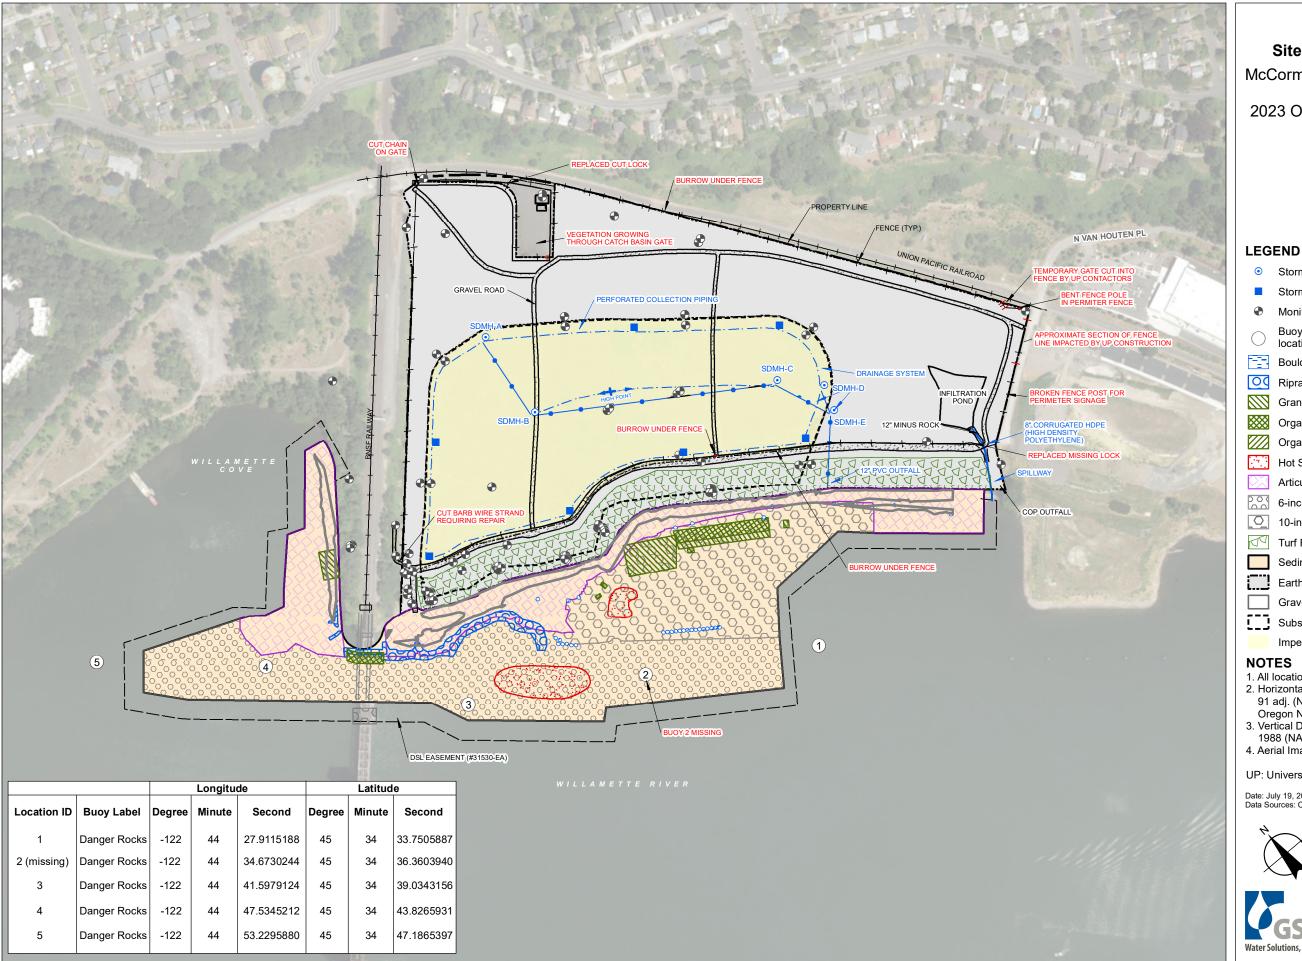
FIGURE 2-1

Site Observation Summary

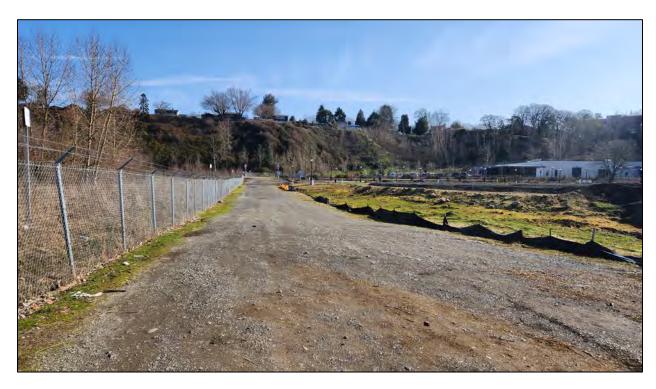
While at the end of N. Van Houten Place near the shoreline, the group discussed the upcoming construction/improvements to the road that will be done by University of Portland. The plans call for raising the roadway approximately 3 feet. The group discussed how that would affect the site as the perimeter fence is next to the roadway (Photograph 6). If the roadway is raised immediately next to the property line, then the fence would need to be raised and some sloping down to the site elevation would need to occur. DEQ will communicate with University of Portland regarding the construction activities and the impact to the site.

Photograph 6: Western end of N. Van Houten Place that will be raised approximately 3 feet during upcoming University of Portland improvements to the road. View facing east.

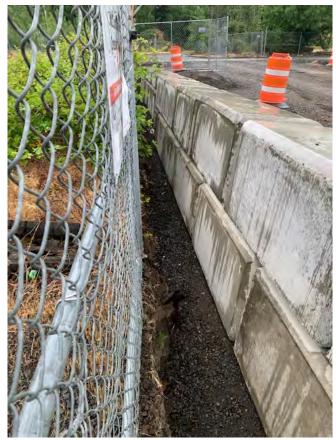
Photograph 8: Main site entry gate seen in Photo 7. Materials surrounding fence posts removed, potentially undermining fence posts. View facing east.

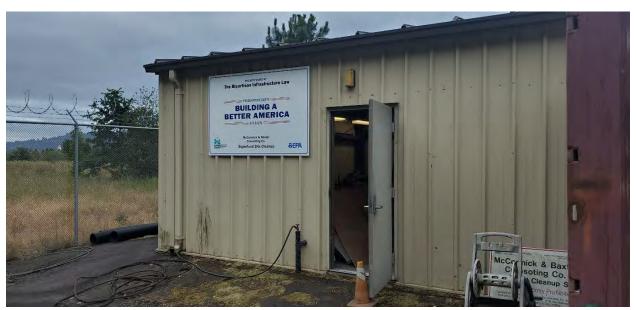
Photograph 9: Sign indicating the project is funded by EPA. View facing southwest.

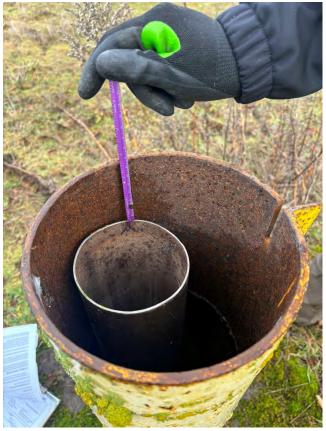
- EW-1s and MW-23d area of subsidence: The distance between the inner and outer casing of MW-23d was 2.75 inches, which is similar to recent measurements. See Photo 7.

Photograph 7: Measured distance between the inner and outer casing of MW-23d was 2.75 inches, which is similar to recent observations. View facing east.

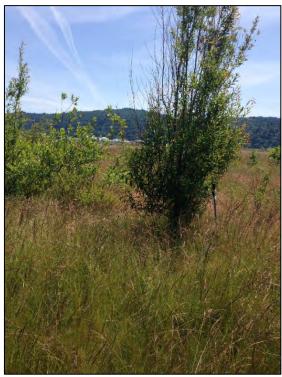
B2

B2: Tree and shrub plantings on the earthen cap. Taken looking southeast from Photograph Station 1 (September 2023).

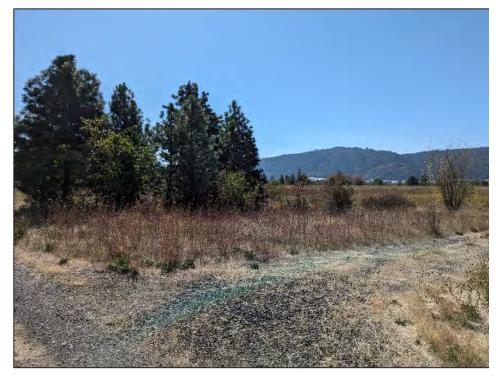
B4

B4: Tree and shrub plantings on the earthen cap are healthy and spreading. Taken from Photograph Station 2 looking southeast (September 2023).

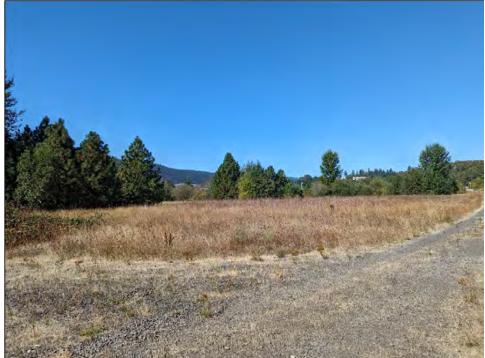
B6

B6: Eastern edge of the earthen cap with perimeter road in foreground. Taken from Photograph Station 3 looking west (September 2023).

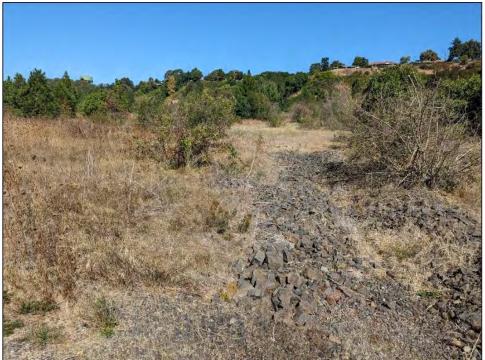
B8

B8: Stormwater pond dominated by willow and alder. Taken from Photograph Station 4 looking northeast (September 2023).

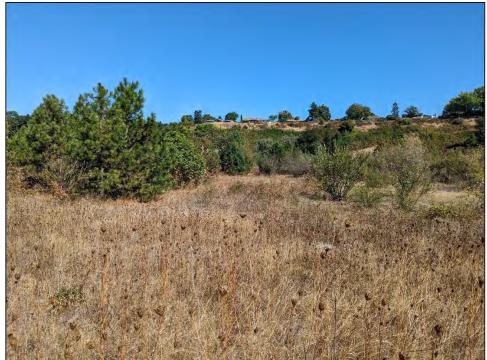
B10

B10: Willow plantings on the earthen cap. Taken from Photograph Station 5 looking northeast (September 2023).

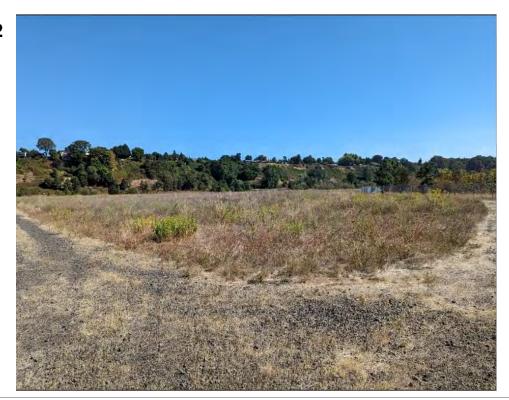
B12

B12: Impermeable cap dominated by grasses and herbaceous vegetation. Taken from Photograph Station 6 looking east (September 2023).

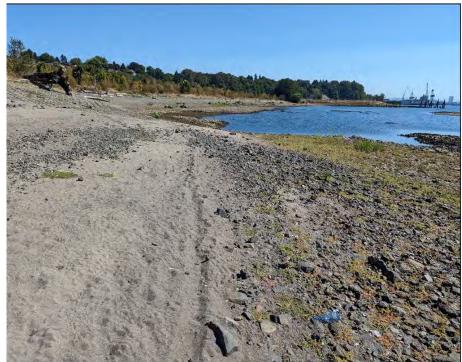
B14

B14: Vegetation growth and wood debris within the lower riparian component and along the shoreline. Taken from Photograph Station 7 looking southeast (September 2023).

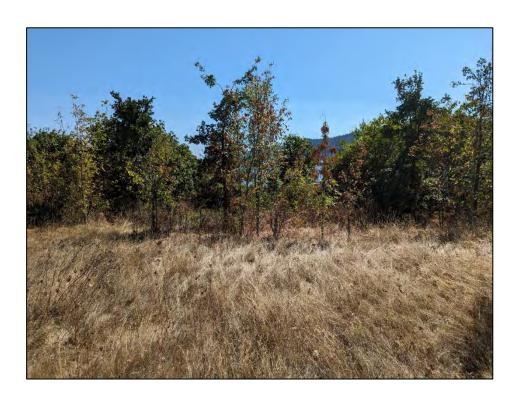
B16

B16: Upper riparian component with trees, shrubs, and herbaceous plants. Taken from Photograph Station 8 looking southwest (September 2023).

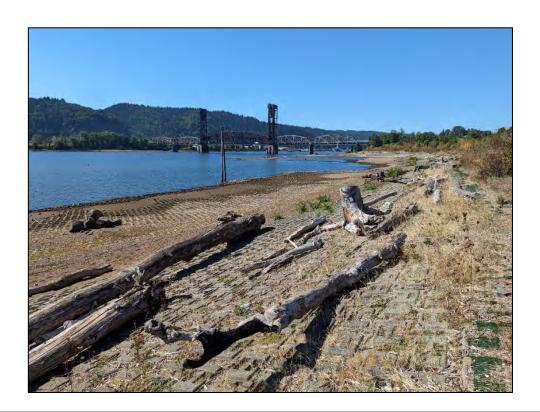
B18

B18: Lower riparian component with large wood along the edge. Taken from Photograph Station 9 looking northwest (September 2023).
