REMEDIAL EXCAVATION REPORT DEQ Site No. 03-93-0008

April 3, 2000

Project Number 990621-A4

DELCO PETROLEUM CO. LLC 17873 SE McLoughlin Blvd. Milwaukie, Oregon

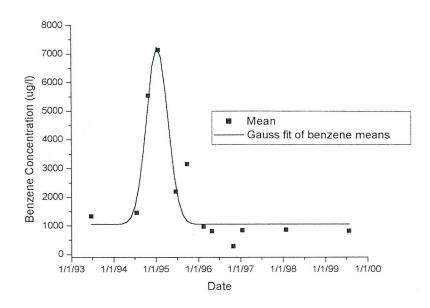
Figure 9 – BENZENE GROUNDWATER MEAN CONCENTRATIONS

On September 3, 1994, NDE Environmental Corp., Austin, TX tested the gasoline lines. The Regular and Unleaded lines passed, but the Premium gasoline line leak detector failed the test (see Appendix C). Mean benzene concentrations from groundwater samples are shown in Figure 9 – "Benzene Groundwater Mean Concentrations". A peak in the concentrations occurs in late 1994 and early 1995. The benzene concentration contours for January 24, 1995 (see Figure 10E) indicate a large increase along the gasoline pipeline and near MW-2. This indicates that the replacement gasoline pipeline may have leaked, or the elbows (or pipeline bends) may have again leaked in late 1994 through early 1995. As discussed below, an area of high concentration of gasoline contaminated soil was excavated from around MW-2 and the gasoline pipeline elbows/bends as it turned southward toward the pump islands.

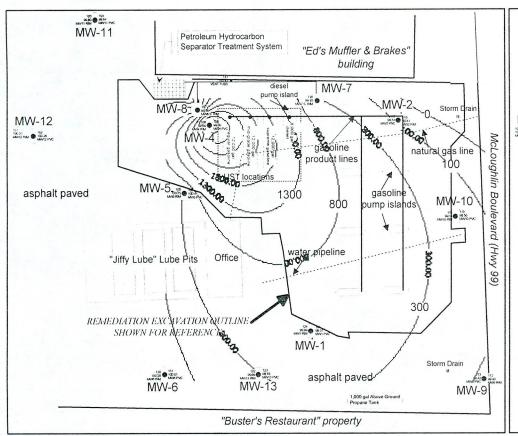
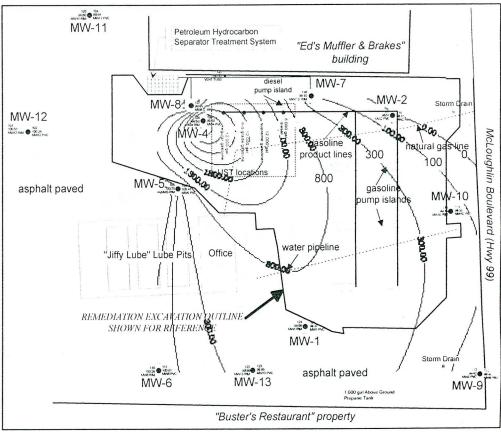
After the installation of a submersible pump in MW-8 in late January 1995, the benzene concentration contours through 1997 indicate the decreasing concentrations as the groundwater was pumped through MW-8. For example, the benzene concentration contours of February 15, 1996 (Figure 10C) indicate hydrodynamic control by pumping had been established. In early 1996, apparently the submersible pumps required maintenance and were replaced in MW-8 and MW-7 on May 2, 1996. Dissolution and partitioning of benzene from the contaminated source soil apparently continued to occur until the time of remedial excavation.

The relatively high ratio due to sample results collected from MW-1 appears to be associated with a pipeline leak at the nearest pump island. This is somewhat confirmed by a slight southeasterly bulge of high benzene concentrations (> $800\mu g/l$) contour in Figures 10C – "Benzene Concentration Contours (Groundwater)".

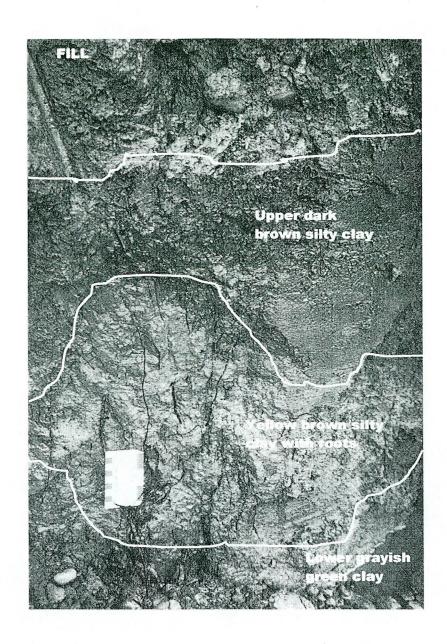
Figure 18 - CONTACT FILL AND UPPER PART OF SILTY CLAY

A typical cross-section of material encountered during remedial excavation is shown in Figure 12 – "Pre-Excavation Cross-Section A-A". The upper part of the silty clay layer is shown in Figure 18 – "Contact Fill and Upper Part of Silty Clay".

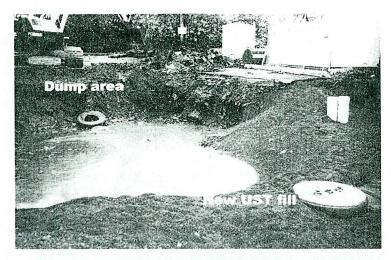
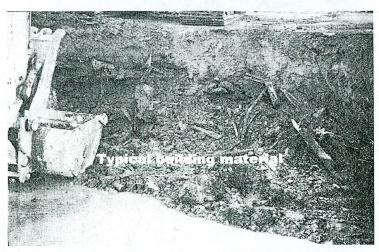
Figure 21 – AUTO PARTS AND BUILDING MATERIALS DUMP AREA

Monitor well drilling logs describe the Site as underlain by medium to dark gray clay and clayey silt to approximately 12- to 15-feet depth where dark gray silty fine sand to medium sand was encountered. Remedial excavation to maximum depths below ground surface of approximately 14- to 15-feet in places encountered essentially backfill material to a continuous silty clay bed at about 8.5- to 9-feet (Figure 18). Sandy cobbly gravel and a fine-medium sand unit underlie the approximate four (4)-foot thick clay unit (Figure 20). The backfill material is predominantly uncompacted dark gray clayey silt to silty clay with medium to fine sand. Heterogeneous fill material included stumps, tires, concrete blocks up to six (6)-feet diameter, asphalt shingles, bricks, lumber, buckets, hay bales, and other material. An auto parts and building materials dump was uncovered in the northwest area of the excavation (Figure 21). All excavated soil and dump material was disposed off-site.

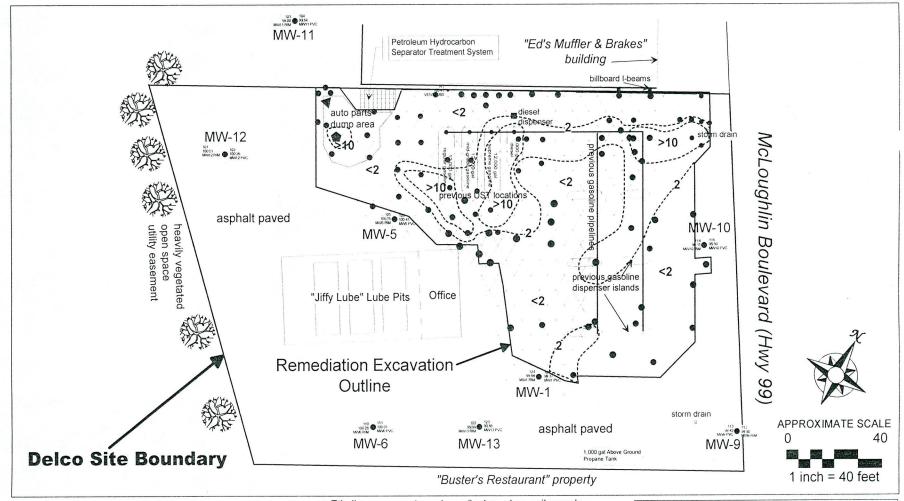
Figure 23E - ETHYLBENZENE CONTOUR MAP

Ethylbenzene contours in mg/kg based on soil sample concentrations. Areas shown as "<2" were excavated because sample analysis, PID field measurements or visual observations of strong petroleum odors, colors, and sheen indicated high concentrations of TPH.

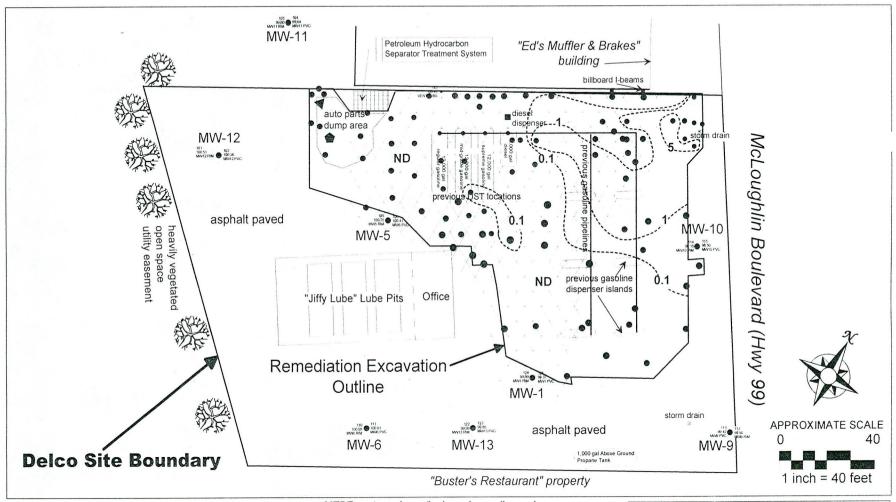
Figure 23G - MTBE CONTOUR MAP

MTBE contours in mg/kg based on soil sample concentrations. Areas shown as "ND" were excavated because sample analysis, PID field measurements or visual observations of strong petroleum odors, colors, and sheen indicated high concentrations of TPH.

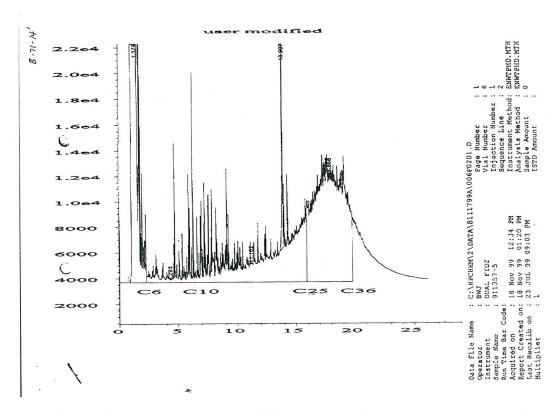
Figure 24 – CHROMATOGRAM SOIL SAMPLE B-71-4'

Each analyzed constituent result was contoured to evaluate distribution within the excavation. The contours are shown in Figures 23A through 23G. Certain analyses resulted in less definitive characterization of petroleum products. For example, Sample B-71-4', located approximately central to the excavation, apparently contained a mixture of weathered gasoline and diesel (see Figure 24 – "Chromatogram Soil Sample B-71-4"). Other samples containing apparent multiple interpretations of petroleum are listed above as "Notes to accompany Table 5". This would indicate that there was a possible mixture of diesel and gasoline beyond the highest diesel concentrations shown in Figure 23B.

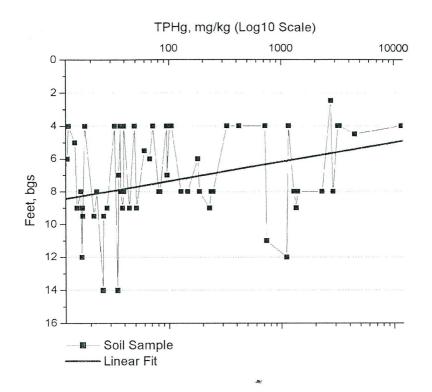
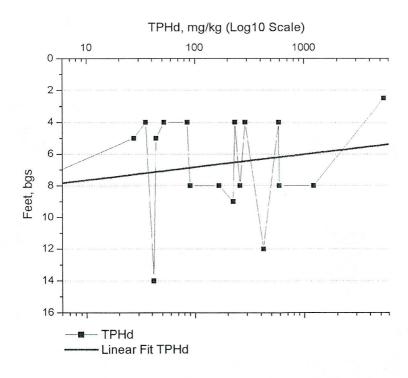
Figure 25 – TPH LINEAR REGRESSION AND SAMPLE DEPTH PLOTS

A linear regression fit of all detected gasoline and diesel in soil samples is shown in Figure 25 – "TPH Linear Regression and Sample Depth Plots". The plots indicate a decrease in concentration with depth. The slope of the line fit coincides with the approximate depth of the underlying grayish-green silty clay unit, considered to be a natural aquitard, although distinct monitoring above and below this unit has not been established. In general, the sample results reflect the annual vertical movement of the water table. The lowest concentrations of gasoline and diesel occur at the greatest depth of sampling (about fourteen (14)-feet).

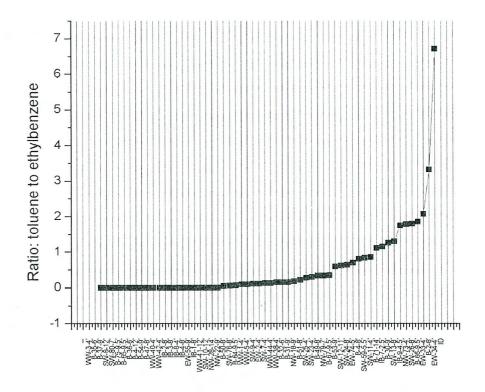
Figure 27 – TOLUENE TO ETHYLBENZENE CONCENTRATION RATIO (SOIL)

A high ratio, approximately 10:1, of toluene to ethylbenzene appears to indicate fresh gasoline. As shown in the lower Figure 27 – "Toluene to Ethylbenzene Concentration Ratio (Soil)", samples EW-33-4' and EW-34-4' have high ratios of toluene to ethylbenzene.
