**RE: THIRD QUARTERLY 2024 TEMPORARY PROTECTIVE CAP INSPECTION
NAVIGATION CENTER CAP INSPECTIONS
1111 NORTHWEST NAITO PARKWAY
PORTLAND, OREGON
FARALLON PN: 2395-017**

THIRD QUARTERLY 2024 TEMPORARY PROTECTIVE CAP INSPECTION
Navigation Center Cap Inspections
1111 Northwest Naito Parkway
Portland, Oregon

Farallon PN: 2395-017

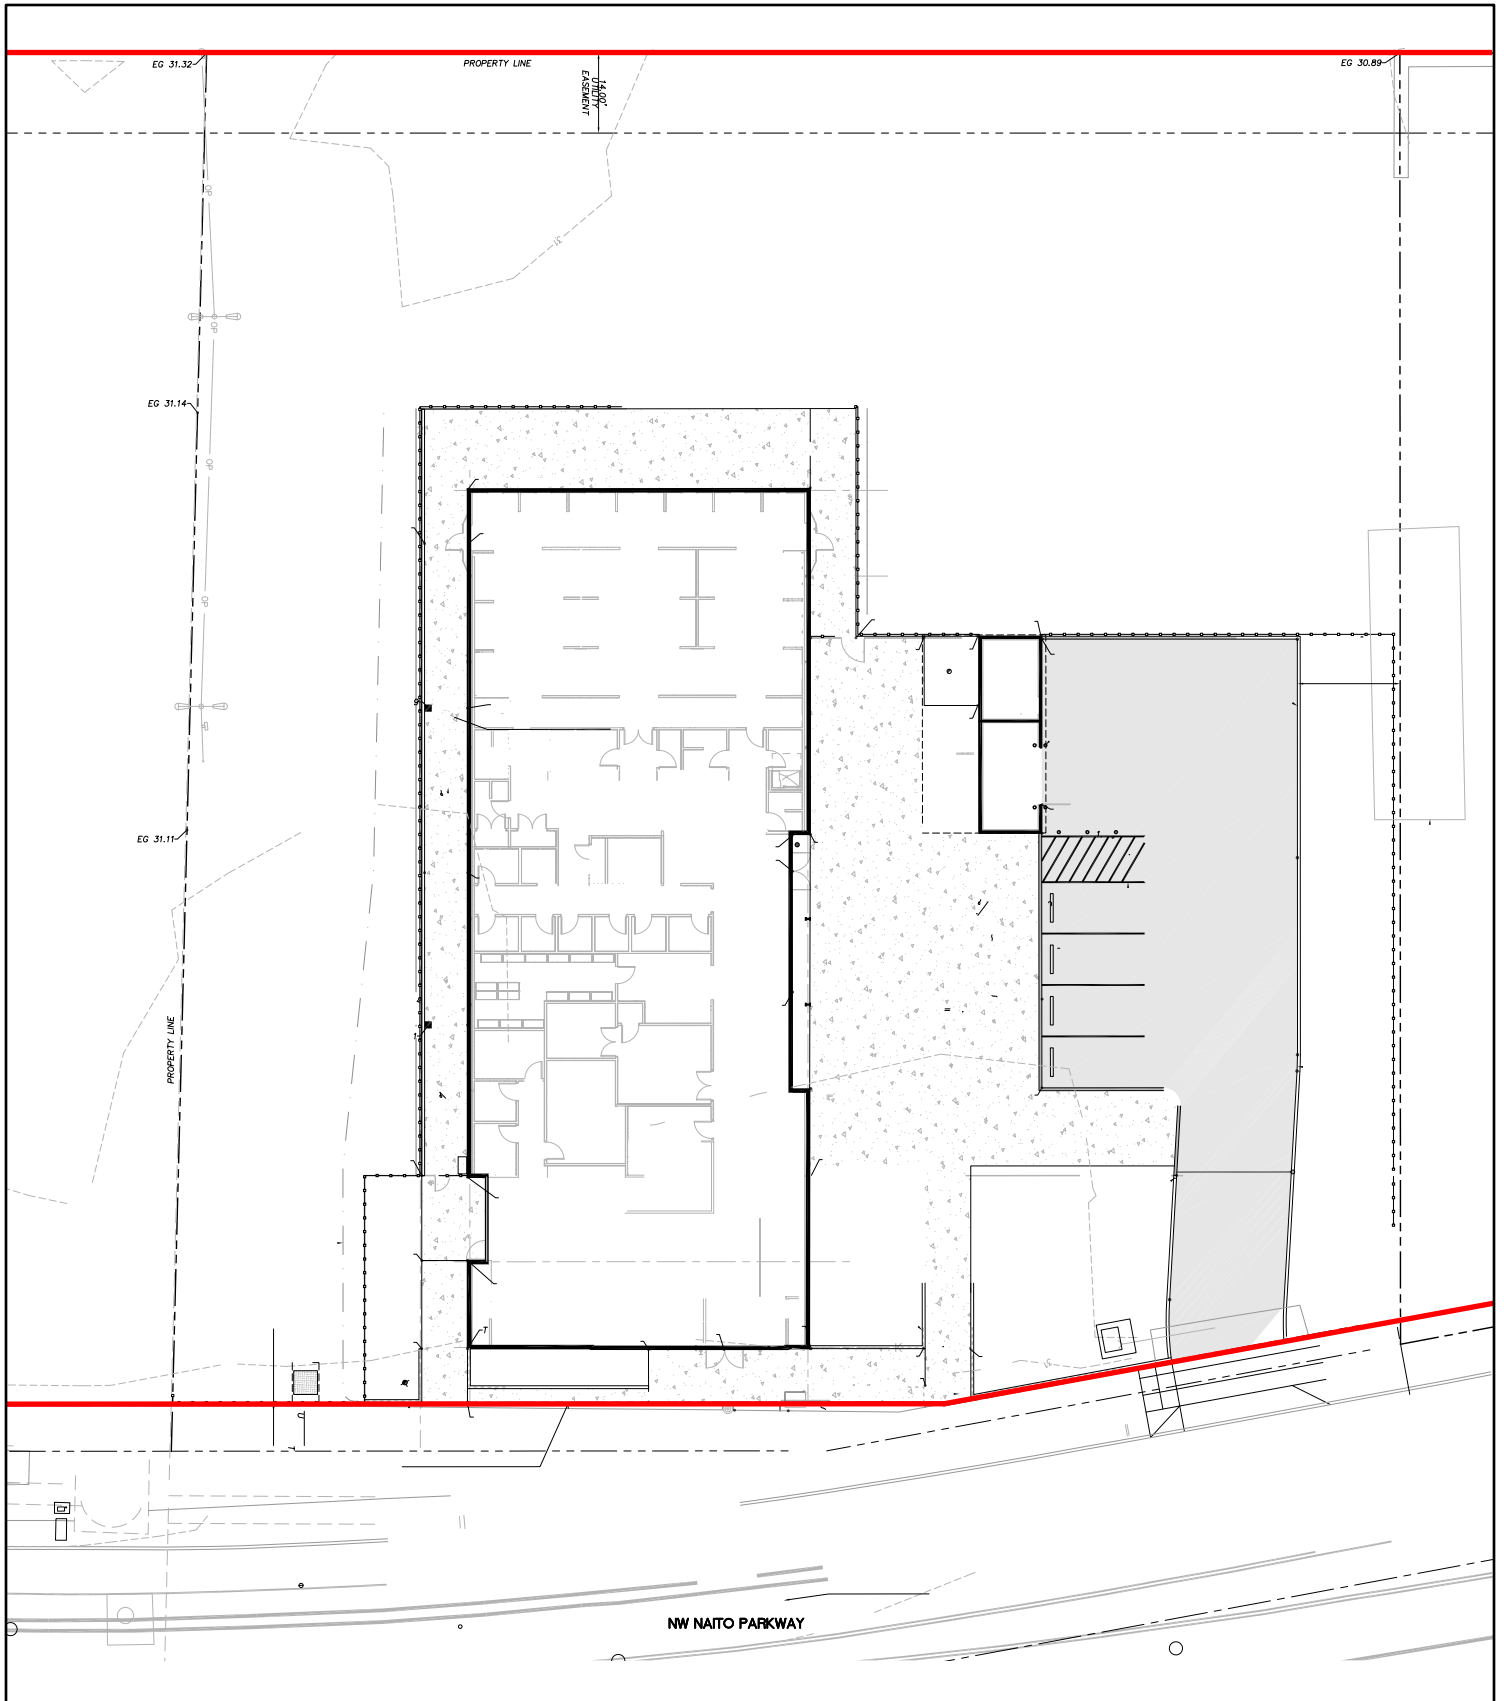
FIGURE 3

the Property. To date, the final remedy has only been implemented on Lot 1 during development of the Oregon State University Food Innovation Center. DEQ found that the capping elements installed on the Property (Figure 3) as part of the construction of the Navigation Center would be acceptable as a temporary measure.
