RE: Annual Inspection for Parcel AP  
North Ridge Estates Superfund Site  
ECSI No. 5998

Operations and Maintenance Inspection Form

2023 Annual Inspection Summary Report  
North Ridge Estates - Operable Unit 1  
Klamath Falls, Oregon

Figure  
AP.3

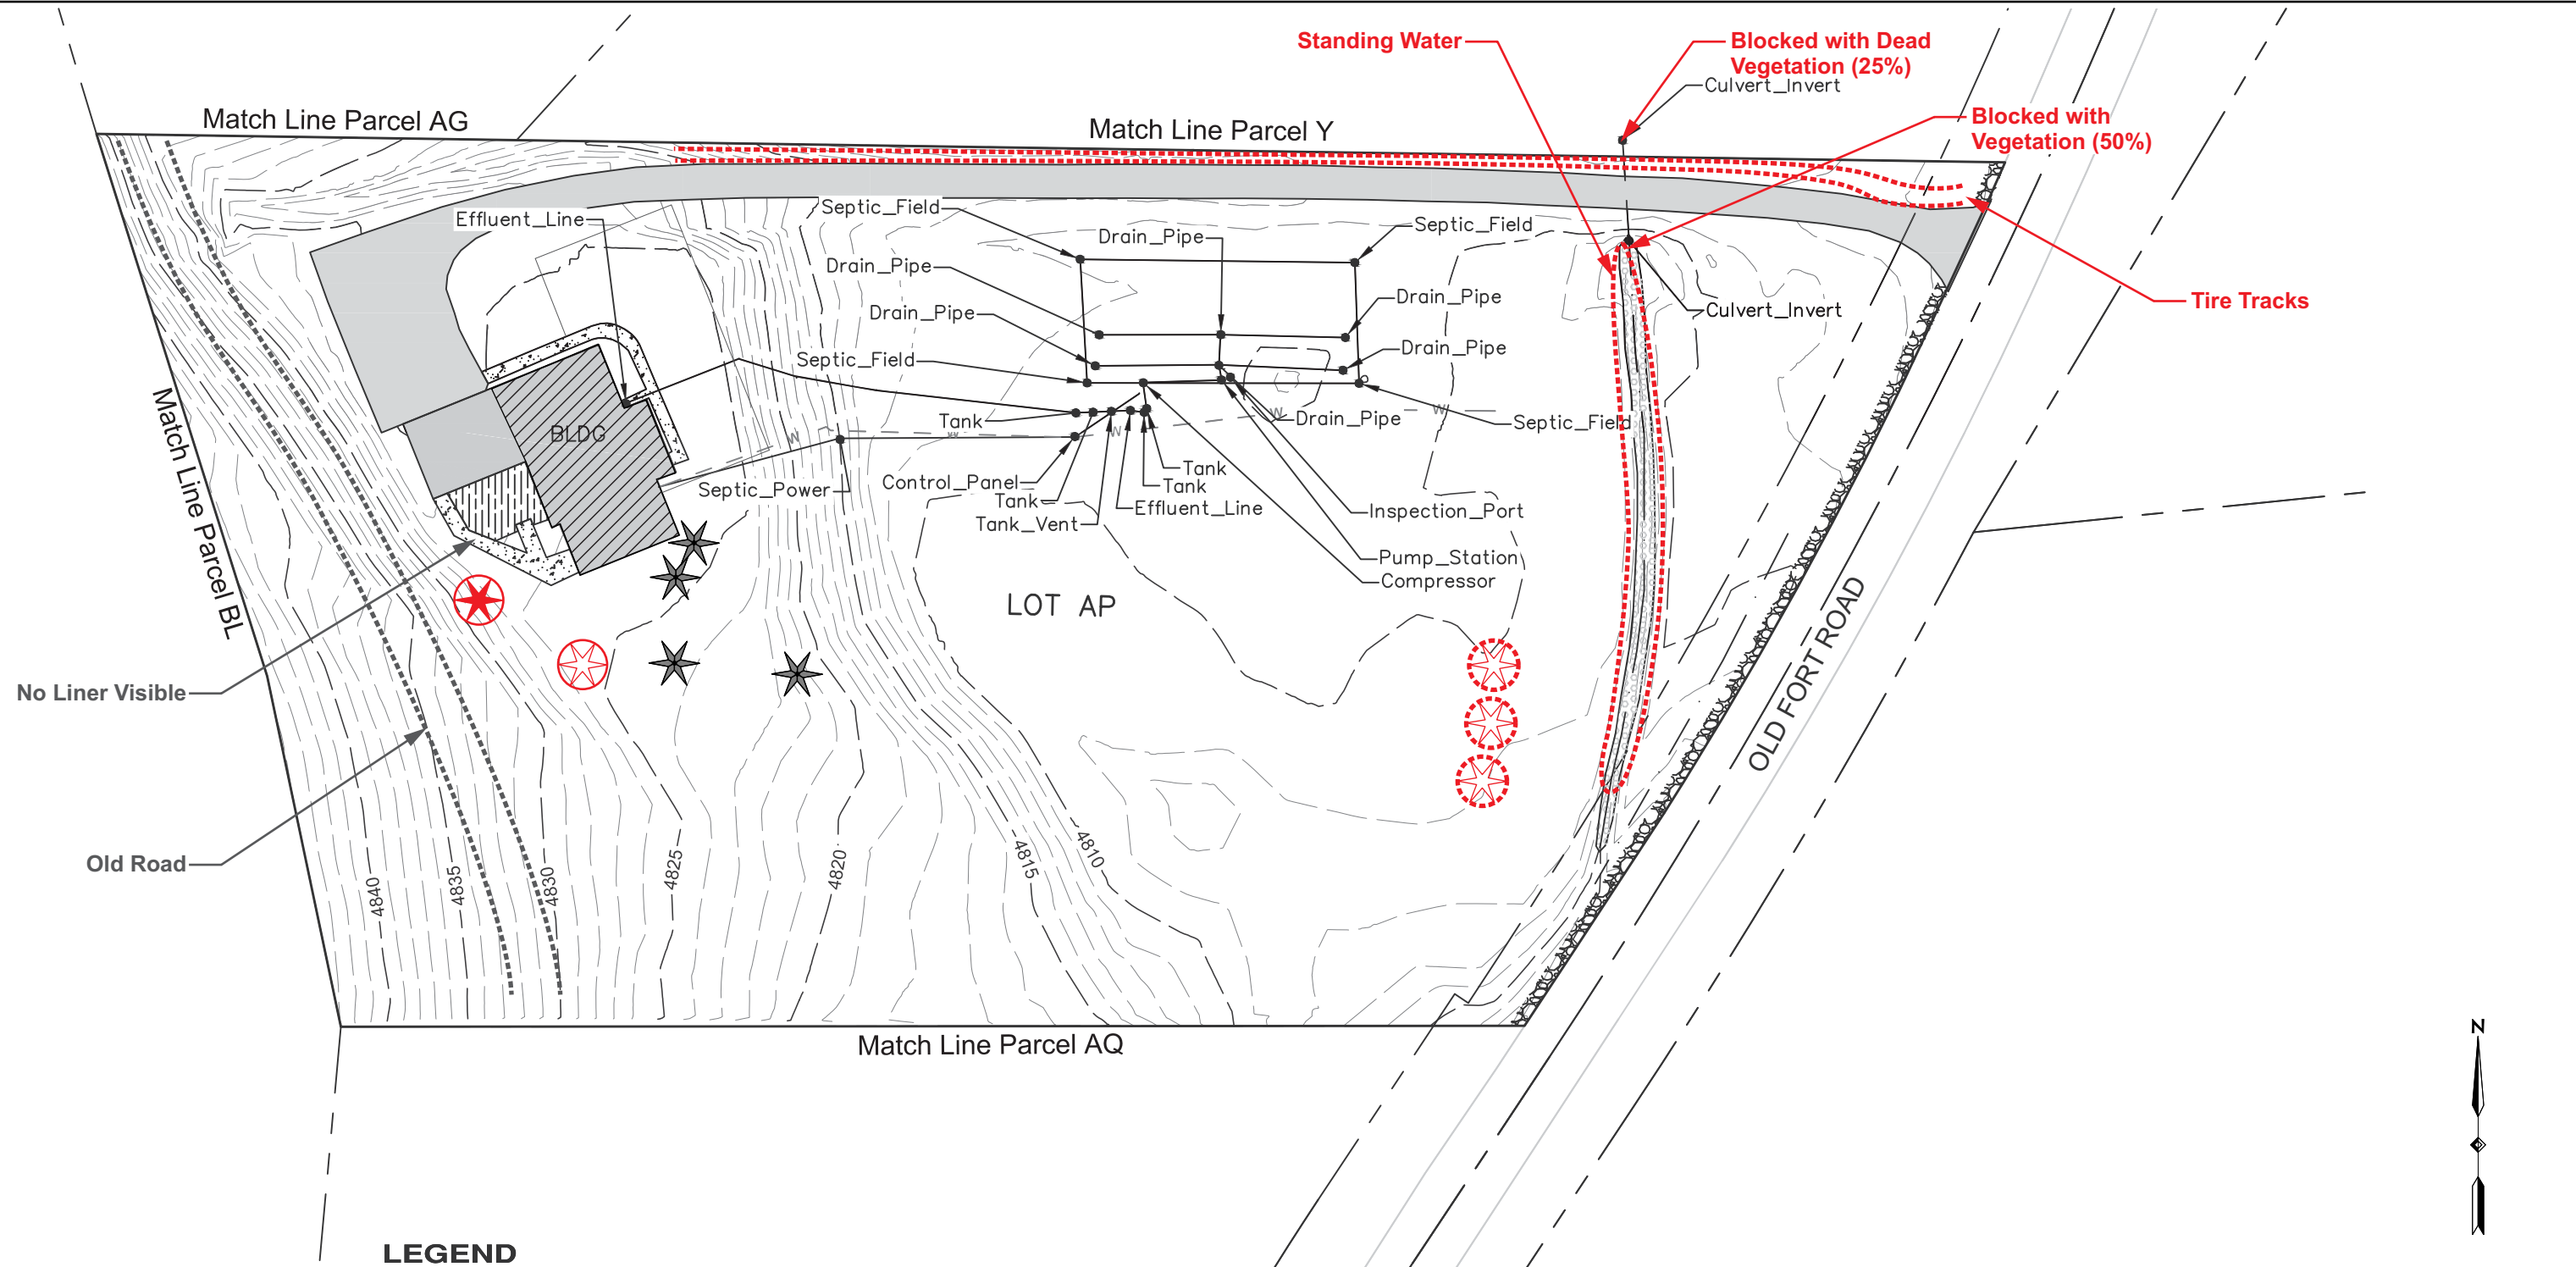
1. **Blocked culvert.** The end of the culvert located below your driveway remains partially obstructed (see enclosed figure).

Ditches and Culverts	Obstructions observed in ditches or culverts that may impede conveyance of stormwater?	<input checked="" type="checkbox"/>	<input type="checkbox"/>	<input type="checkbox"/>	<input type="checkbox"/>	Culverts near the northeast area of parcel were observed to be obstructed; standing water observed near culverts.	Remove vegetation obstructing culverts to enable stormwater flow.
	Damaged observed to riprap surface? Note if riprap is not intact or not effectively providing armor protection.	<input type="checkbox"/>	<input type="checkbox"/>	<input checked="" type="checkbox"/>	<input type="checkbox"/>		
	Are there any areas that show signs of excessive scour? (i.e., gullies forming along centerline of ditch)	<input type="checkbox"/>	<input type="checkbox"/>	<input checked="" type="checkbox"/>	<input type="checkbox"/>		
	Are culvert inlets and outlets damaged?	<input type="checkbox"/>	<input type="checkbox"/>	<input checked="" type="checkbox"/>	<input type="checkbox"/>

**Corrective Action.** Remove the material obstructing the culvert to allow the unrestricted flow of stormwater by November 12, 2023.
