RE: Annual Inspection for Parcel H (part of)
North Ridge Estates Superfund Site
ECSI No. 5998

Parcel H

Operations and Maintenance Inspection Form

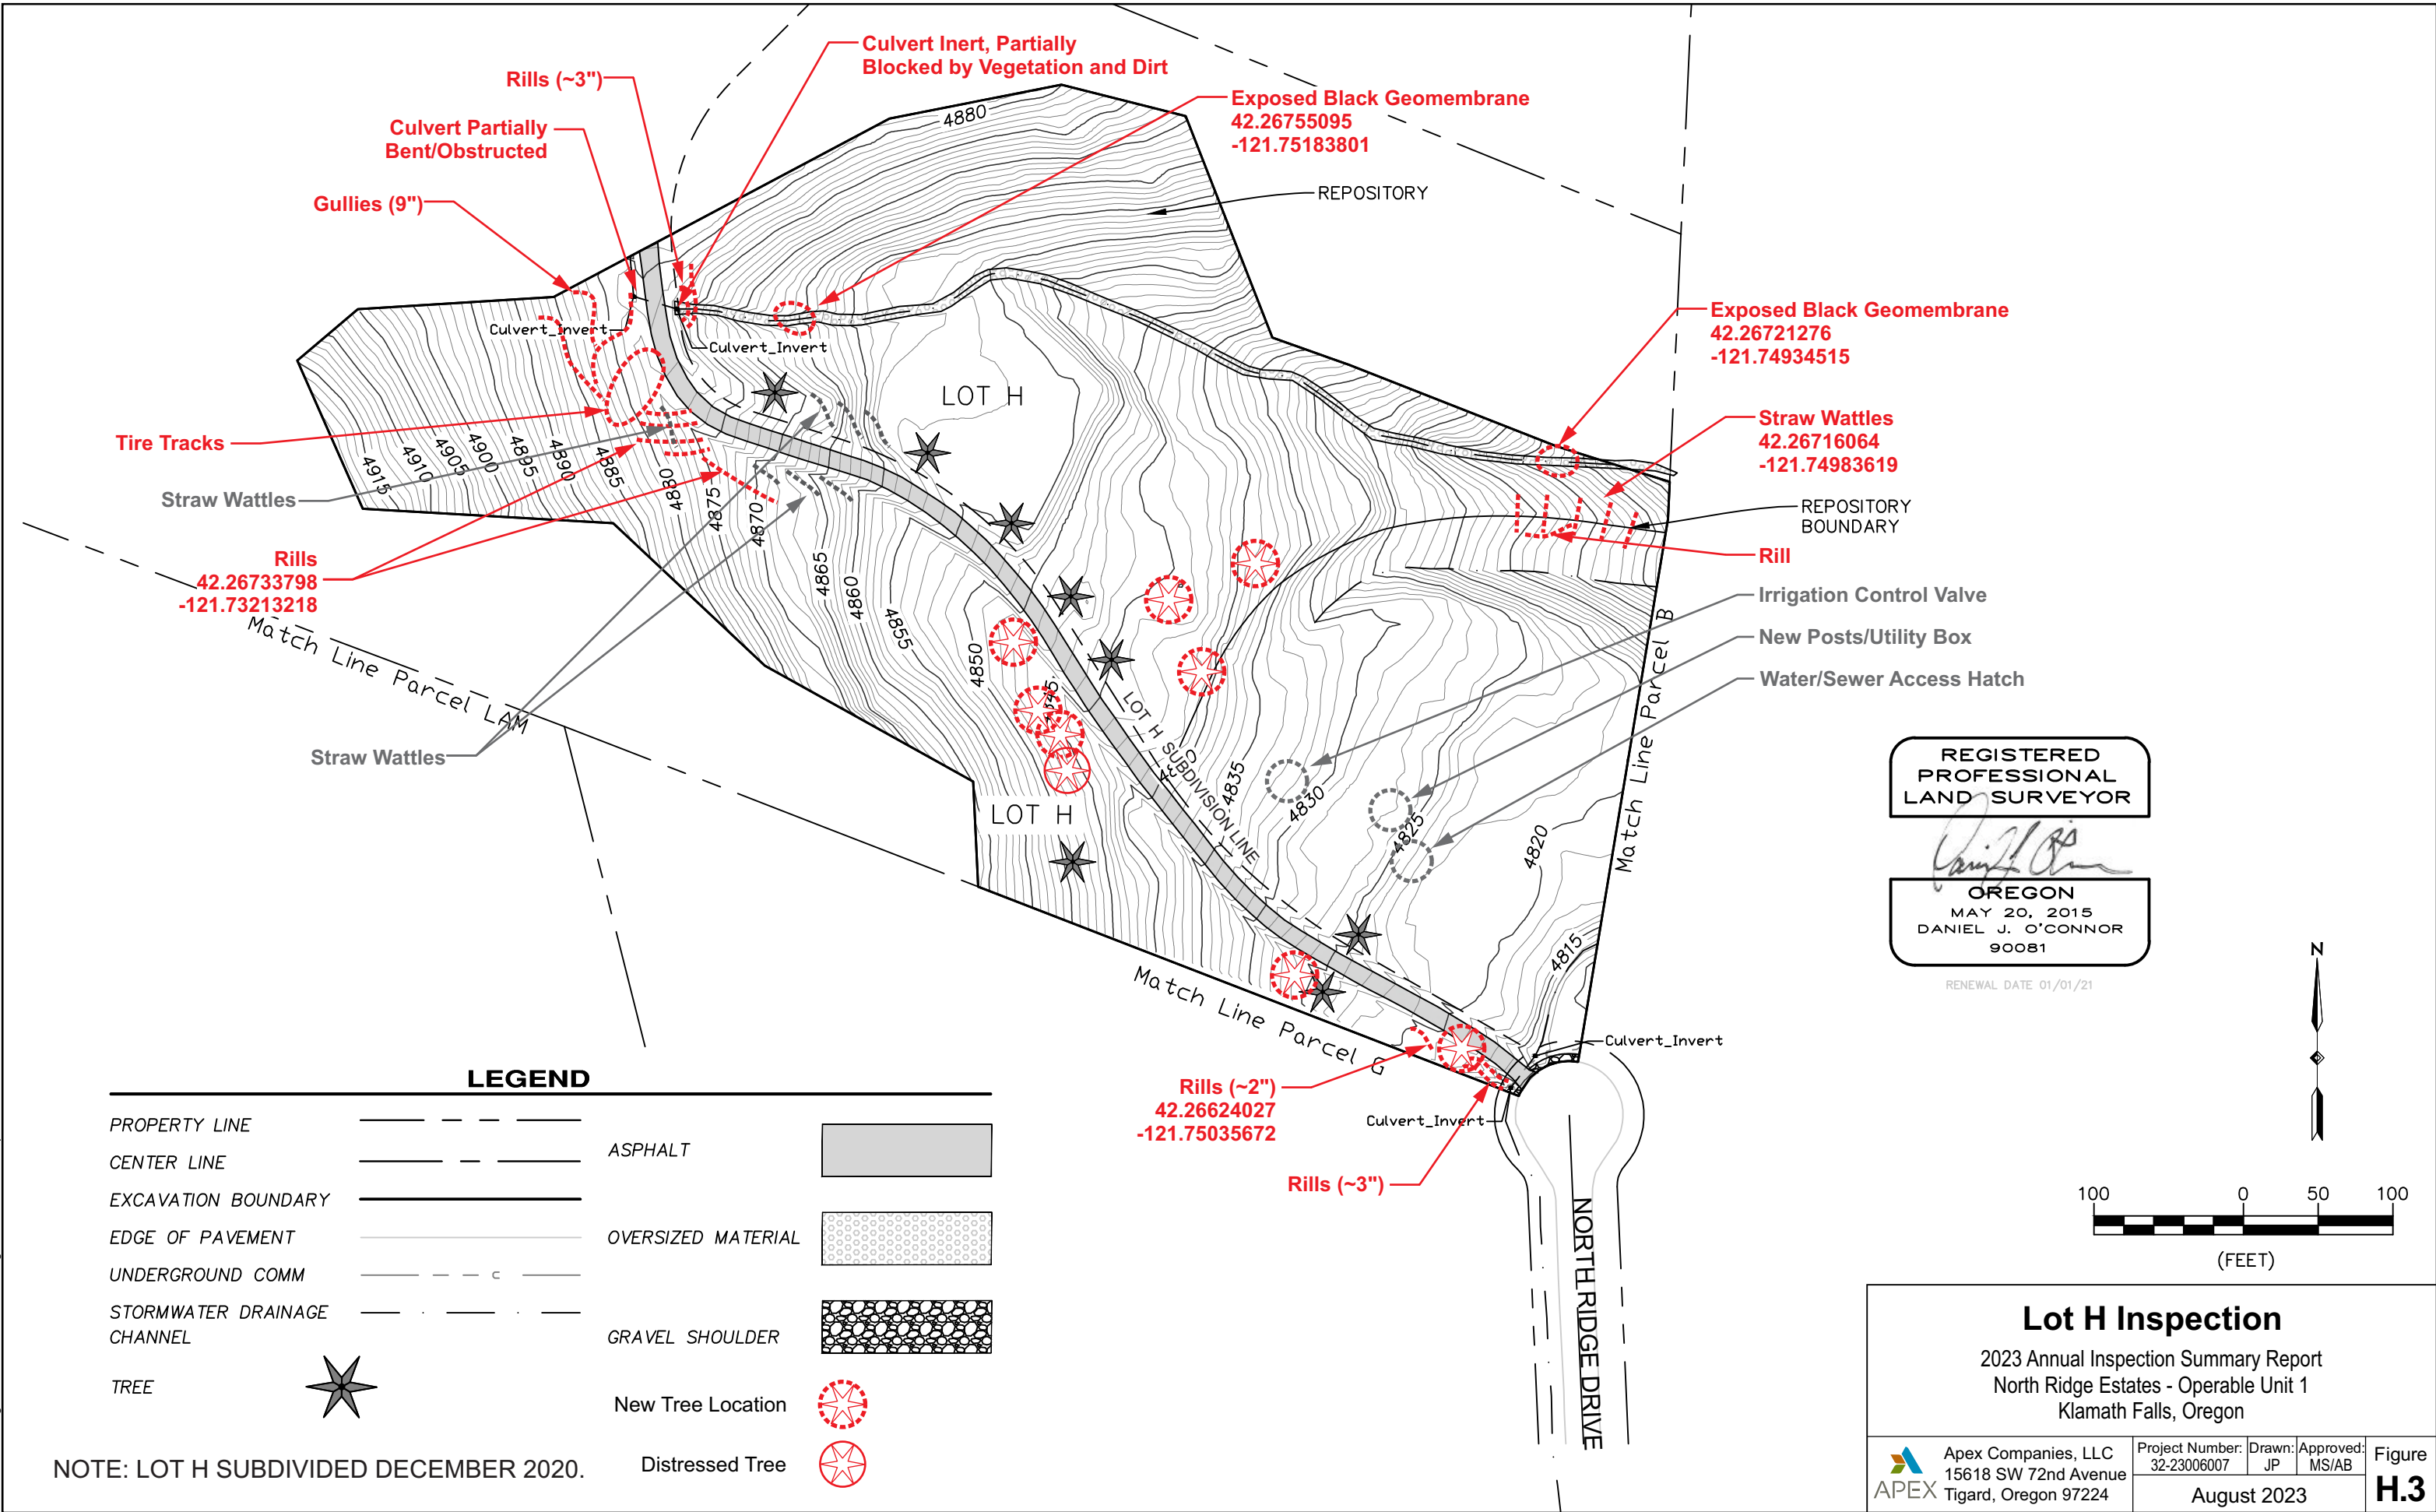
Parcel H

1. **Blocked culvert.** The culvert located beneath the private drive is partially obstructed (see enclosed figure).

Ditches and Culverts	Obstructions observed in ditches or culverts that may impede conveyance of stormwater?	<input checked="" type="checkbox"/>	<input type="checkbox"/>	<input type="checkbox"/>	<input type="checkbox"/>	Partially obstructed culverts and exposed membrane in the northeast and northwest culvert.	Remove obstruction from culvert to enable stormwater flow.
	Damaged observed to riprap surface? Note if riprap is not intact or not effectively providing armor protection.	<input type="checkbox"/>	<input type="checkbox"/>	<input checked="" type="checkbox"/>	<input type="checkbox"/>		
	Are there any areas that show signs of excessive scour? (i.e., gullies forming along centerline of ditch)	<input type="checkbox"/>	<input type="checkbox"/>	<input checked="" type="checkbox"/>	<input type="checkbox"/>		
	Are culvert inlets and outlets damaged?	<input type="checkbox"/>	<input type="checkbox"/>	<input checked="" type="checkbox"/>	<input type="checkbox"/>

Corrective Action. Remove the material obstructing the culvert to allow the unrestricted flow of stormwater by November 12, 2023.
