RE: Annual Inspection for Parcel AM
North Ridge Estates Superfund Site
ECSI No. 5987

Operations and Maintenance Inspection Form

2023 Annual Inspection Summary Report
North Ridge Estates - Operable Unit 1
Klamath Falls, Oregon

Figure
AM.3

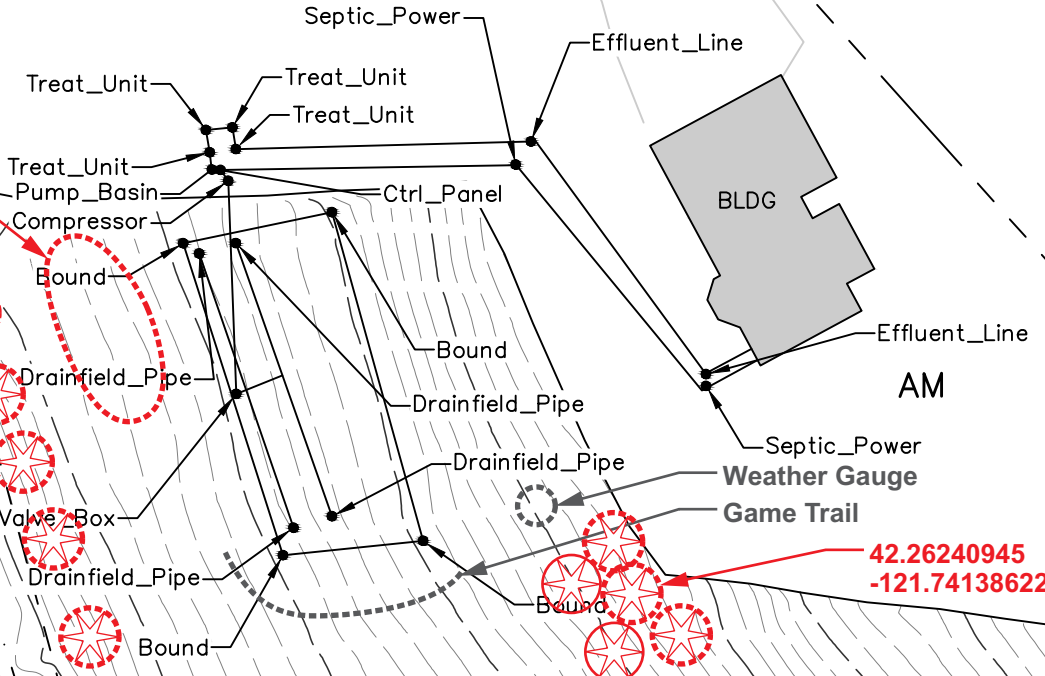
Lot AM Inspection

Have gullies developed deeper than 6 inches?	<input checked="" type="checkbox"/>	<input type="checkbox"/>	<input type="checkbox"/>	<input type="checkbox"/>	A gully was observed on Parcel AM along the middle of the western property line draining to the ditch along Old Fort Road. (Same as 2022)	Backfill gully to prevent further erosion.
	Have animals created burrows in the protective cap?	<input type="checkbox"/>	<input type="checkbox"/>	<input checked="" type="checkbox"/>	<input type="checkbox"/>		
	Have vehicles damaged the protective cap?	<input type="checkbox"/>	<input type="checkbox"/>	<input checked="" type="checkbox"/>	<input type="checkbox"/>		
	Any evidence of ACM on Site including areas where the protective cap is less than 2 feet (see as-built drawings) or within the dripline of the legacy trees?	<input type="checkbox"/>	<input type="checkbox"/>	<input checked="" type="checkbox"/>	<input type="checkbox"/>

Are there areas that show evidence of unstable slopes, subsidence, or slope failure? Are there signs of active bank erosion and/or lateral cutting?	<input type="checkbox"/>	<input type="checkbox"/>	<input checked="" type="checkbox"/>	<input type="checkbox"/>		
	Any visible ACM along the perimeter of the Site (where applicable)?	<input type="checkbox"/>	<input type="checkbox"/>	<input checked="" type="checkbox"/>	<input type="checkbox"/>		
Vegetation	Evidence of distressed or sparse vegetation? (sparse vegetation no greater than 10 percent of area and bare areas no greater than 100 square feet)	<input checked="" type="checkbox"/>	<input type="checkbox"/>	<input type="checkbox"/>	<input type="checkbox"/>	Sparse vegetation was noted on Parcel AM in the northern and eastern portions of the parcel.	Reseed areas and supply irrigation to support vegetation growth.
	Evidence of trees and shrubs in distress?	<input type="checkbox"/>	<input checked="" type="checkbox"/>	<input type="checkbox"/>	<input type="checkbox"/>	A total of 10 new trees were observed to be in healthy condition; two newly planted trees show signs of distress.

Sparse Vegetation

Corrective Action. Backfill, smooth out and vegetate the areas identified by November 12, 2023.
