RE: Annual Inspection for Parcel AR
North Ridge Estates Superfund Site
ECSI No.6013

Parcel AR and BK

Operations and Maintenance Inspection Form

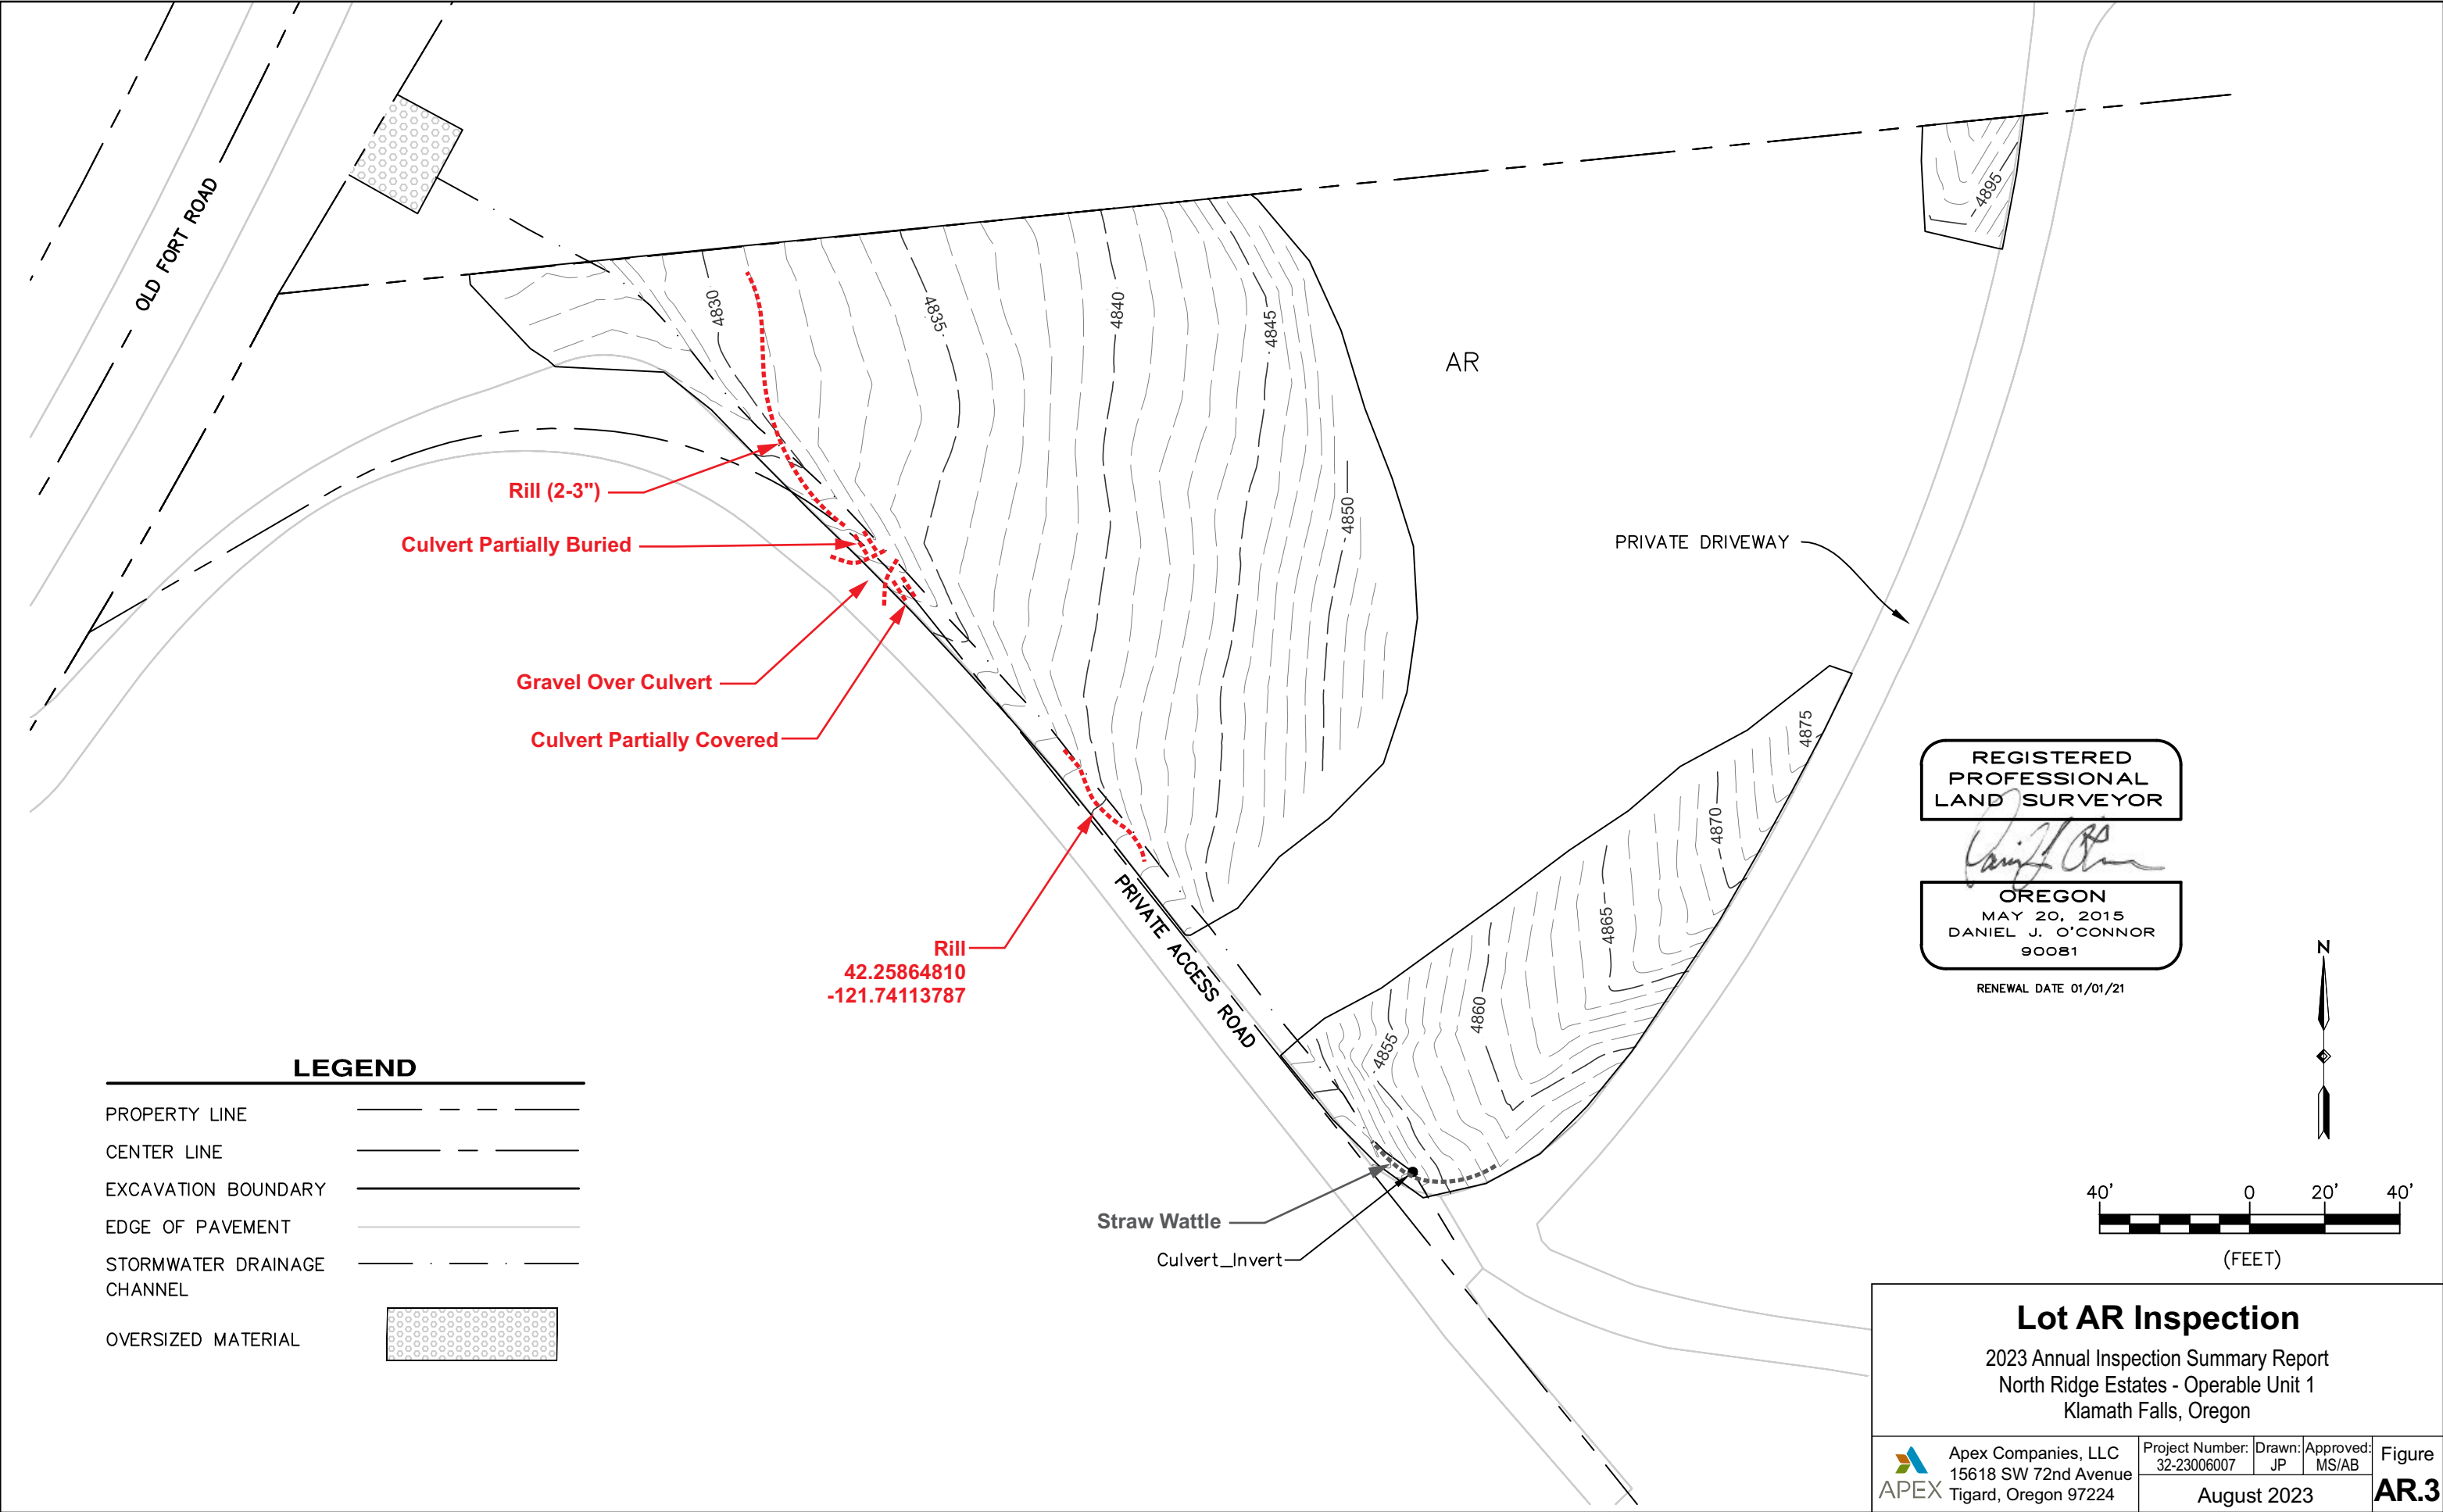
1. **Blocked culvert.** The culvert located along the private drive on your property was obstructed (see enclosed figure).

Ditches and Culverts	Obstructions observed in ditches or culverts that may impede conveyance of stormwater?	<input checked="" type="checkbox"/>	<input type="checkbox"/>	<input type="checkbox"/>	<input type="checkbox"/>	Partially blocked and fully buried culverts were identified on the west side of Parcel AR.	Remove obstructions from culverts to enable stormwater flow.
	Damaged observed to riprap surface? Note if riprap is not intact or not effectively providing armor protection.	<input type="checkbox"/>	<input type="checkbox"/>	<input type="checkbox"/>	<input checked="" type="checkbox"/>		
	Are there any areas that show signs of excessive scour? (i.e., gullies forming along centerline of ditch)	<input type="checkbox"/>	<input type="checkbox"/>	<input type="checkbox"/>	<input checked="" type="checkbox"/>		
	Are culvert inlets and outlets damaged?	<input type="checkbox"/>	<input type="checkbox"/>	<input type="checkbox"/>	<input checked="" type="checkbox"/>

Corrective Action. Remove the material obstructing the culvert to allow the unrestricted flow of stormwater by November 12, 2023.
