RE: Annual Inspection for Parcel BP  
North Ridge Estates Superfund Site  
ECSI No. 6022

Operations and Maintenance Inspection Form

**Lot BP Inspection**

2023 Annual Inspection Summary Report  
North Ridge Estates - Operable Unit 1  
Klamath Falls, Oregon

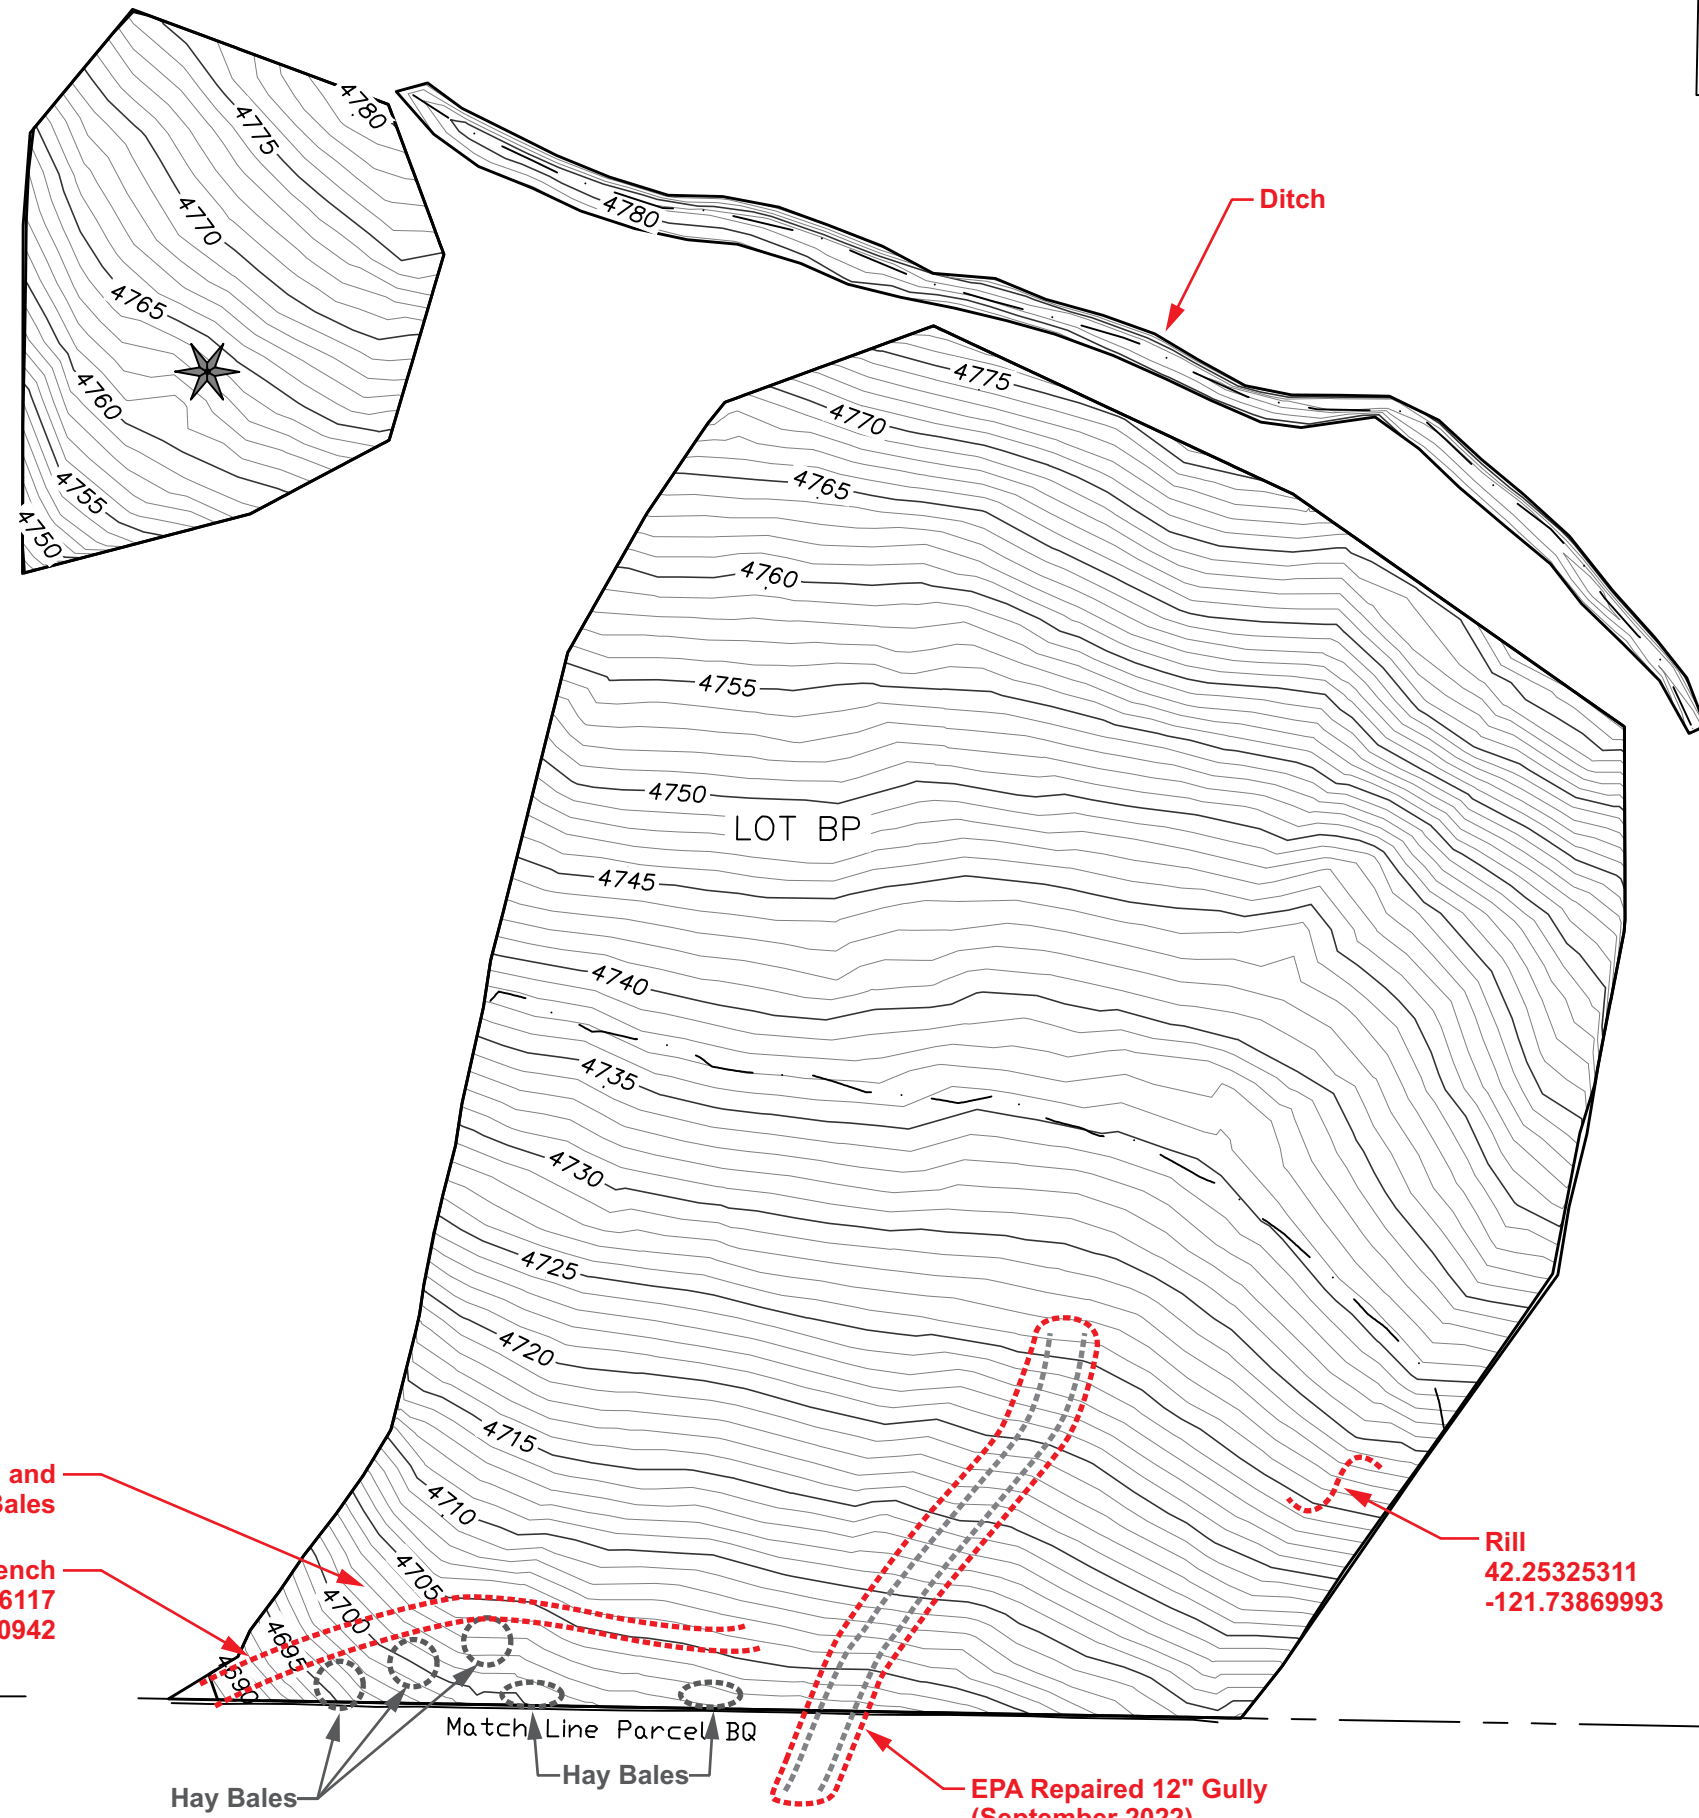
| | | <input type="checkbox"/> | <input type="checkbox"/> | <input type="checkbox"/> | <input type="checkbox"/> | U.S. EPA entended SW cutoff trench and repaired some rills and gullies in 2022. | |

**EPA Repaired 12" Gully**  
(September 2022)
