Background: The Tanner Springs Park is a municipal park located in NW Portland. Area soils beneath the cap may contain elevated concentrations of petroleum hydrocarbons, lead, and / or polynuclear aromatic hydrocarbons. For the Tanner Springs Park, the cap consists of landscaped soil, concrete sidewalks, wood walkways, water features, and other hardscaping. This inspection report was completed to assess the condition of the capped area which includes the entire park.

Site: Tanner Springs Park

Inspection Date: 11/18/2019

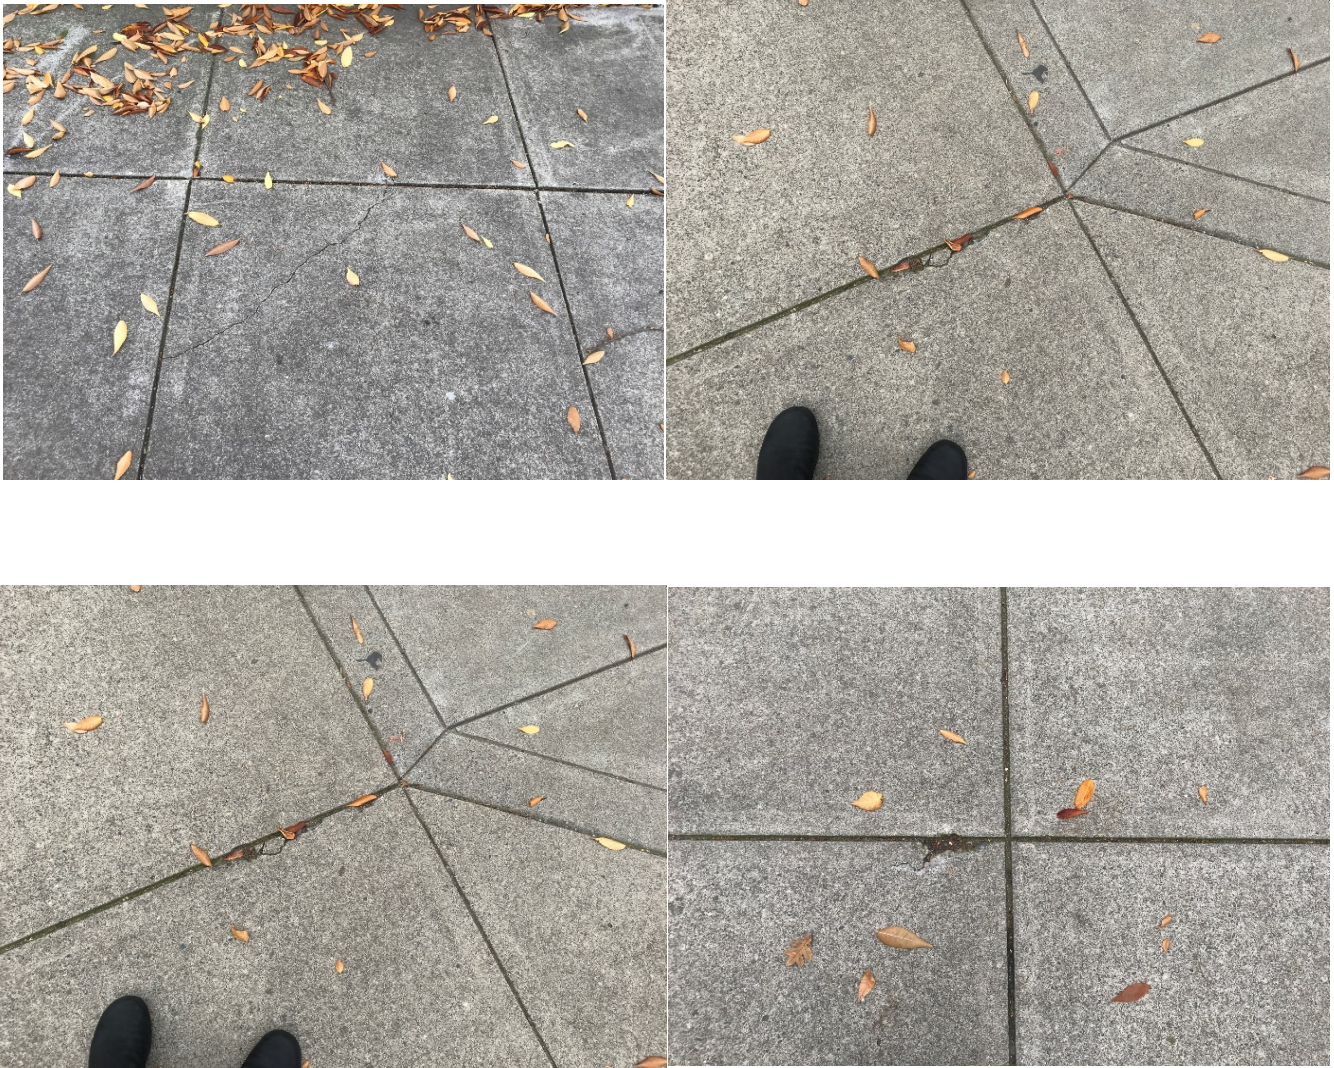
Location: Very minor cracks (less than 0.5 inches) at few locations within concrete sidewalks (see attached photos).

Photos 1-4 : Minor cracking in concrete panels
