Site: Tanner Springs ParkInspection Date: 12/7/2022

**Tanner Springs Park
Annual Cap Inspection
Photo Locations Map**

Attachment 1

Photo Log

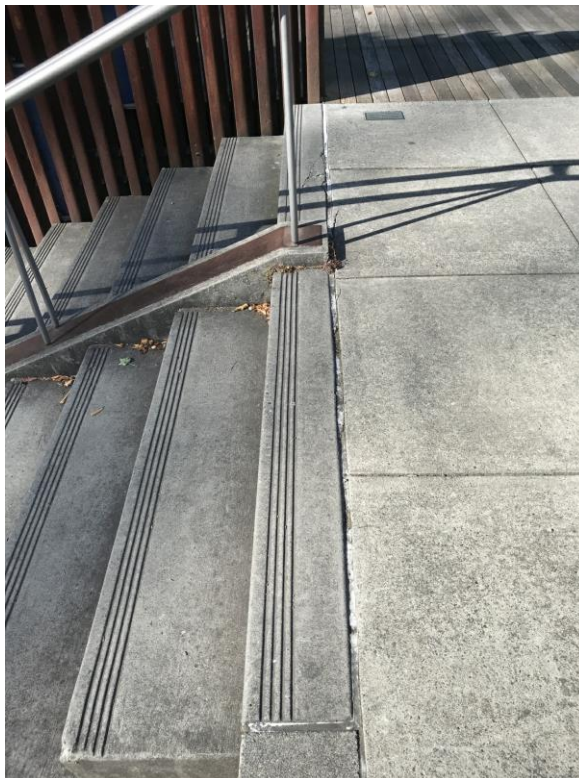
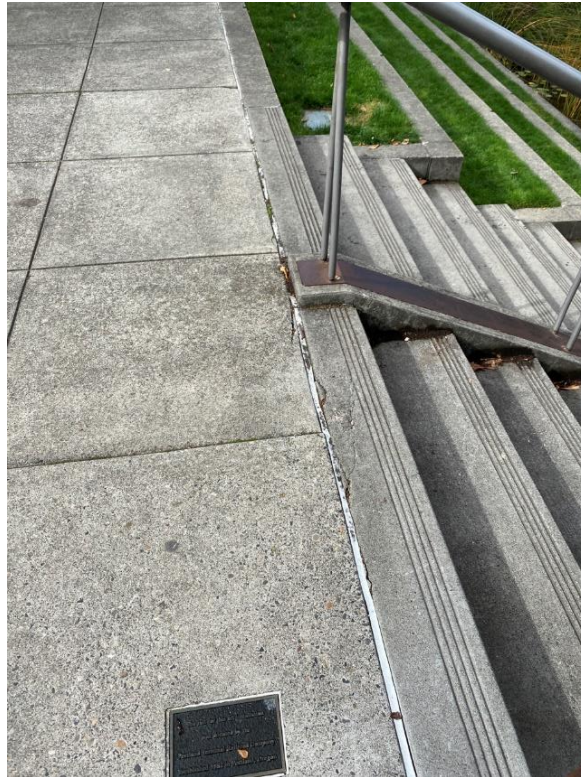
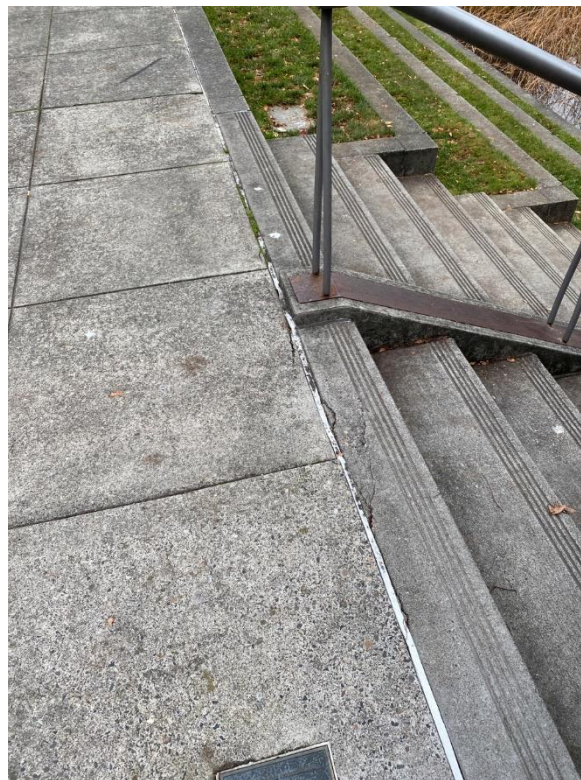
Photo Point #5

Several minor cracks in concrete were documented in the attached photo log and accompanying map. Many of those cracks were documented in last year's inspection report and have not changed in appearance since last year (photo points 1-4 and 10-12). Several areas of minor separation (0.5 to 1.5 inches) were noted within the cobblestone path (photo points 6-9 13-16). Weathering is likely to have impacted seams in the cobblestone paths that appeared mostly in fair condition, but caulking was missing in a few places. None of these observations appear to have compromised the cap or have allowed subsurface soil to be exposed and no patching is recommended.
