Site: The Fields Neighborhood Park

Inspection Date: 10/3/2023

**Fields Park  
Annual Cap Inspection  
Photo Locations Map**

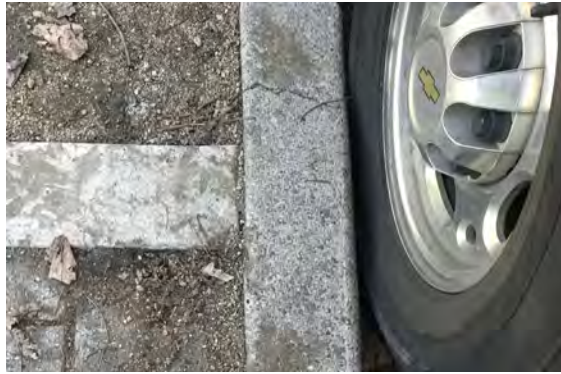
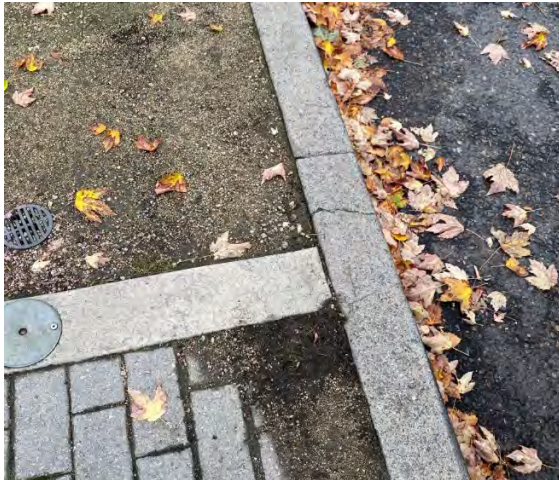
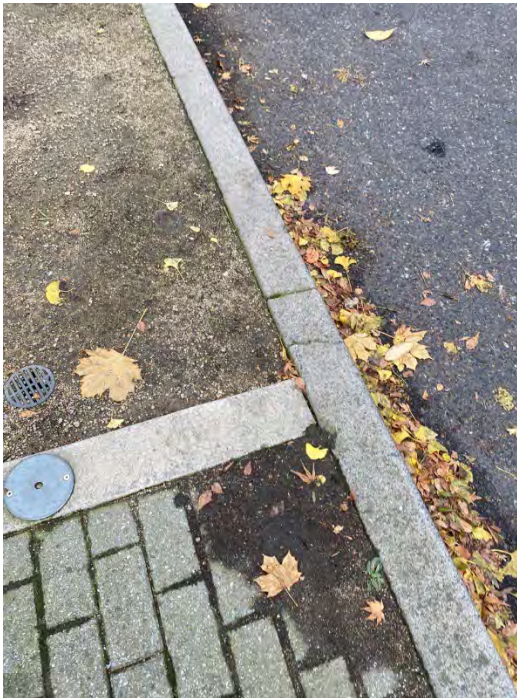
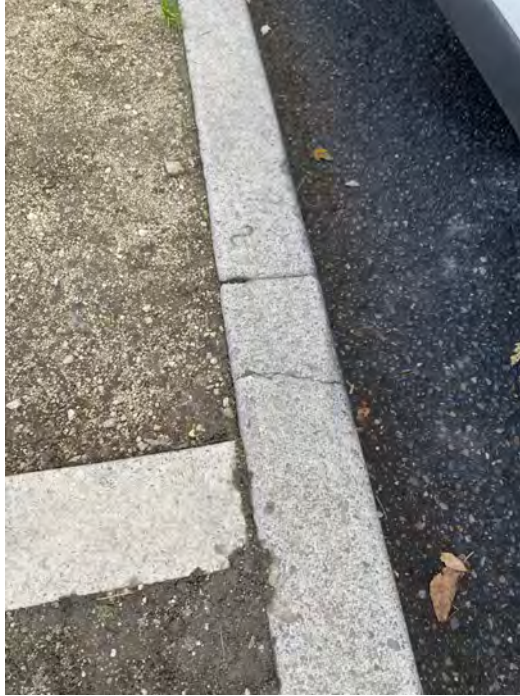
### Photo Point #1

Only minor cracking and evidence of settling was observed in the concrete sidewalks and structural foundations on the perimeter of the park (photo points 1-3, 6-13, and 18). These minor cracks (generally <0.5 inches) have been observed in previous inspections and do not appear to penetrate the cap. Separation at the cracks was not observed. One (1) brick pathway is separating slightly but the separation has not changed in the past few years (photo point #4) and does not appear to penetrate the cap. Monitoring wells 2, 3, and 4 were also inspected for cracking, separation, and signs of damage. All monitoring well monuments were in good condition. See attached Photo Log for copies of previous and current year inspection photos. BES will continue to monitor these locations in the following years.

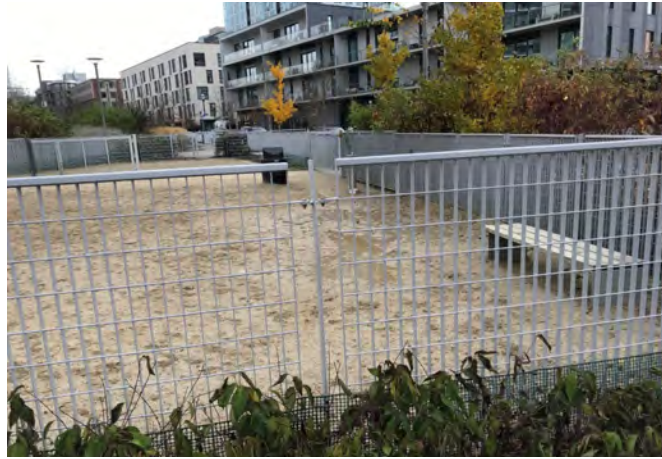
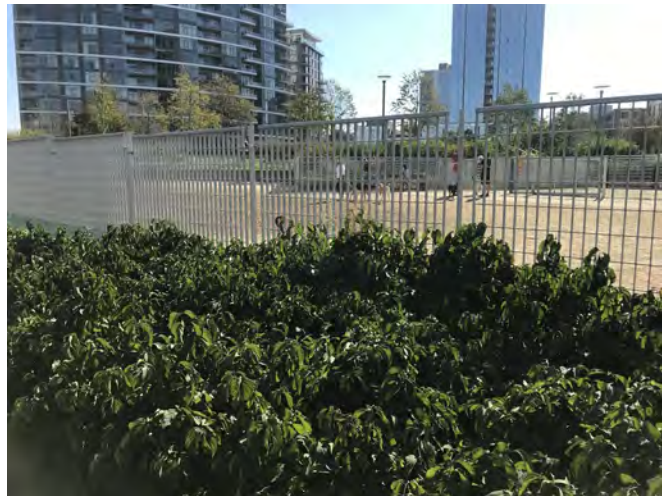
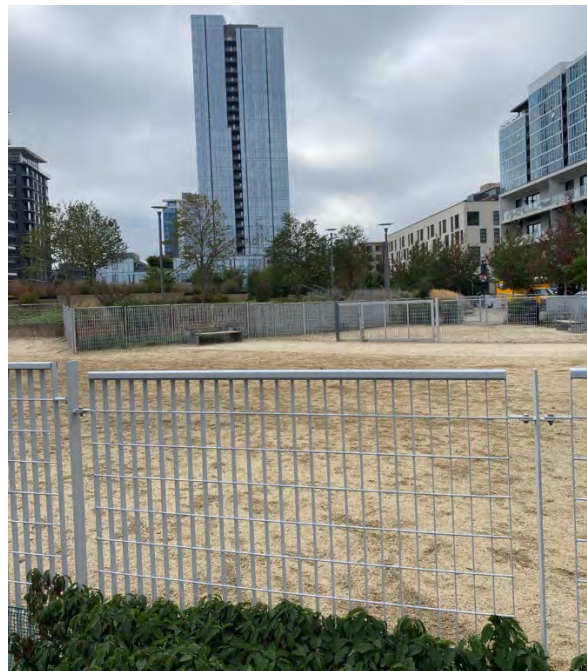
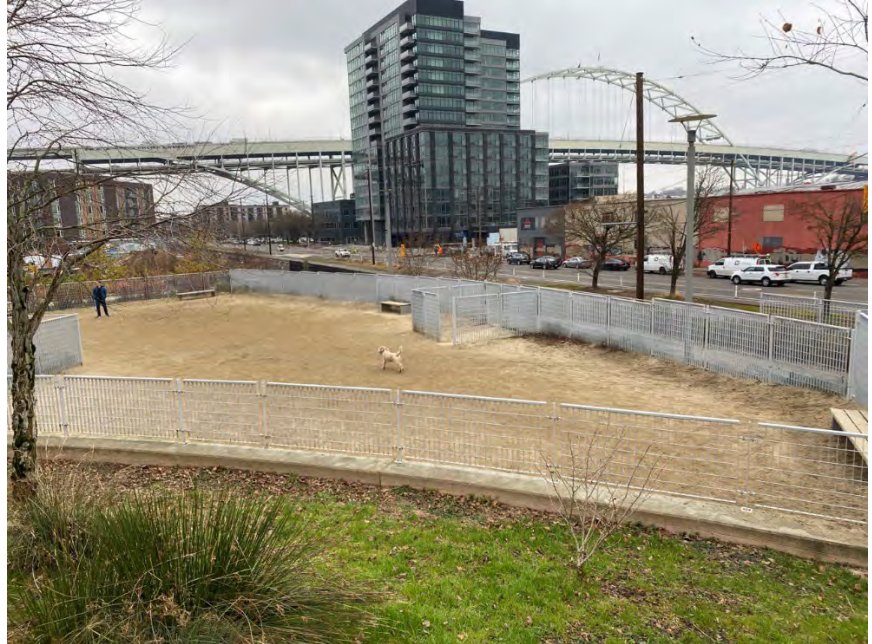
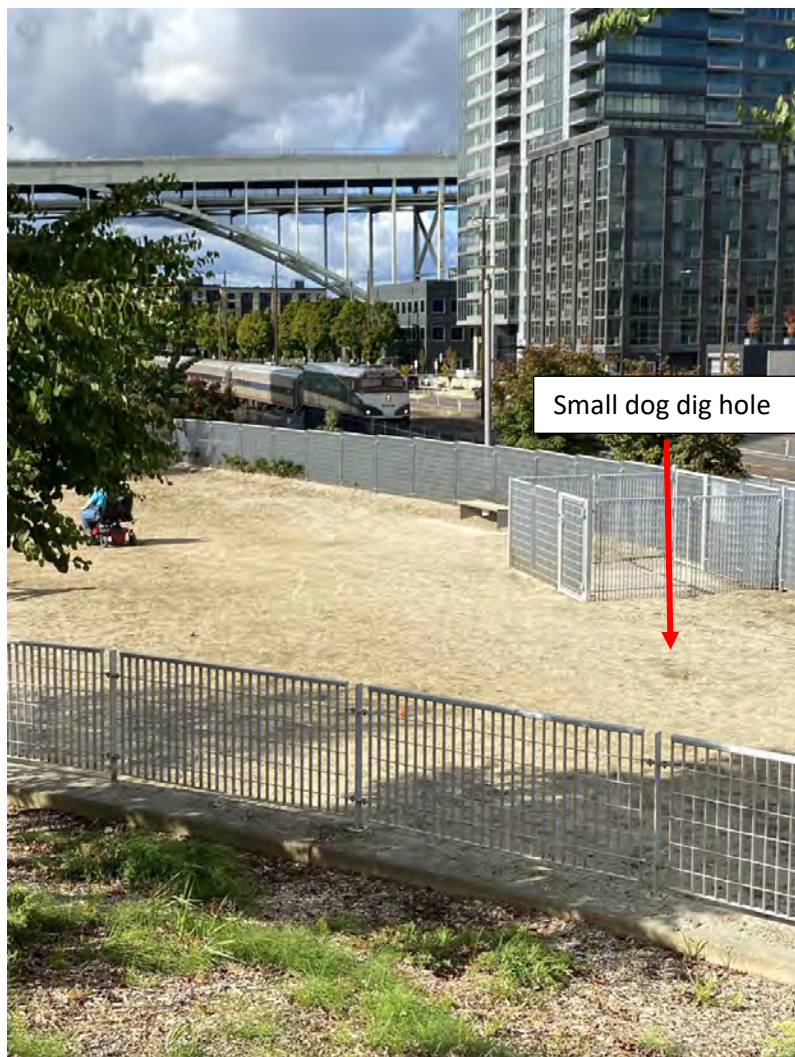
### Photo Point #15 (off-leash dog park area)

Landscaped areas, including the central grass area, other areas with plantings, as well as the dog off-leash area in the northern end of the park and the children's playground in the southern end of the park, were inspected for holes, cracks, and visual evidence of exposed demarcation geotextile fabric. No damage was observed in the landscaped areas. The dog off-leash area had one dog dig hole that was approximately 2 inches deep. The surface was regraded with extra surface material at the time of the inspection. The children's playground was in excellent condition and no damage was observed. Evidence of animal burrows were not observed this year and Parks staff continues to control for rodents in the park (photo point 16). See attached Photo Log for copies of previous and current year inspection photos.

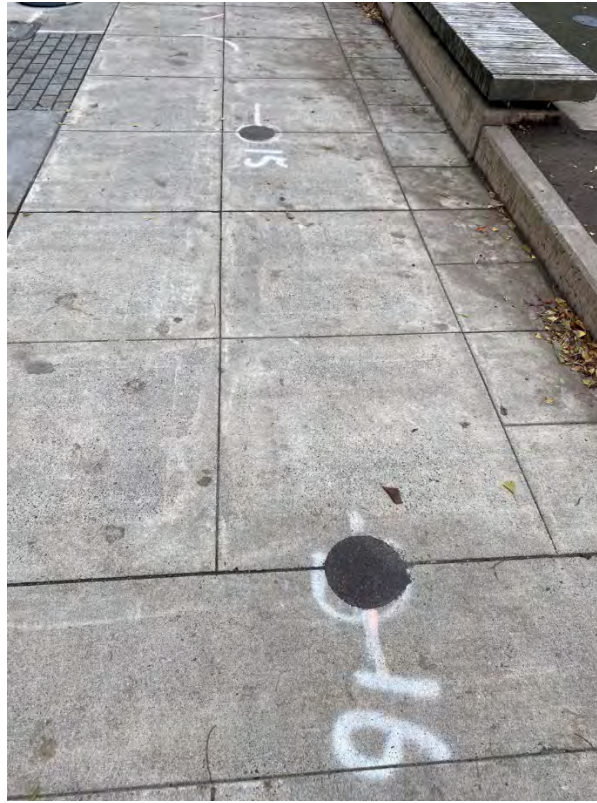
### Photo Point #17

There were two observed utility potholes located on the W sidewalk of the park during the 2022 inspection (photo point 17). These potholes were identified as being completed as part of the upcoming Pacific Power Willamette River Crossing project. The objective of the potholing was to verify the depth of existing utilities in the area and finalize design plans. According to the contractor the potholes were advanced to 29 inches below surface. No demarcation fabric was encountered, and the potholes were backfilled with ¾-inch minus compact rock and patched with asphalt. During this year's inspection the asphalt in the southern pothole location was missing, and a hard, concrete-like surface was encountered about ¼ inch below ground surface. No exposed subsurface soil was observed during the inspection. The Pacific Power Willamette River Crossing project is set to begin October 2023 and patching this pothole will be required as part of the restoration work. BES will continue to monitor these locations and other areas of the park impacted by this project in the following years.
