Matcon Annual Inspection Report for the Taylor Lumber Superfund Site
Stella Jones Company
22125 SW Rock Creek Road, Sheridan, Oregon
Construction date for cap: 2007

Inspection date: March 26, 2024

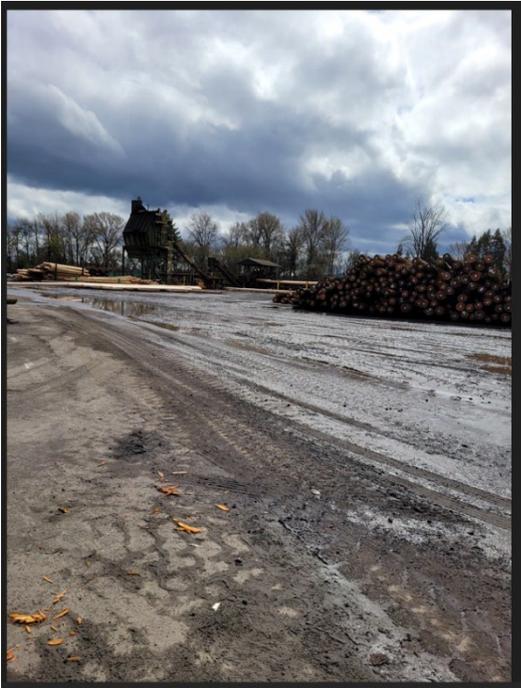
Photo 7

- e. Barrier wall demarcation: The yellow line demarcating the barrier wall was difficult to inspect around the entire site due to the mud and dirt accumulation. Where the line was visible near the peeler, it looked ok, but was starting to fade and wear out (see Photo 7).
