SUBJECT: M Carter Commons (MCC) Development
PPA Consent Order, Exhibit C Scope of Work, Item 7: Hazardous Building Material
Survey Report
3715-3717 N Interstate Ave, Portland, OR 97227

Hazardous Building Materials Survey

3715-3717 N Interstate Ave

November 18, 2024

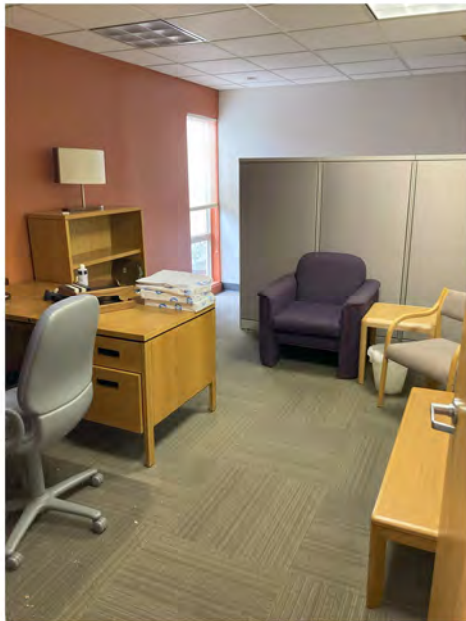
Photo 1 - View of sample location KP1p, an orange paint on gypsum wallboard in medical office 1. (11/10/2023)

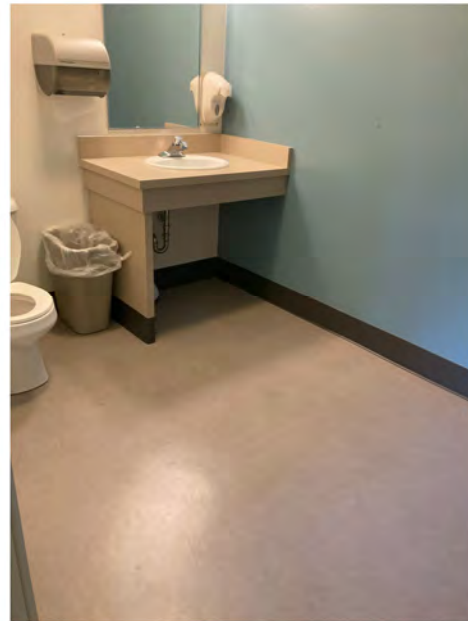
Photo 2 - View of sample location KP2p, a blue paint on gypsum wallboard in the medical office restroom. (11/10/2023)

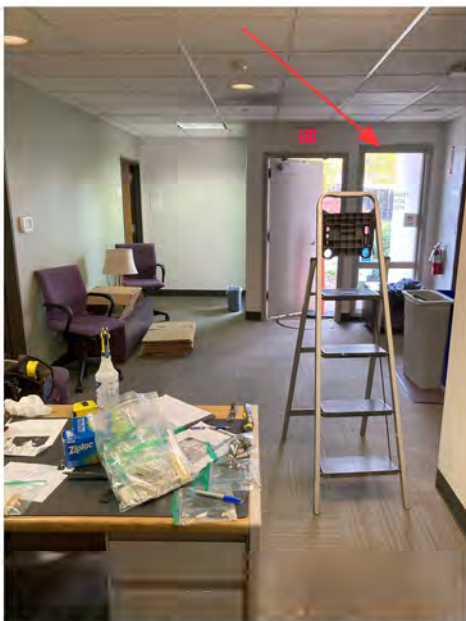
Photo 3 - View of sample locations KP3p, a green paint on gypsum wallboard in the medical office reception, and KP6p, a tan/gray paint on wood window trim (red arrow). (11/10/2023)

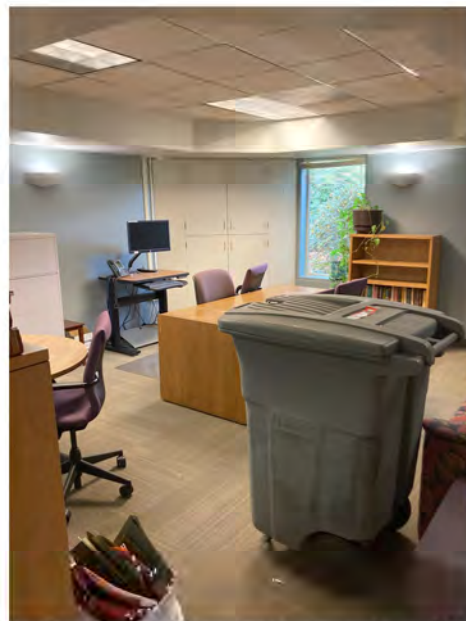
Photo 4 - View of sample location KP4p, a gray/blue paint on gypsum wallboard in medical office 3. (11/10/2023)

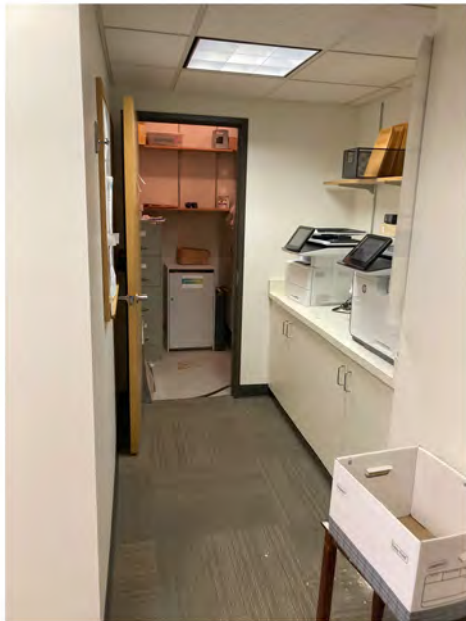
Photo 5 - View of sample location KP5p, a white paint on gypsum wallboard in medical office administration area. The white paint was used throughout the medical office area. (11/10/2023)

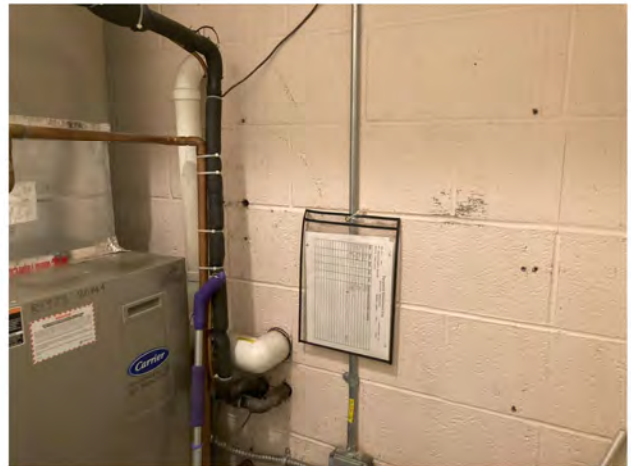
Photo 6 - View of sample location KP7p, an off-white paint on the CMU wall in the medical office utility room. Sample KP18p was collected from the opposite wall. (11/10/2023)

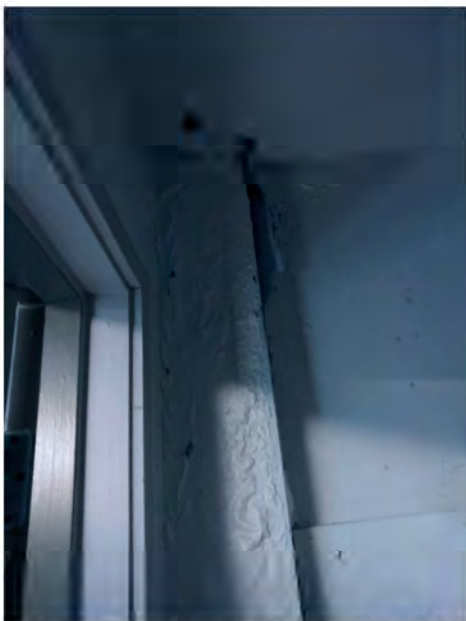
Photo 7 - View of sample location KP8p, an off-white paint on wood and gypsum wallboard in the landscape office. (11/10/2023)

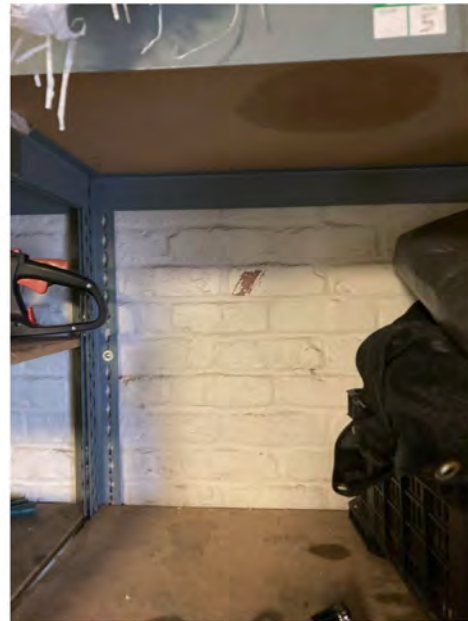
Photo 10 - View of sample location KP12p, an off-white paint on the brick wall in the landscape area garage bay. (11/10/2023)

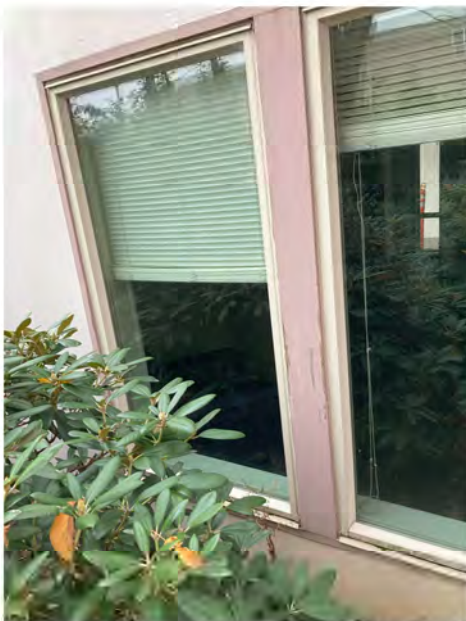
Photo 11 - View of sample locations KP13p, an off-white/rose paint on exterior wood and cement board siding, and KP14p, a brown/pink paint on exterior wood trim. (11/10/2023)
