Report on an Underground Storage Tank Removal and Investigation:

Dralle International Truck, Inc. Site  
595 East First Street  
Gladstone, OR

Volume II: Site Cleanup

by  
Northwest Environmental Corporation  
Portland, OR

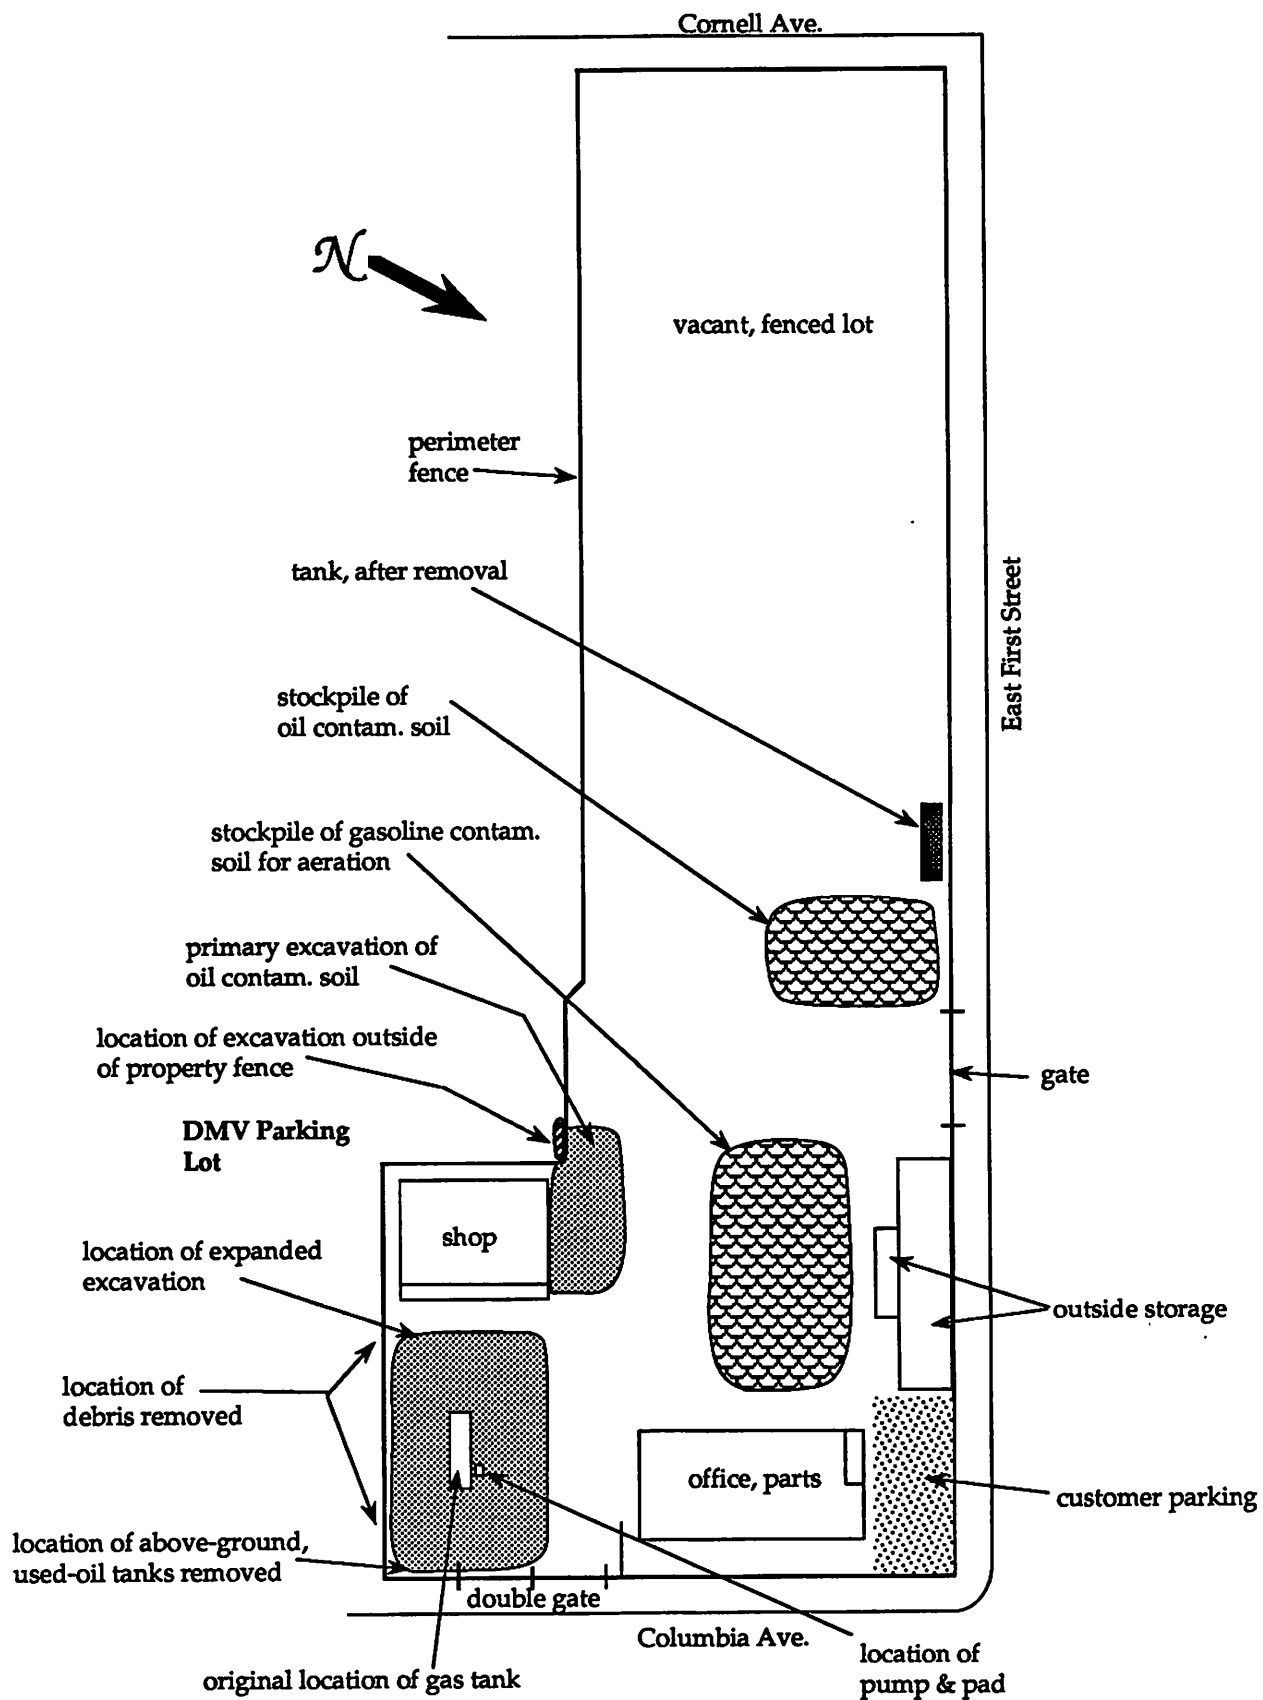
# Plan View Sketch of Dralle International Truck, Inc. Property, Gladstone, OR

At the western corner of the shop building, heavy oil contamination was observed to the west and southwest of a concrete entrance pad. This oil had saturated the surface soil to a depth of at least 18 inches, based on the excavation of a small test pit. The oil also had flowed to the west, under the perimeter fence and onto the adjacent property. This contamination was interpreted as originating from the shop operation because of its location. The contaminated area most likely was used for the convenient disposal of used motor oil. It should be emphasized that this assumed source for the oil is not supported by records or previous employee interviews. It is based solely on site observations by Northwest Environmental Corporation employees.

The soil excavated for the tank removal was piled around the perimeter of the excavation pit. Oil contamination could be observed to a depth of up to two feet at various locations in the bank of the pit. Gasoline odors could be detected in the area where the gasoline pump had been located. The initial tank removal report describes the results from an analysis of soil samples taken from the UST-removal pit. It also presents photographs that document the condition of the site after the UST removal.

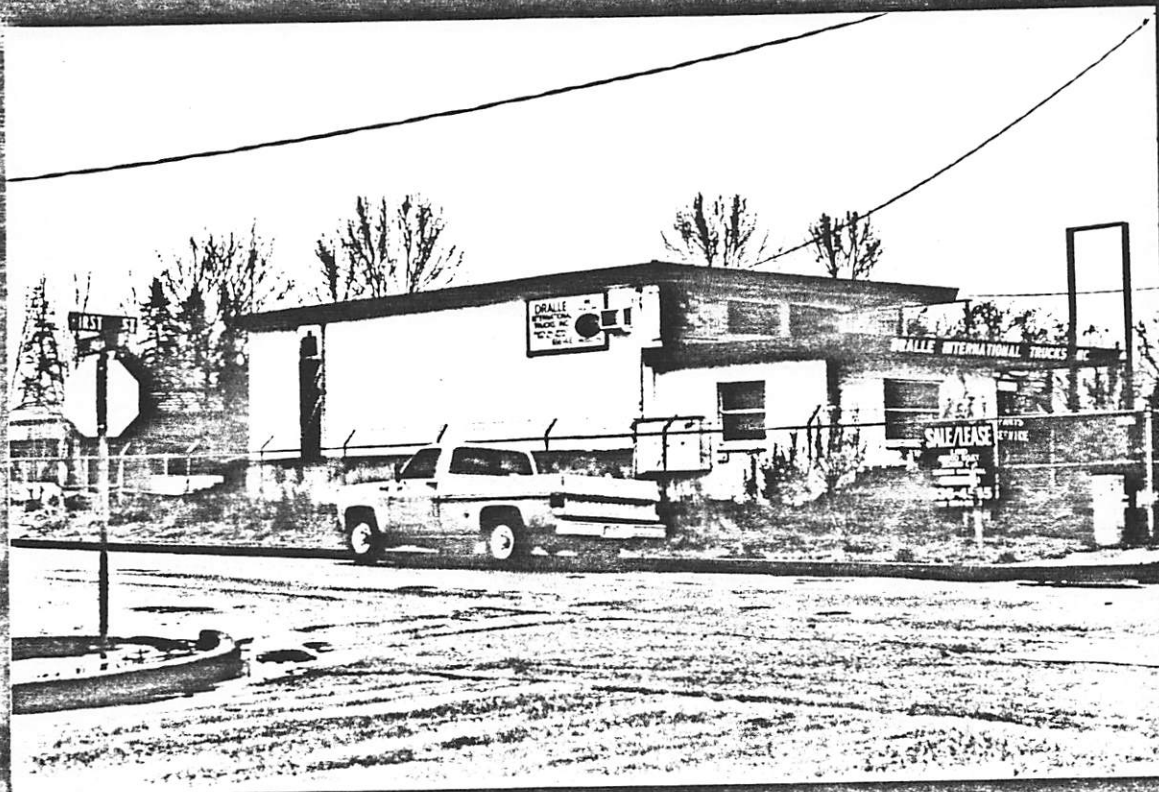
Overview of Property
