Re: Riverbank Monitoring Report  
Swan Island Upland Facility - Operable Unit 5  
Portland, Oregon  
ECSI No. 271  
1115-25

Apex Companies, LLC (Apex) prepared this *Riverbank Monitoring Report* on behalf of the Port of Portland (Port) for the Swan Island Upland Facility – Operable Unit 5 (OU5; Figures 1 and 2). This report documents monitoring of the OU5 riverbank completed on October 28, 2021 and December 13, 2022 according to the *Revised Riverbank Monitoring Work Plan* (Work Plan; Apex, 2018).

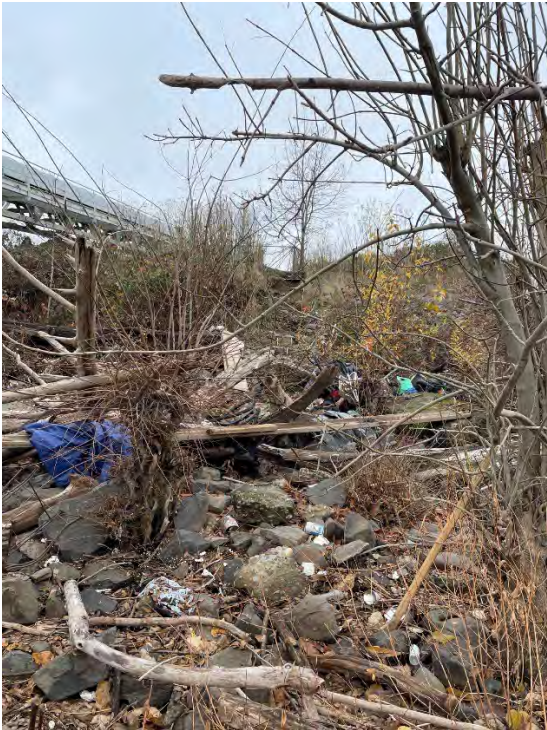
| <b>Photo Station:</b> NA | |

| <b>Description:</b><br><br>Steps installed at the north end of J1. | |

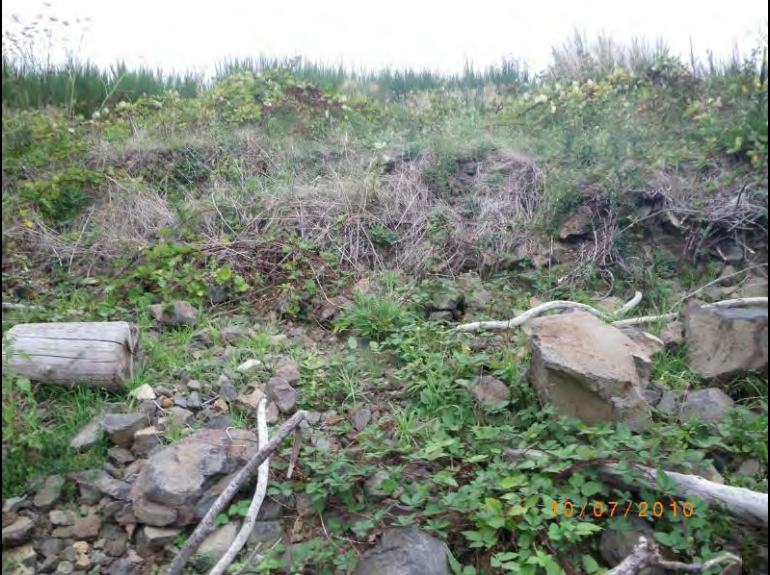
| <b>Photo Station:</b> M | |

| <b>Description:</b><br><br>Feature L – Erosion scarp 56 feet long and up to 3 feet high. | |
