Attached is a copy of the Annual Cap Inspection Report for Tanner Springs Park (ESCI ID 1080). Please feel free to contact me if you have any questions.

Site: Tanner Springs Park

Inspection Date: 10/22/2024

Tanner Springs Park
Annual Cap Inspection
Photo Locations Map

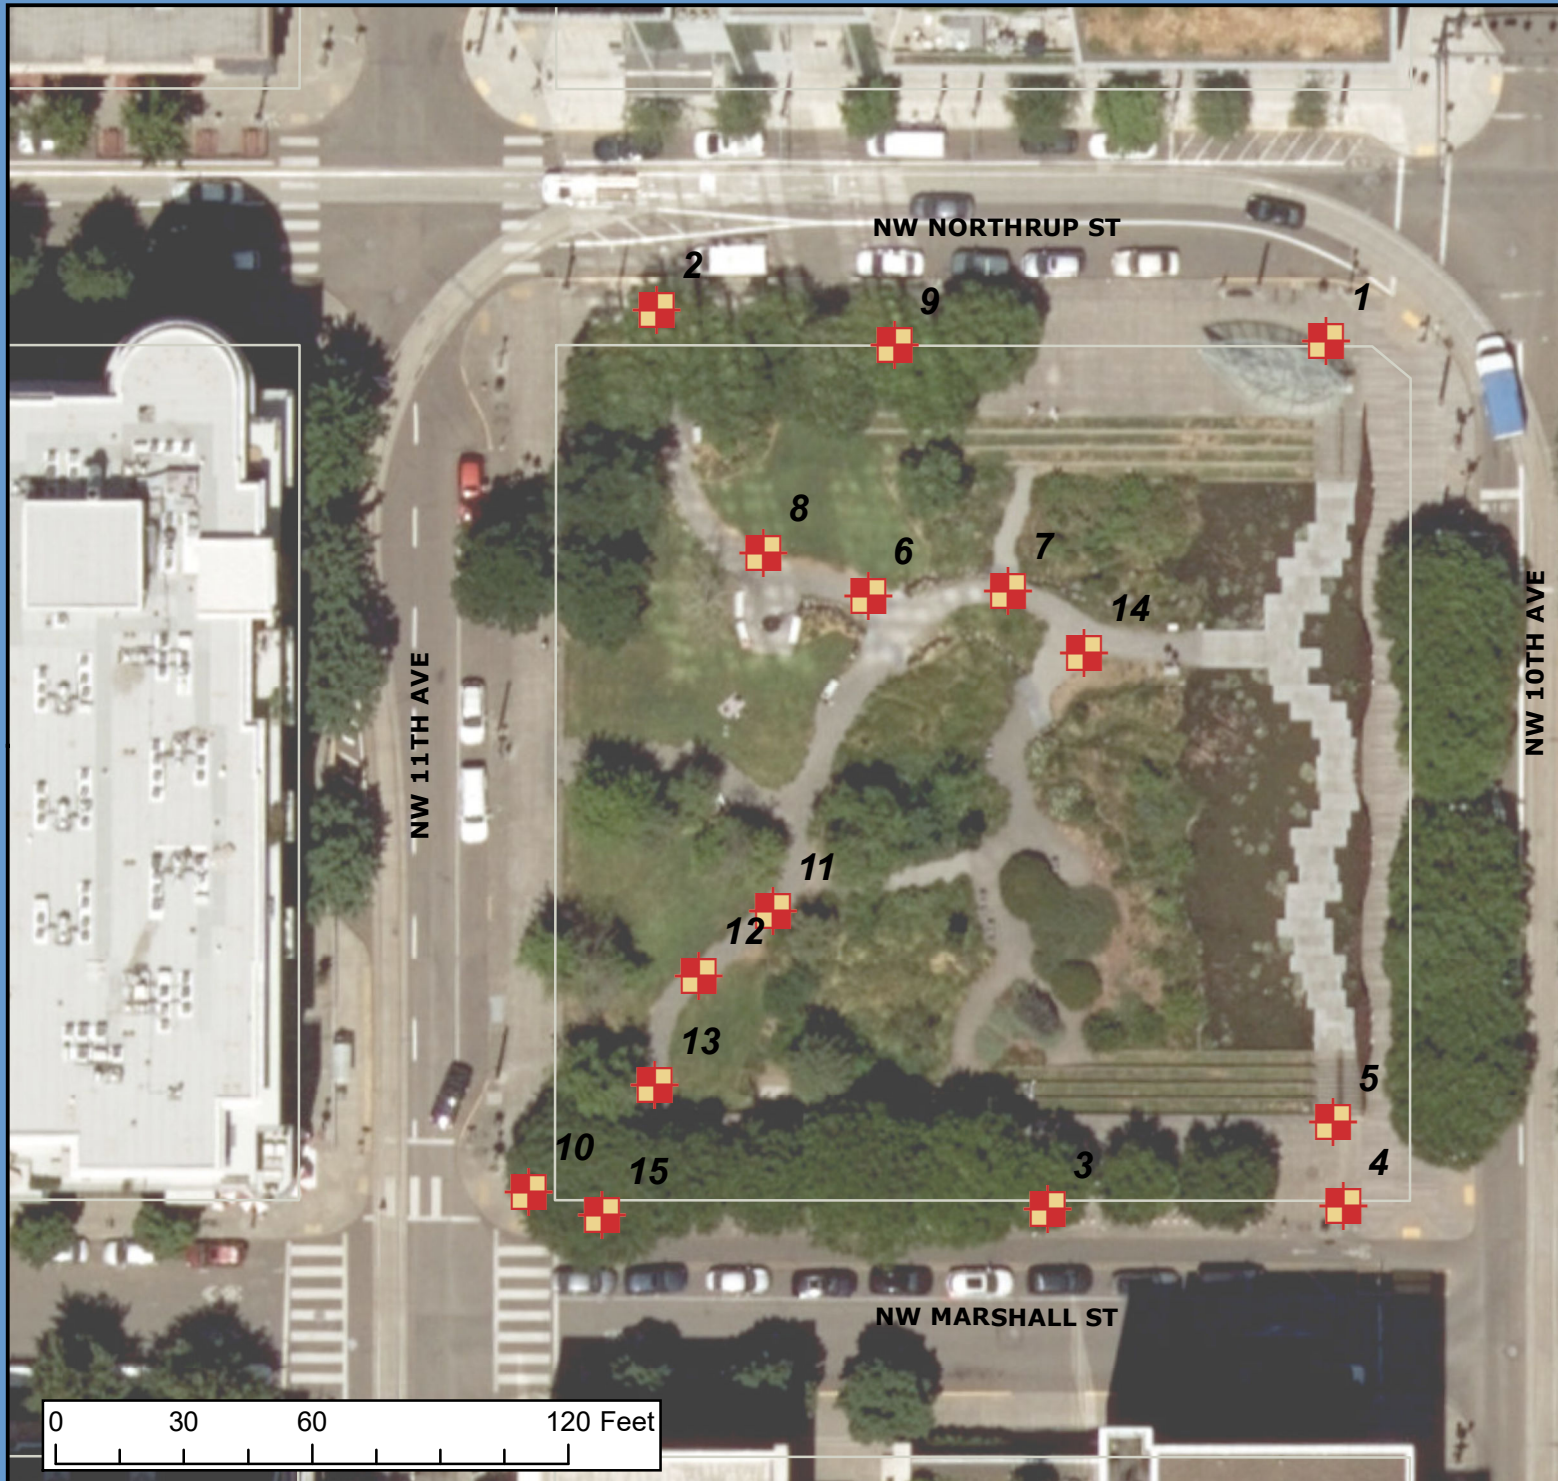
Figure 1

Several minor serviceable cracks in concrete were documented in the attached photo log and accompanying map. These cracks were documented in previous years inspection reports and have not changed in thickness. Several areas of minor separation (0.5 to 1.5 inches) were noted within the cobblestone path (photo points 6-8 and 11-14). Weathering has impacted caulked seams in the cobblestone paths and caulking was missing in a few places; however, the caulked seams were in fair condition. None of these cracks have compromised the cap or have allowed subsurface soil to be exposed. No patching is currently recommended. Photo point (15) is located where a concrete sidewalk panel is being lifted due to street tree roots. This inspection found no changes from last year at photo point (15).
