Site: The Fields Neighborhood Park

Inspection Date: 10/22/2024

The Fields Park - 2024 Annual Cap Inspection Photo Log

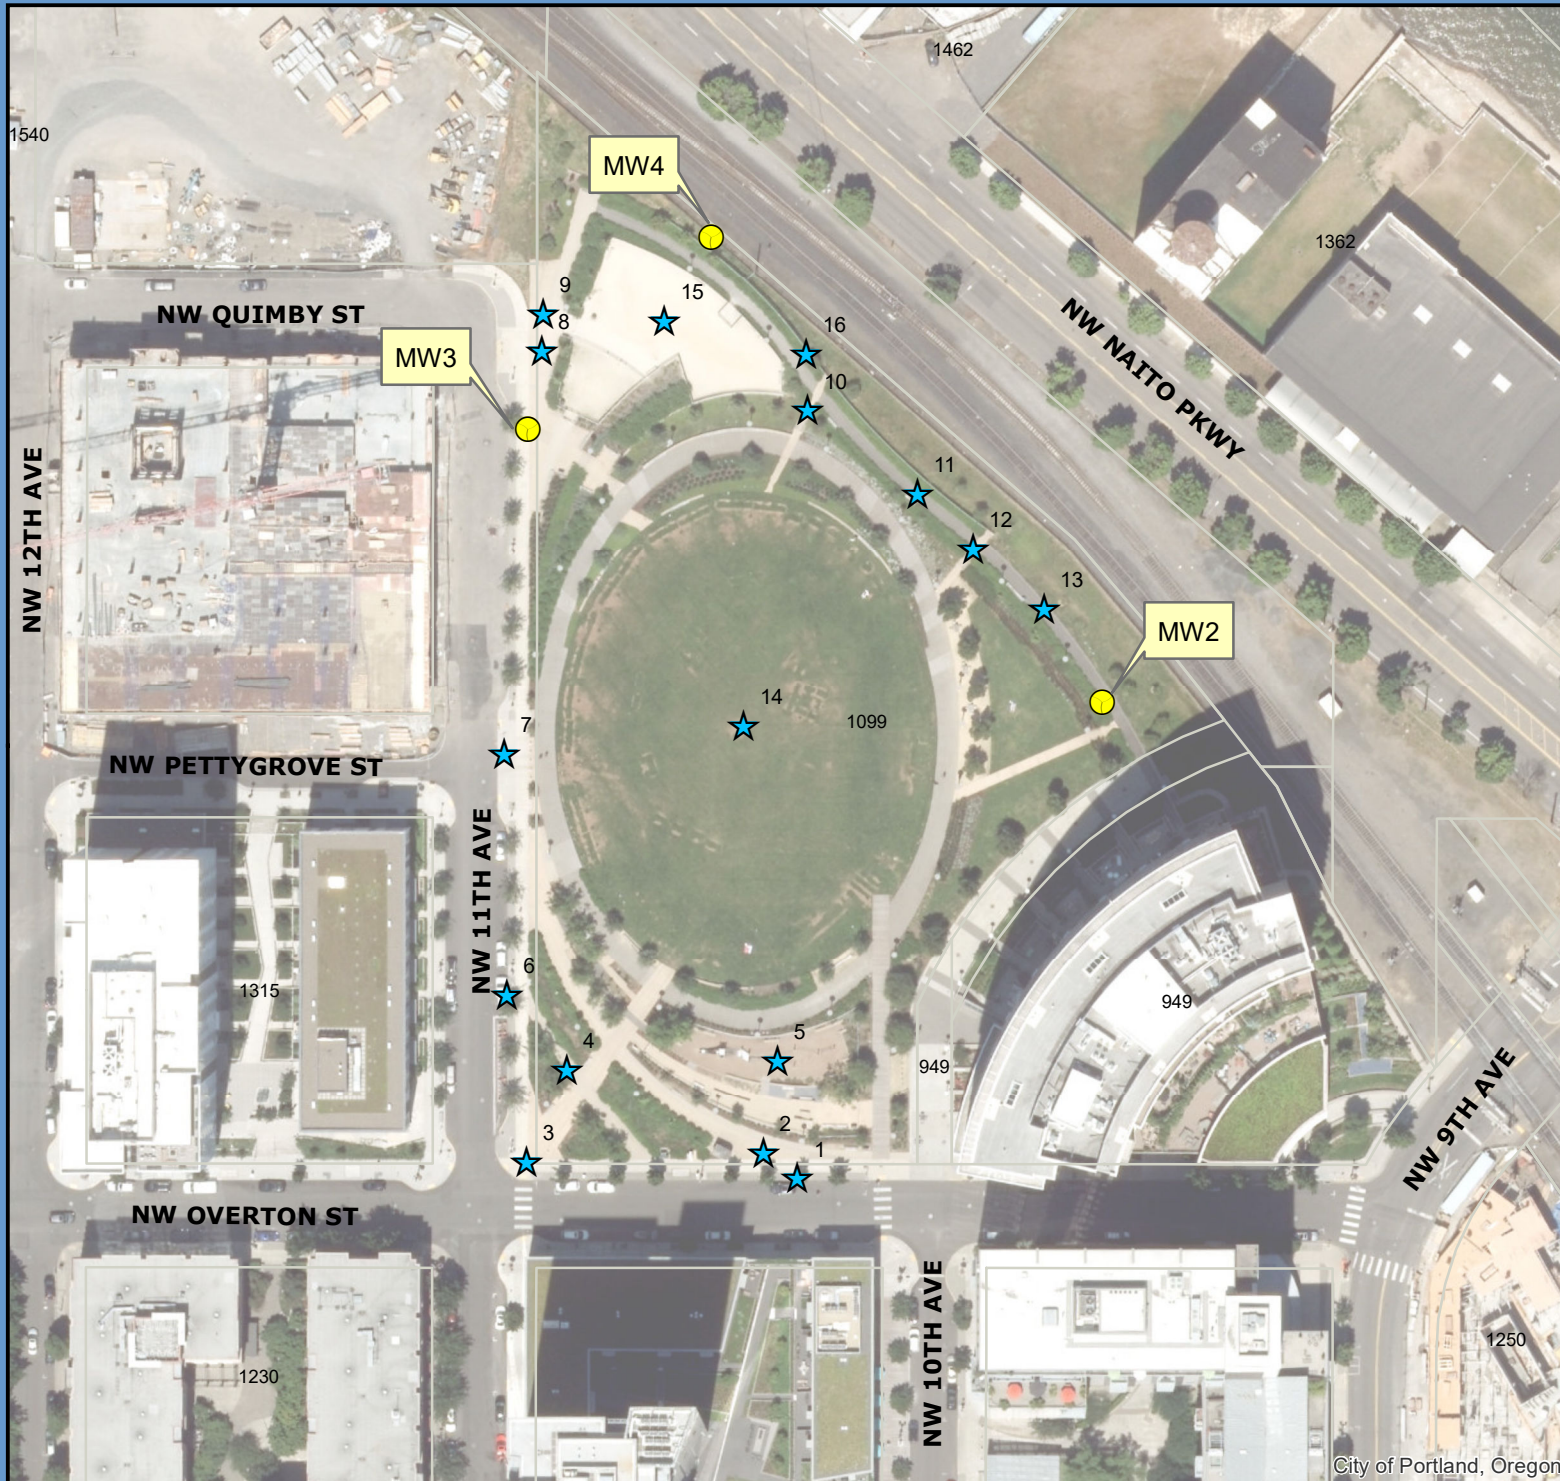
Fields Park Annual Cap Inspection Photo Points

Hardscaped areas are in good condition. The cap is not compromised in the hardscape areas of the park. See attached Figure 1 and Photo Log.
