# ROAD REPAIR WORK PLAN

ALKALI LAKE SITE  
LAKE COUNTY, STATE OF OREGON  
PROJECT # 261M136620

ALKALI LAKE SITE  
LAKE COUNTY, STATE OF OREGON  
PROJECT # US261M136620.3223

September 17, 2024

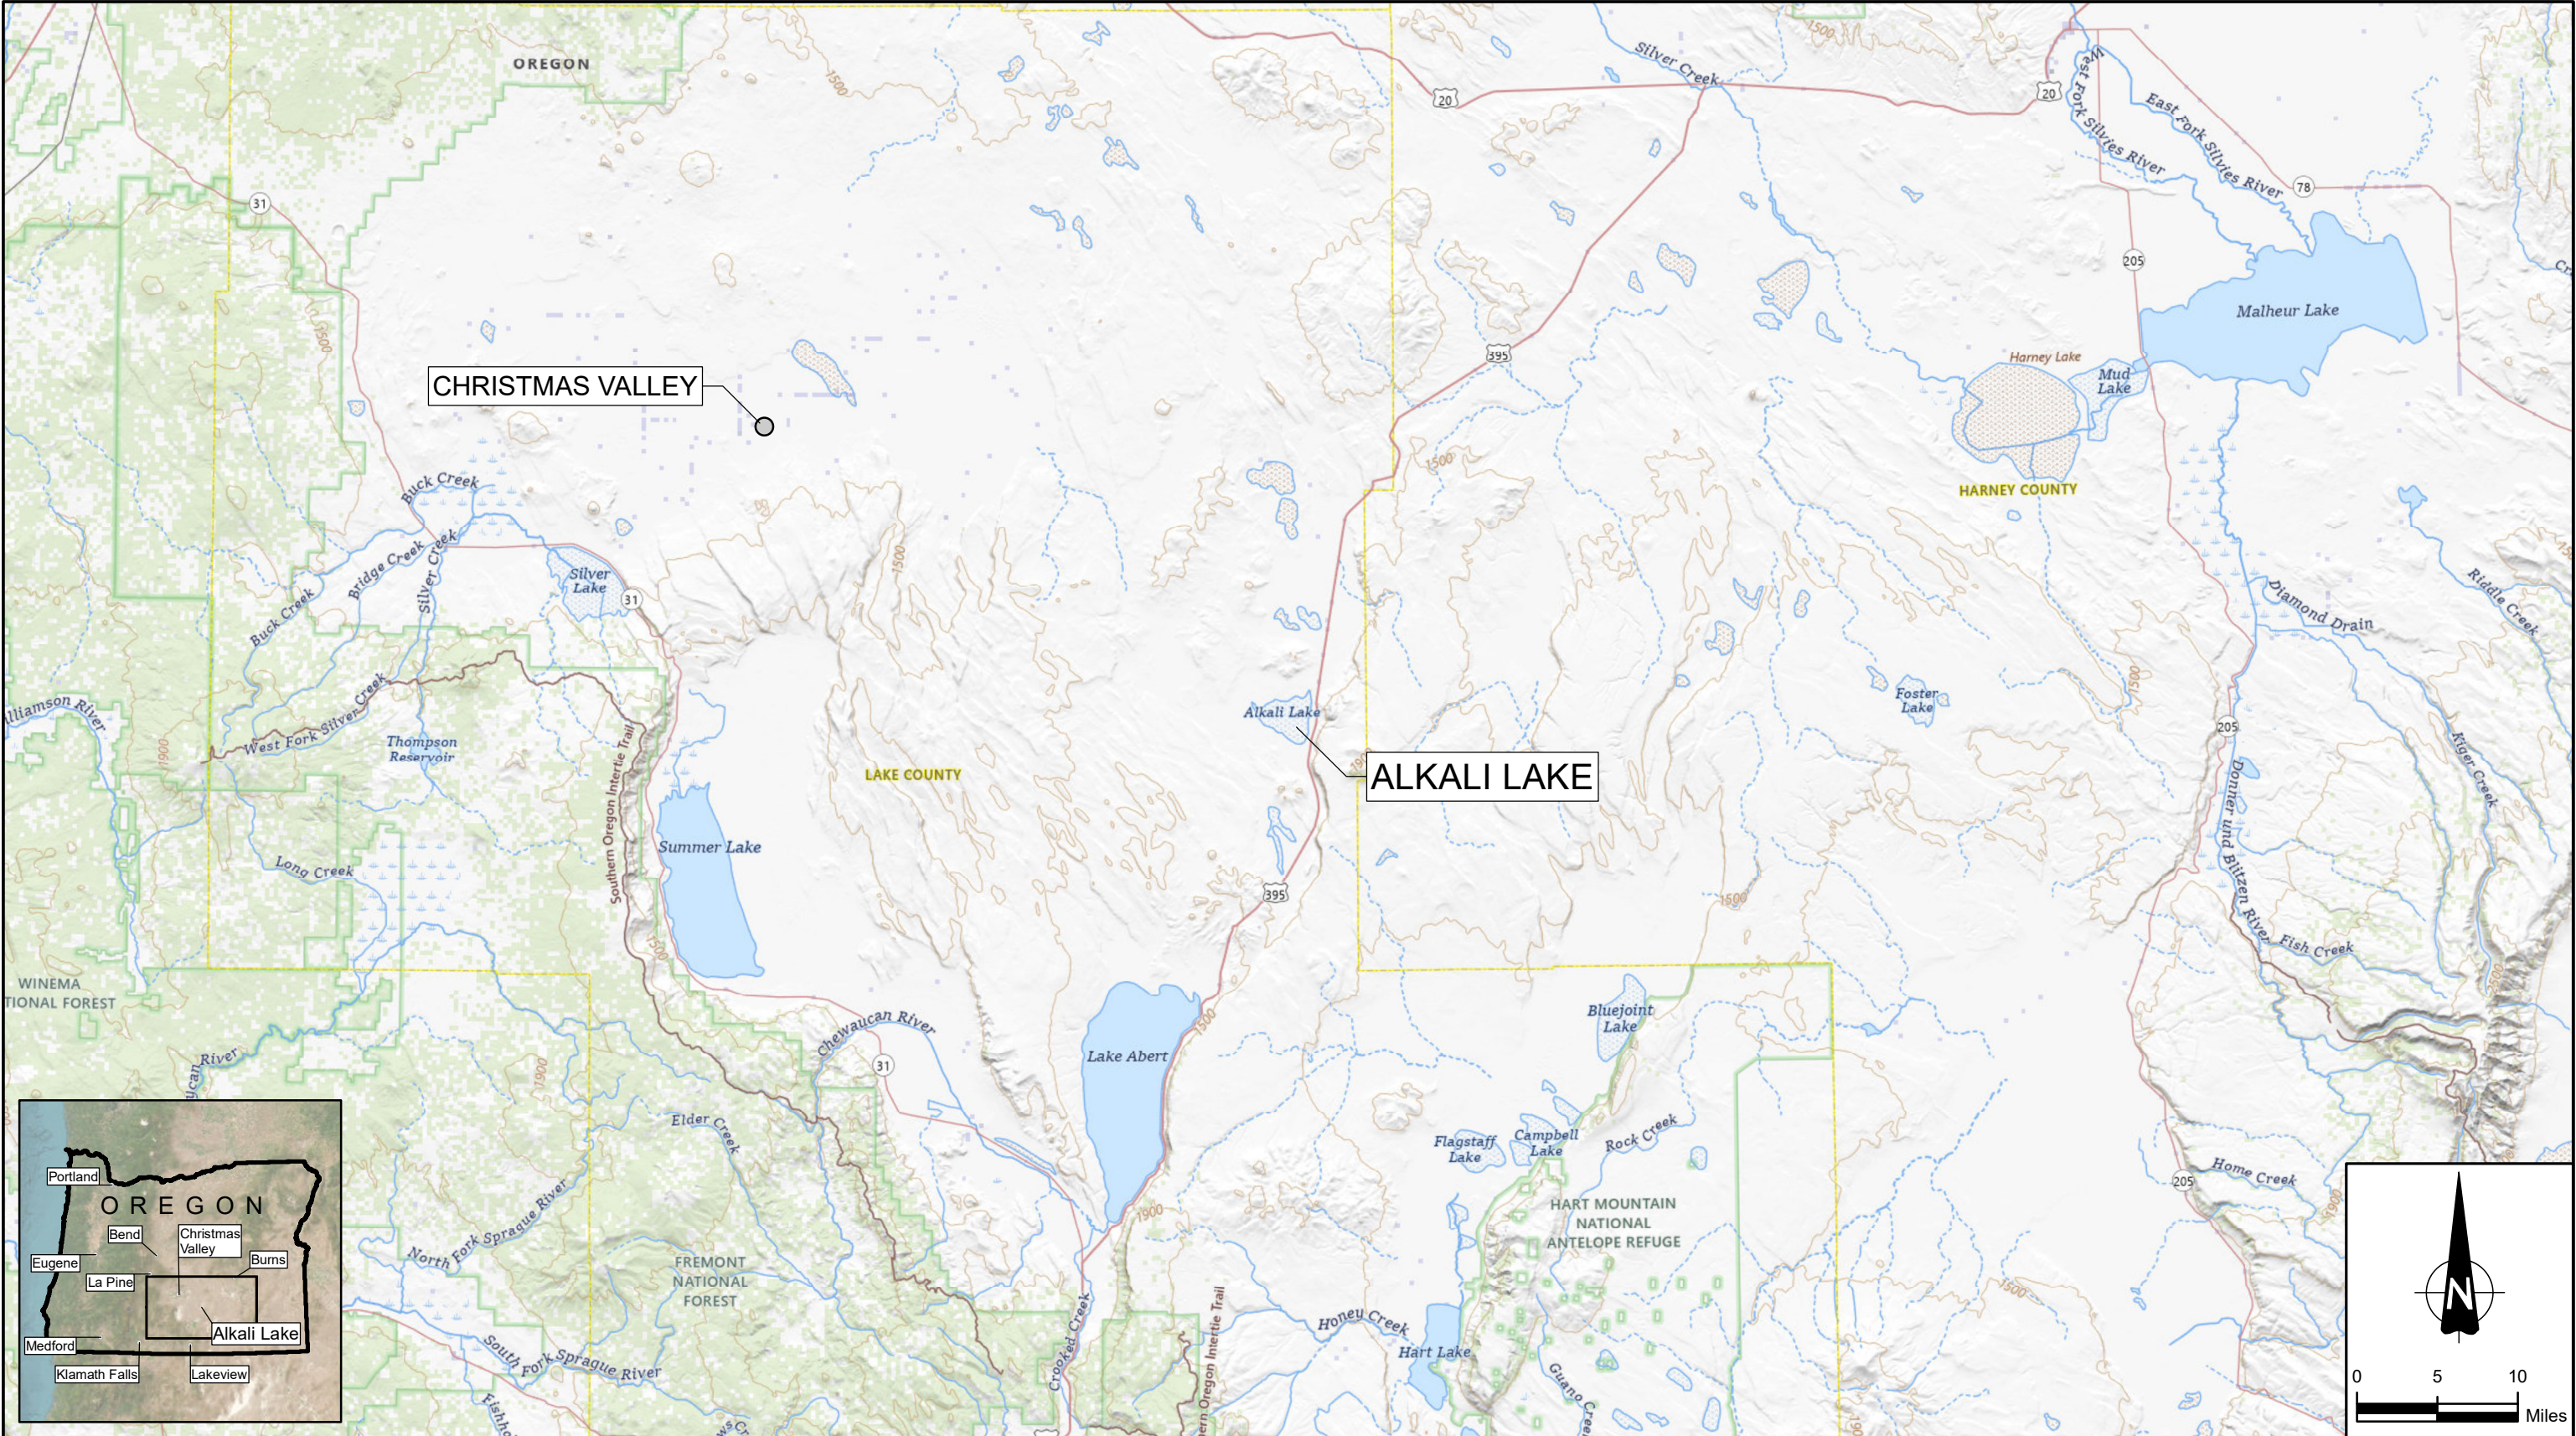
In the locations along the access road identified to be degraded as shown in Figure 2 (i.e., potholes, tire ruts, and other deformations) the proposed repairs are to re-grade the surficial fine-grained soils, flatten the existing surface, and place up to 6 inches of 3/4-inch to 2-1/2-inch clean crushed gravel to fill in these areas as needed to raise the low spots to match the surrounding grade. The gravel repairs will be compacted and verified in the field by the WSP engineer of record or engineer's representative. Compaction verification will be limited to visual inspection via proof-rolling with a fully loaded truck.

The goal of this road project and the proposed repairs is to improve the road so that tractor trailer trucks can safely access the CWDA area (located on State-owned land). The trucks will be hauling in a Conex Box and trailered drill rigs for the anticipated next phase of work for the RI/FS. Proposed repairs will include filling in existing potholes, tire ruts, and low areas with drainage issues with gravel, either to fill in low spots or to match the surrounding road grade. The proposed gravel to be used for the repairs will be a 1.5-inch to 2.5-inch clean crushed gravel. It will be placed in the degraded areas of the existing road bed shown in Figure 2. Assuming

a 6-inch thickness of gravel placement in these areas, the total the amount of gravel needed to perform the repairs is estimated to be approximately 900 tons. This includes creation of a truck turnaround area near the CWDA and placement of gravel under where the Conex box will be placed (both will be located on State-owned land). The access road spans BLM, private, and State property. Approximately 800 tons of gravel will be used on the portion of the road on BLM property. Approximately 100 tons of gravel will be placed similarly in degraded portions of the private-owned portion of the access road. An additional 100 tons will be stockpiled near the CWDA on State-owned land for future-use at the Site.
