**Operation and Maintenance Report
January 2021 to December 2021**

**McCormick & Baxter
Superfund Site
Portland, Oregon
ECSI Site No. 74**

Prepared for
**Oregon Department of
Environmental Quality**

May 6, 2022
0202315-000/003/01

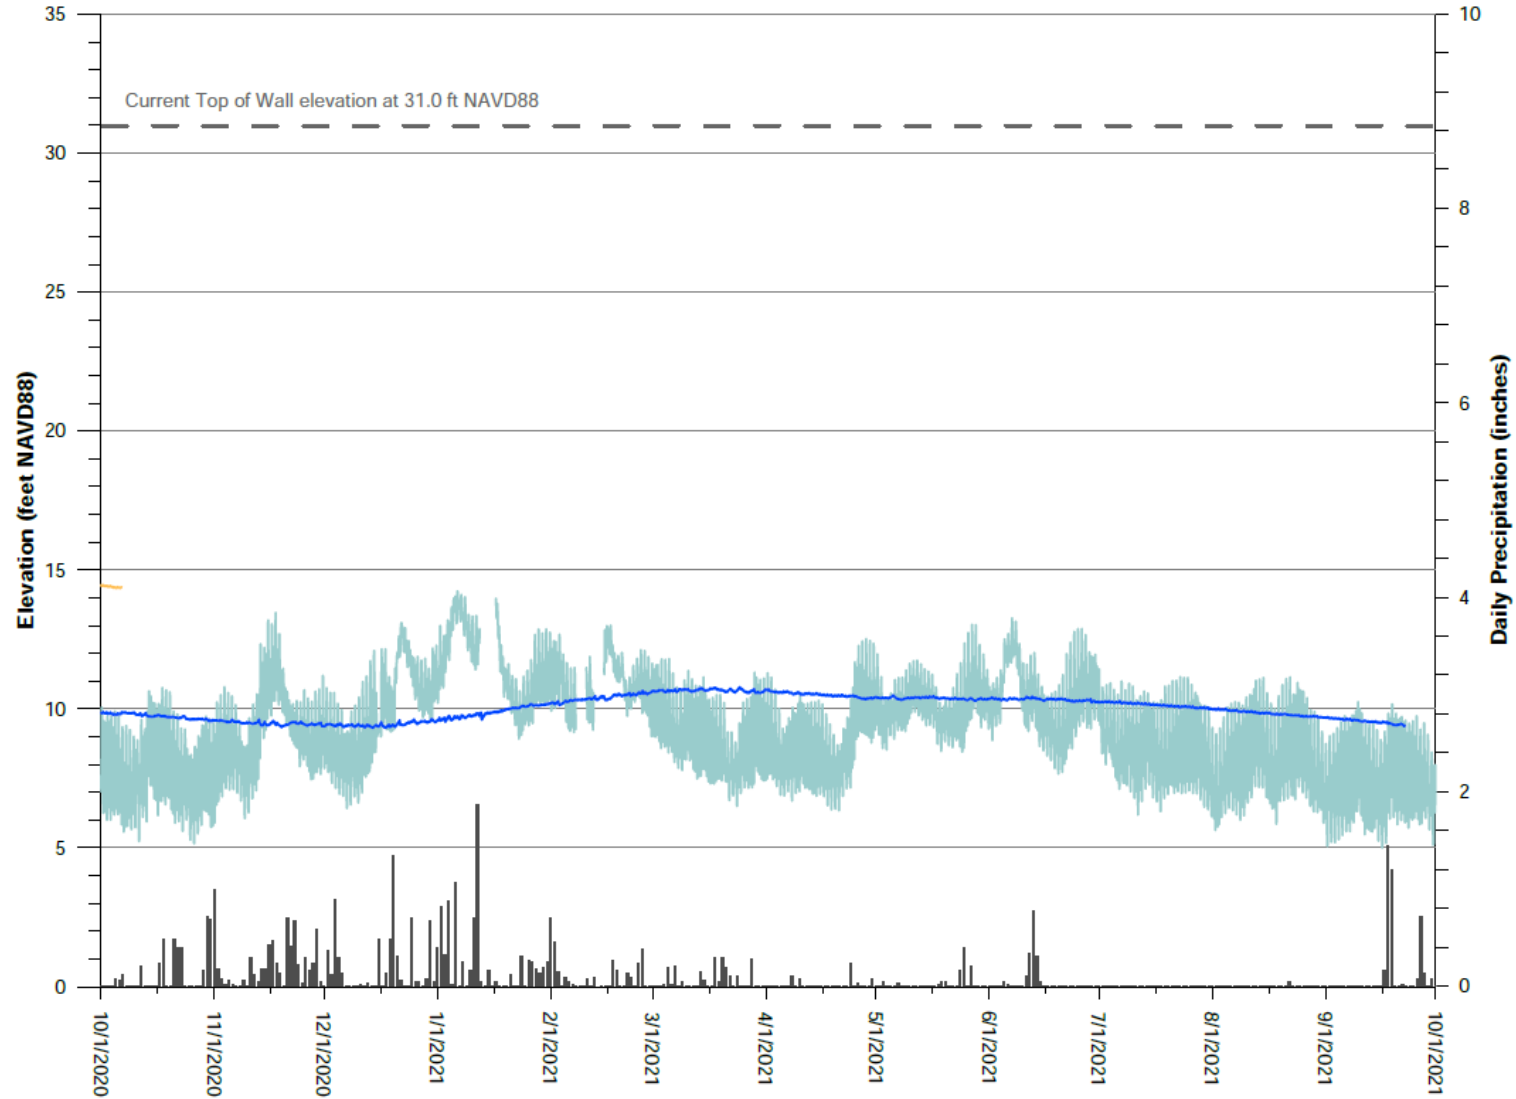
**2021 Groundwater Elevations
in Monitoring Wells MW-52s
and MW-53s**

of the barrier wall. No 2021 data was available for MW-53s due to a pressure transducer failure (Figure 4-5).

1. ME-52s is located inside the barrier wall and MW-53s is located outside the barrier wall.
2. Due to a pressure transducer failure, there is no data available for MW-53s. Data gaps in the Willamette River elevation are due to erroneous data.

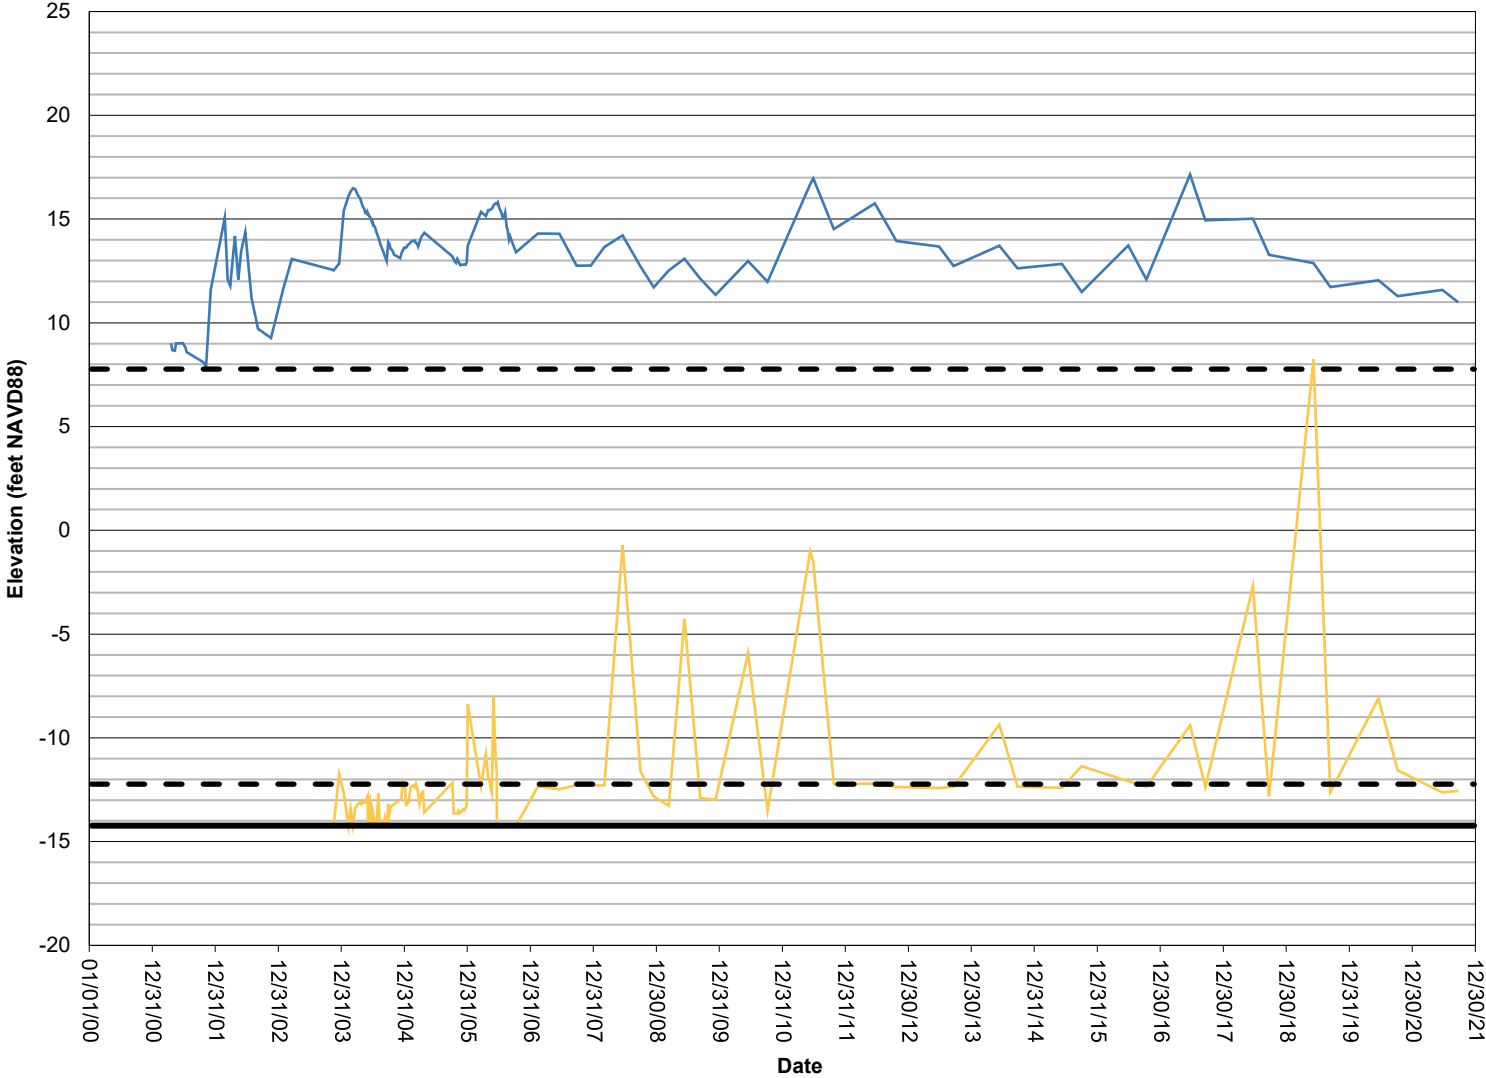
FIGURE 4-18

Overall, both LNAPL and DNAPL appear to be stable except for the DNAPL at EW-8s (Figure 4-18). The pattern in DNAPL thickness at EW-8s is consistent with historical patterns, which vary seasonally. Given these observations, mobilization of LNAPL or DNAPL across either the barrier wall or the Willamette River is unlikely.

**2001 to 2021 NAPL Thickness Plot
for Well EW-8s**
McCormick & Baxter Superfund Site
Portland, Oregon

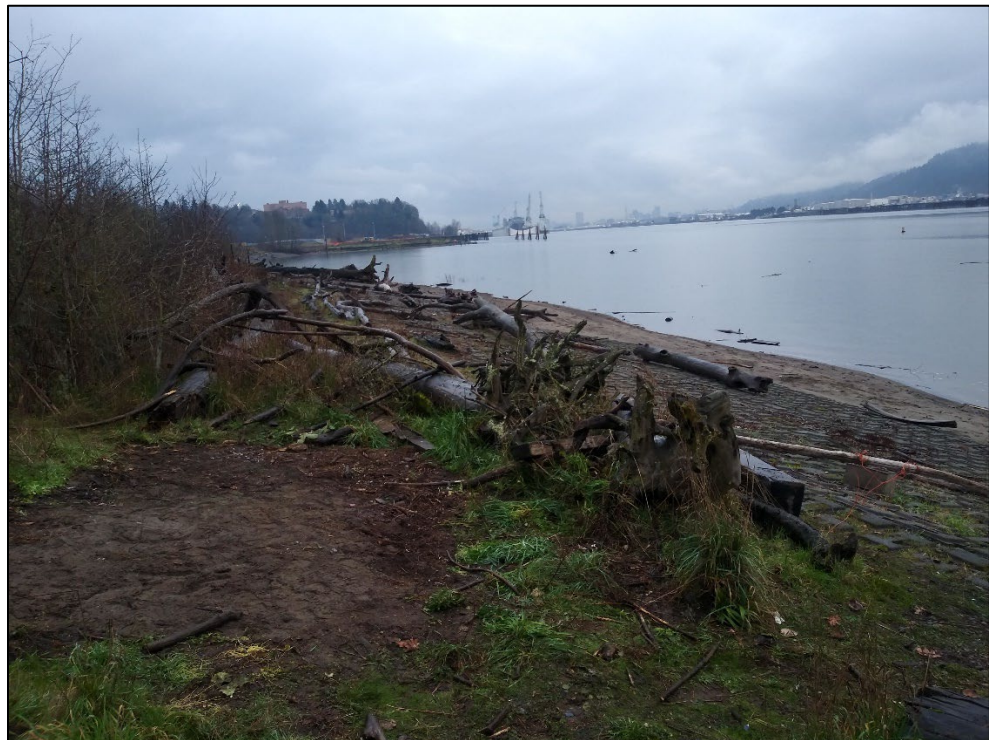
Photograph A4: Former homeless encampment area at the northern end of the Willamette River shoreline after removal of abandoned campsite and trash. View facing southeast (January 2021).

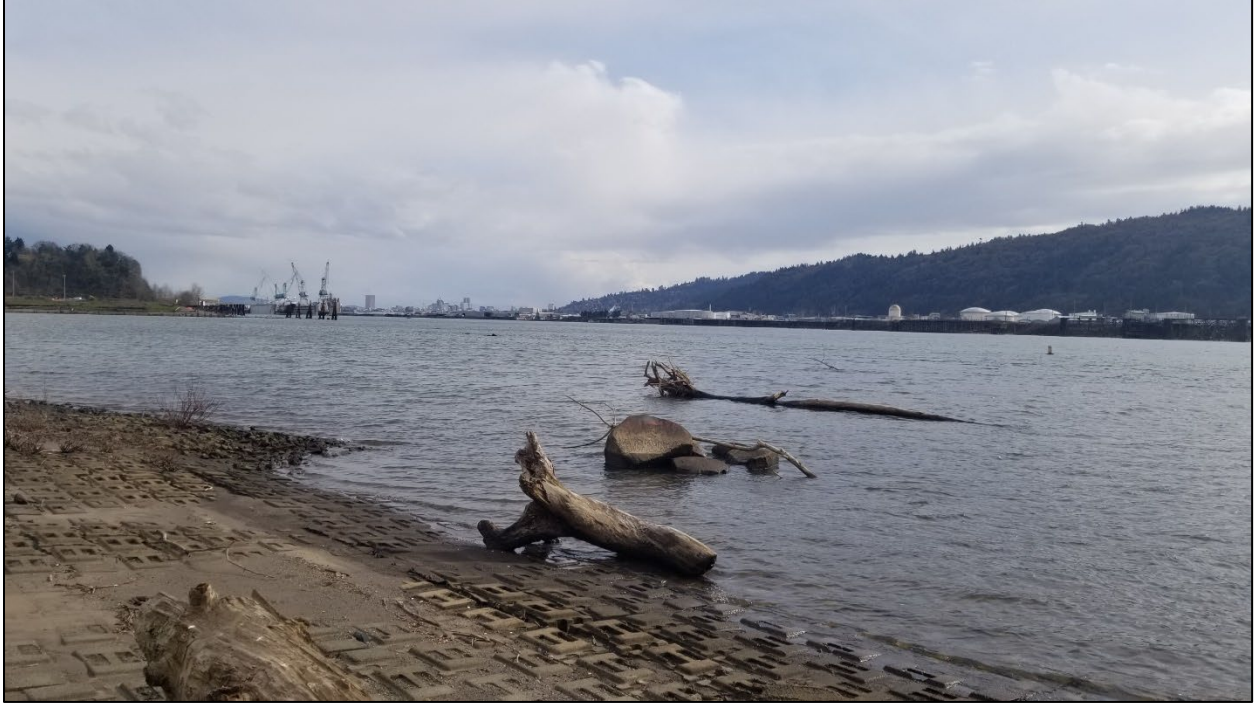
Photograph A5: Willamette River shoreline and view of water over sediment cap. View facing southwest. (March 2021).

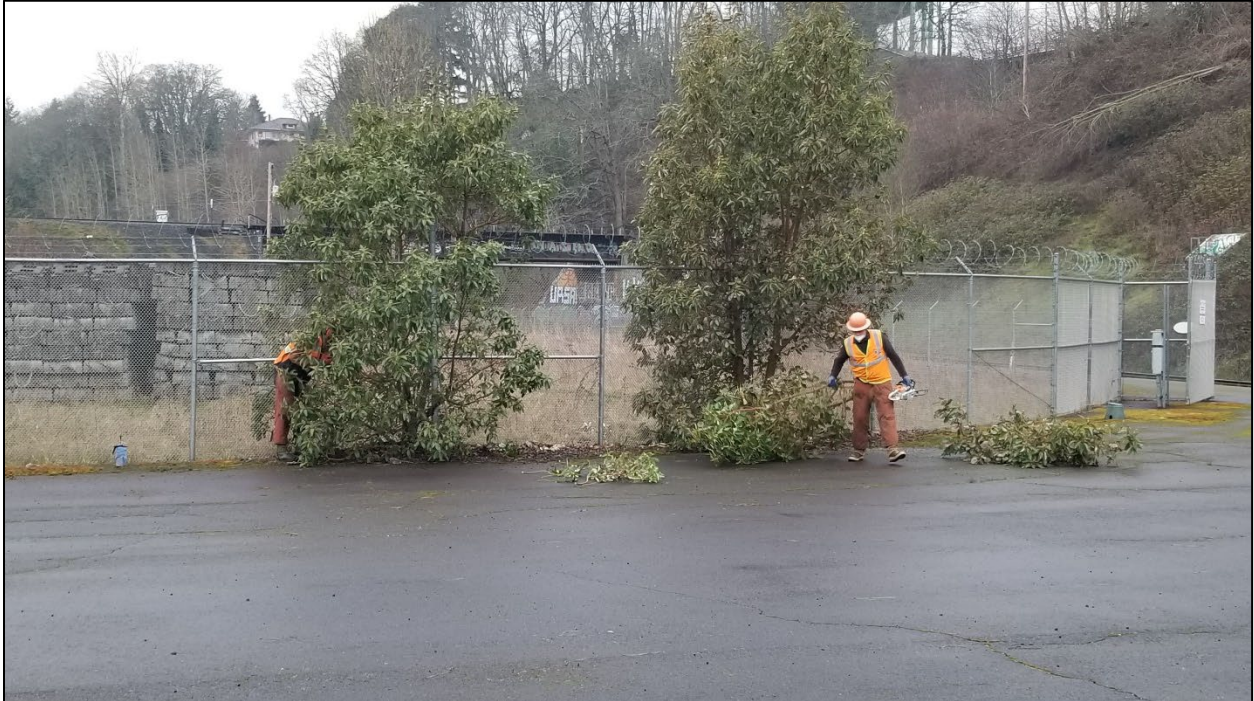
Photograph A6: Removal of trees growing under fence line in paved storage area. View facing north (March 2021).

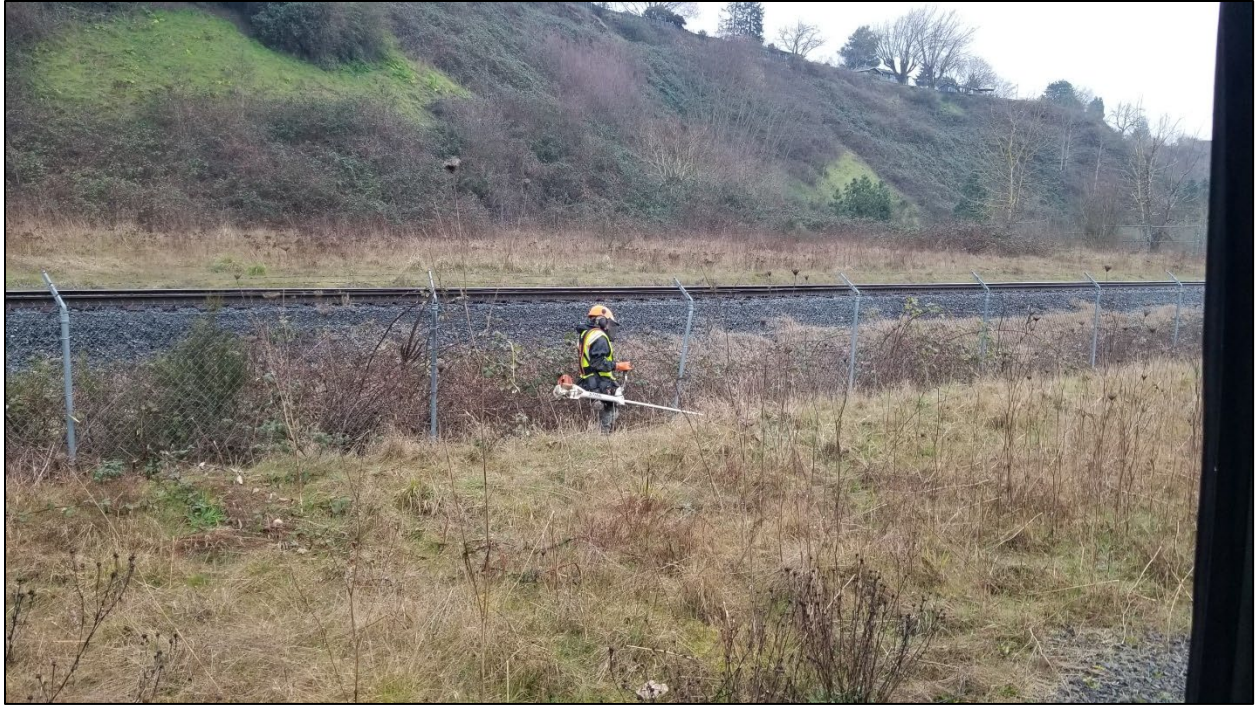
Photograph A7: Weed whacking and removal of blackberry vines growing over eastern perimeter fence. View facing southeast (March 2021).

Routine maintenance activities performed at the Site in 2021 included replacing cut locks and chains, filling animal burrows beneath the perimeter fence, monitoring vegetation, and removing blackberry vines along the perimeter fence. Non-routine maintenance performed in 2021 included completion of replacement signpost and sign installation, tree removal, drum removal and disposal, vault box installation, and fence repairs.

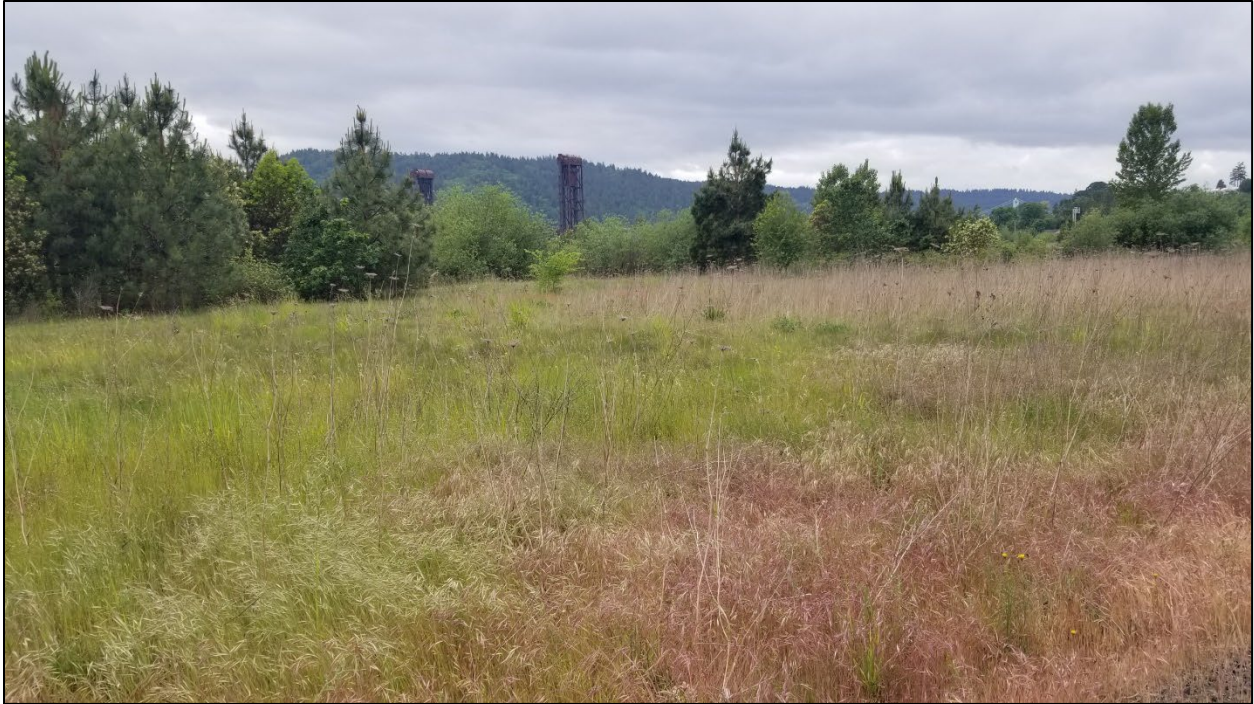
Overall, upland soil cap observations and inspections revealed no significant change in remedy performance or areas of concern. The soil cap continues to have a consistent layer of vegetative cover across the Site (Appendix A, Photographs A9 and A11). Future O&M activities will consist primarily of quarterly inspections and routine maintenance. Although gate locks are periodically cut and require replacement, there is no evidence that trespassers have damaged the integrity of the soil cap.

Photograph A9: Soil cap condition in southeastern quadrant of soil cap during the second quarter site inspection (May 2021).

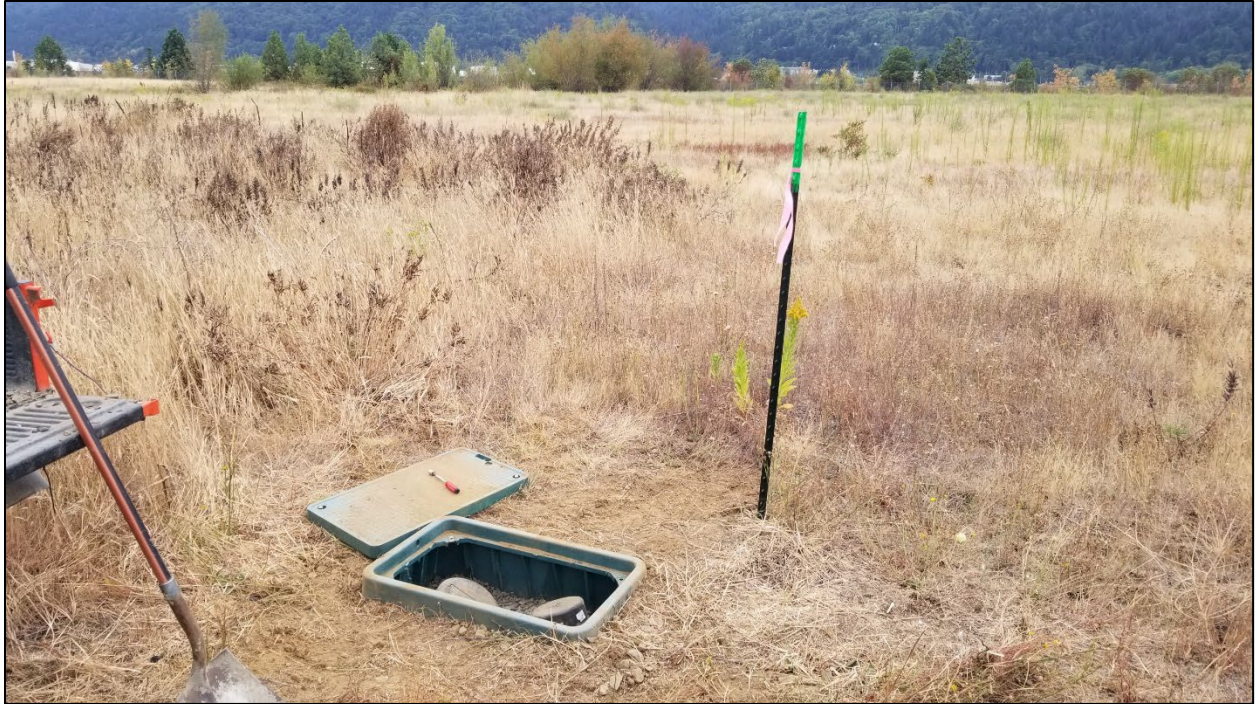
Photograph A11: Installation of marked T-post for location of newly installed stormwater conveyance piping cleanout vault box at CL-4. View facing southwest (August 2021).

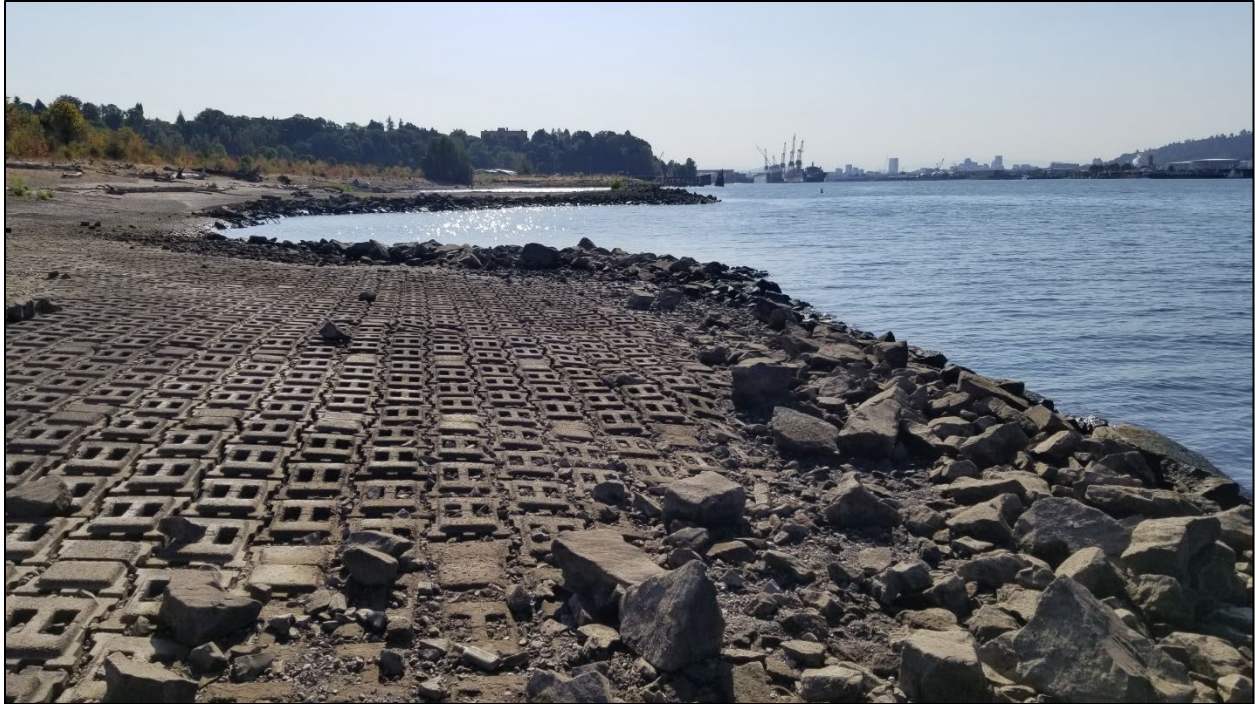
Photograph A15: Low river level conditions showing edge of ACB armoring and transition to rip rap armoring on the sediment cap. View facing southeast (September 2021).

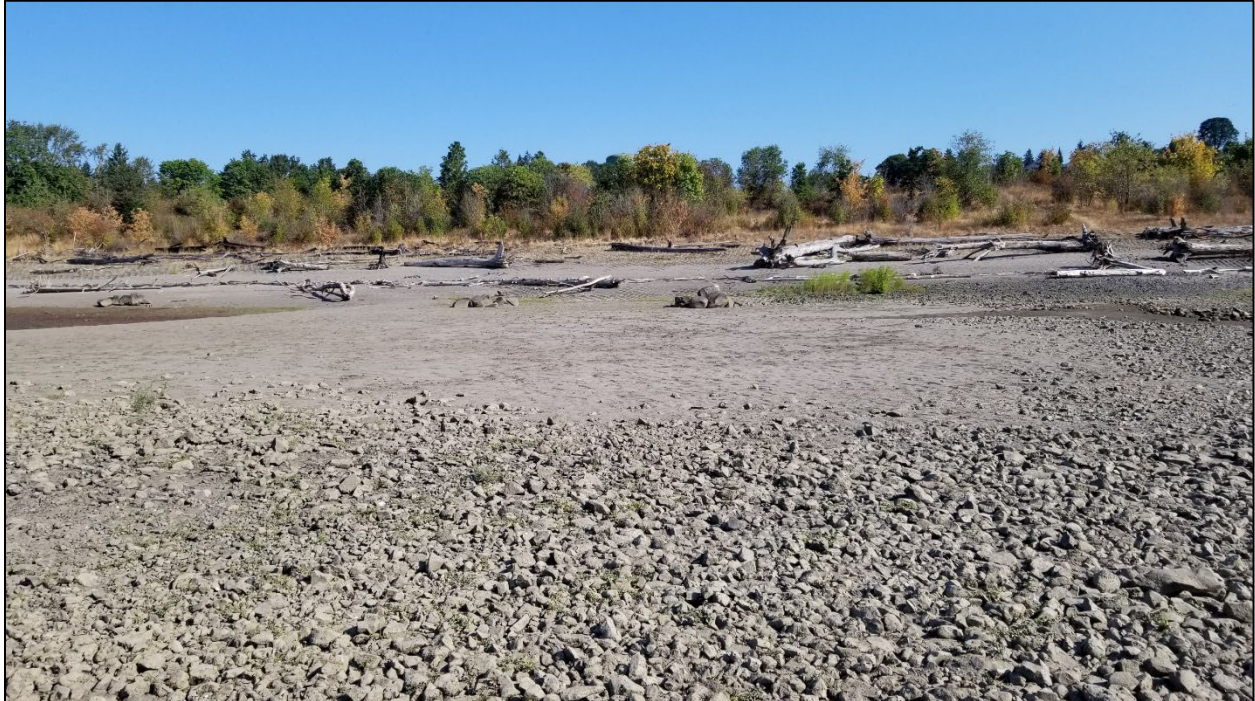
Photograph A16: Exposed sediment cap in intertidal zone during low river level conditions. View facing northeast (September 2021).

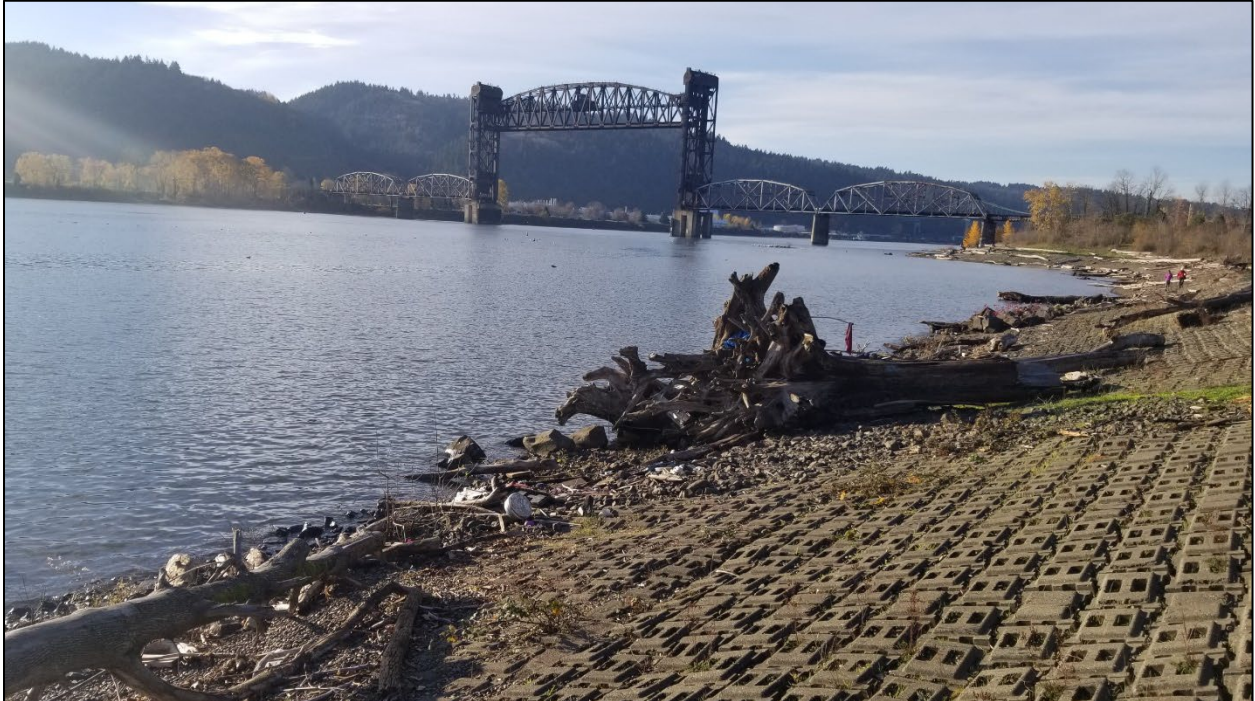
Photograph A18: Shoreline after removal of the derelict vessel. View facing northwest (December 2021).

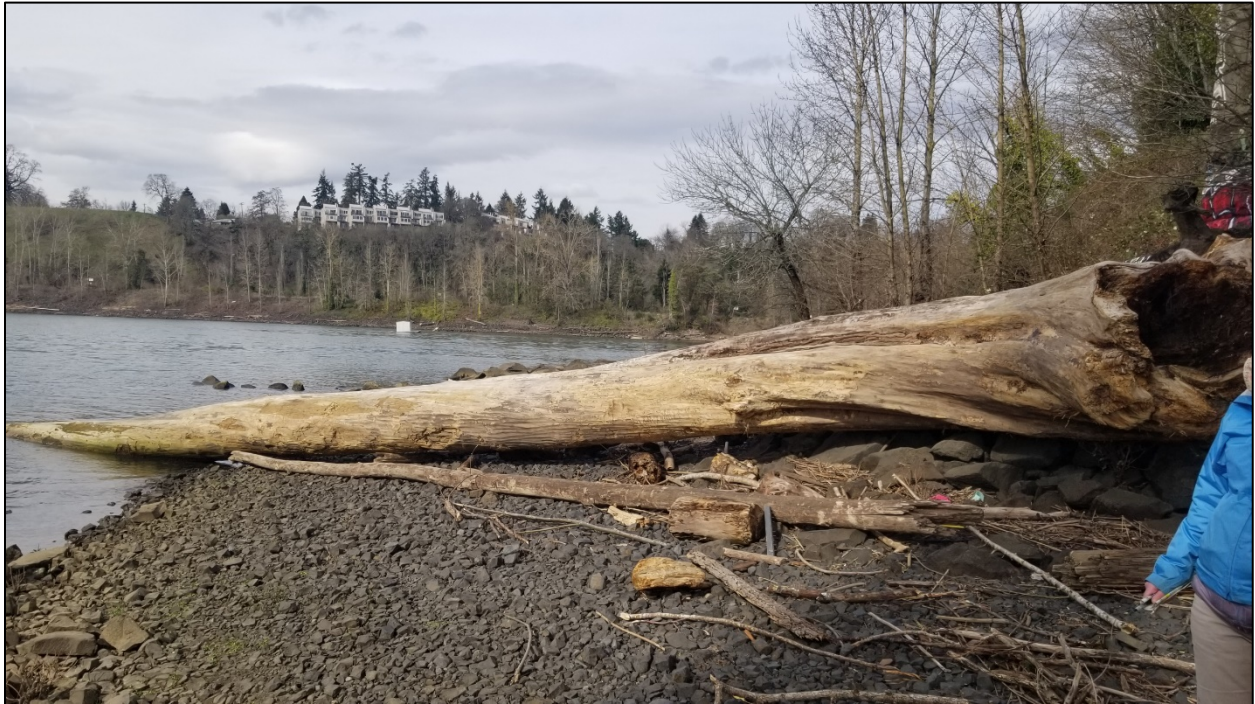
A lot of wood debris (trunks, branches, and small sticks) was deposited on the Willamette River shoreline after the recent rains in January and February 2021. Shoreline conditions are shown in Photographs 1 and 2. Trash and debris was removed from the Willamette River shoreline and the riparian area in January 2020, however small trash items have been washed up and deposited on the shoreline.

Photograph 1: Large tree trunk that washed up on shore at Willamette Cove and Willamette River shoreline junction beneath Burlington Northern Railroad lines. View facing northeast.

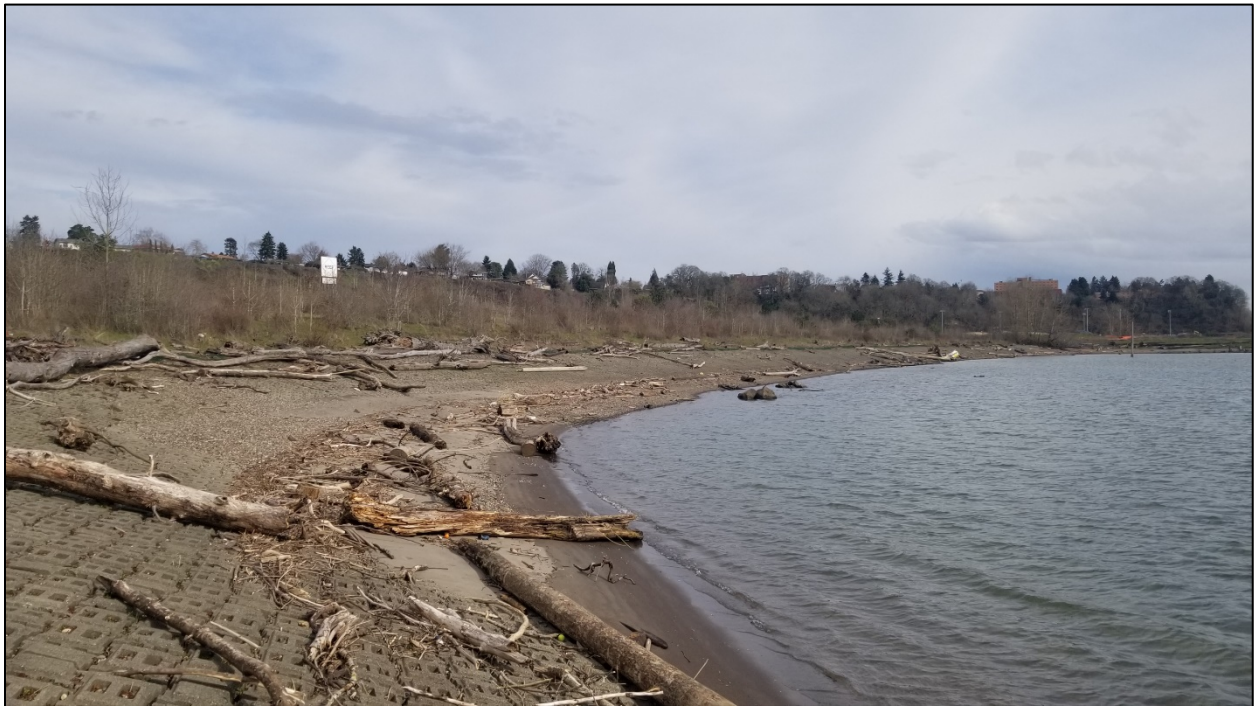
Photograph 2: Willamette River shoreline with lots of wood debris deposited on it. View facing southeast.

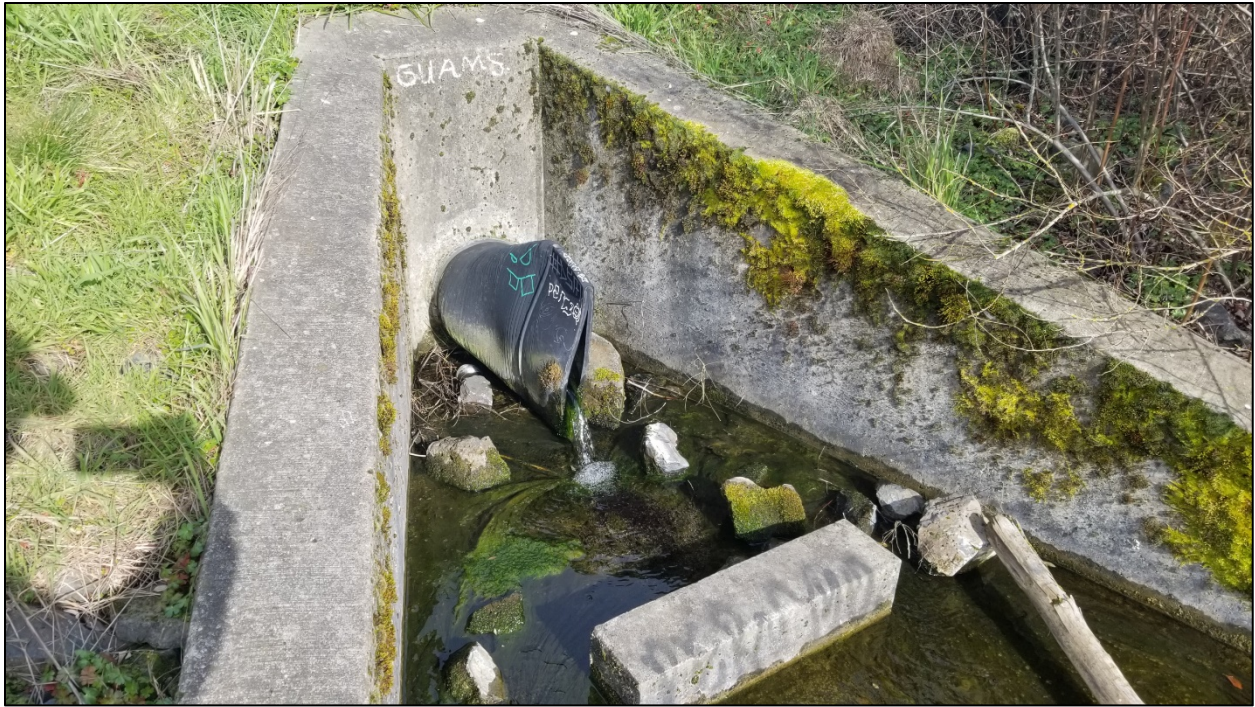
Stormwater discharge (Photograph 3) was occurring from the outfall at an estimated 5-8 gallons per minute. The outfall is in good condition. No change to the outfall armoring was observed since the last inspection. No repairs are planned and the armoring will continue to be monitored during the rainy season for signs of scouring or erosion.

Photograph 3: Stormwater outfall with approximately 5-8 gpm of flow. View facing southeast.

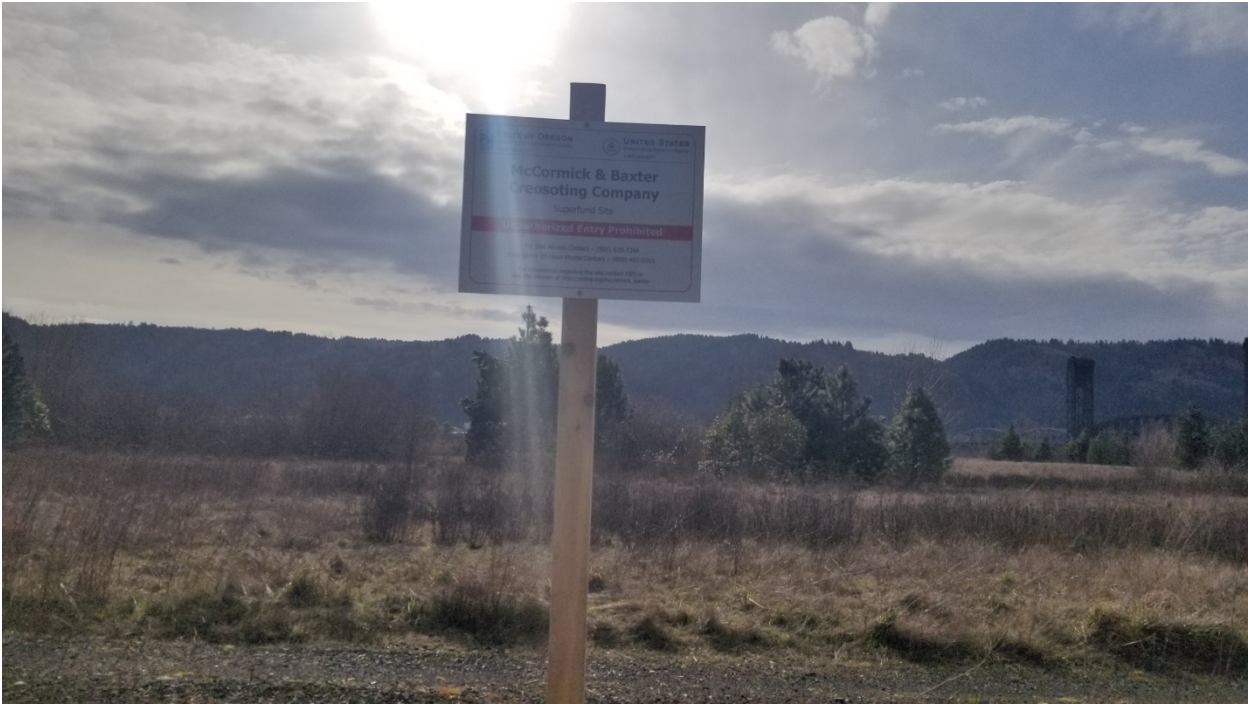
The down sign-posts identified during the previous site inspection were replaced during maintenance activities performed on 12/9/20 with the signs replaced on 1/22/21. The completed sign posts were observed by DEQ and functioning as designed (Photograph 6).

Photograph 6: Replaced sign and sign post by eastern perimeter fence. View facing west.

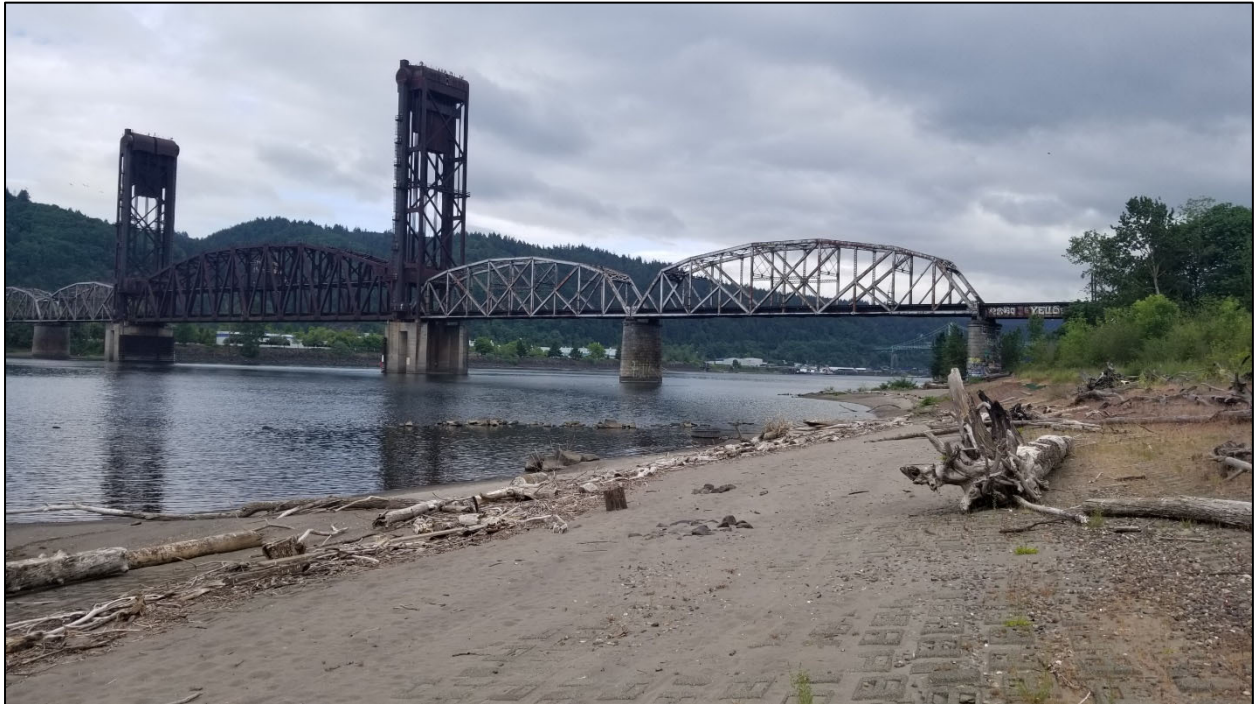
Abundant amounts of wood debris (trunks, branches, and small sticks) are present on the shoreline following the winter high river levels (photograph 1 and 2). Minor amounts of washed up or pedestrian deposited trash are present along the shoreline.

Photograph 1: Willamette River shoreline conditions south of the Burlington Northern Santa Fe Railroad lines. View facing northeast.

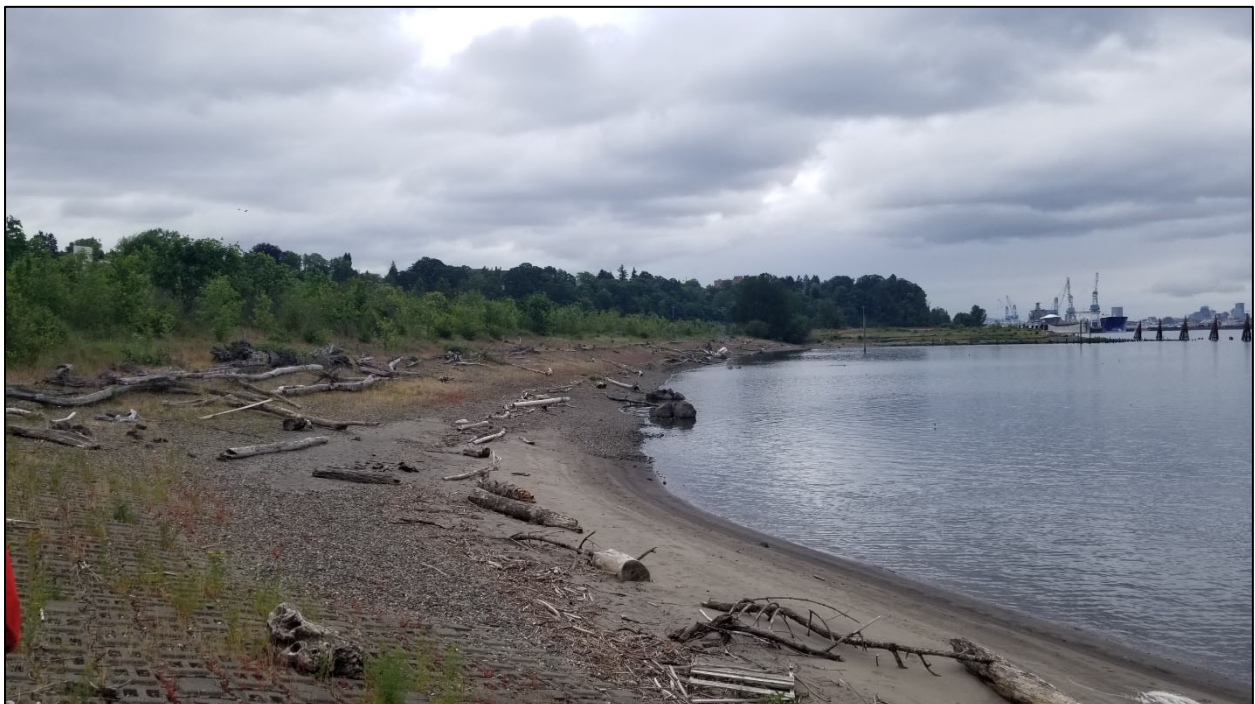
Photograph 2: Willamette River shoreline with lots of wood debris deposited on it. View facing southeast.

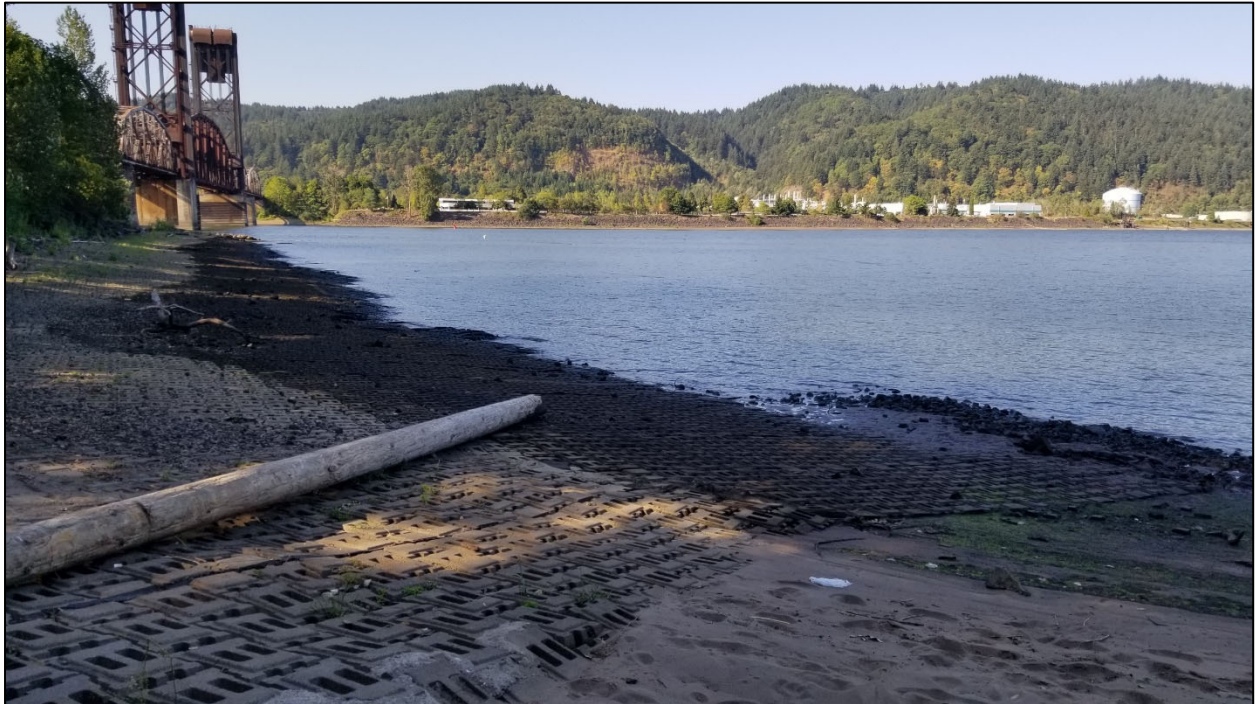
Large logs and woody debris continue to be present at or above the high tide line along the Willamette River shoreline. Tide levels were particularly low during the site inspection as in coincided with low tide and seasonally low river levels (Photograph 1). The ACB unconformities in Willamette Cover were able to be observed. Photographs 2 through 4 show several views of the buckled ACB causing the unconformities. An action item for Hart Crowser and DEQ will be to review records on ACB unconformities to evaluate if additional buckling has occurred since previous reporting and if repairs need to be made to this portion of the ACB armoring.

Photograph 1: Low tide and seasonally low river level conditions for the Willamette River in Willamette Cove.

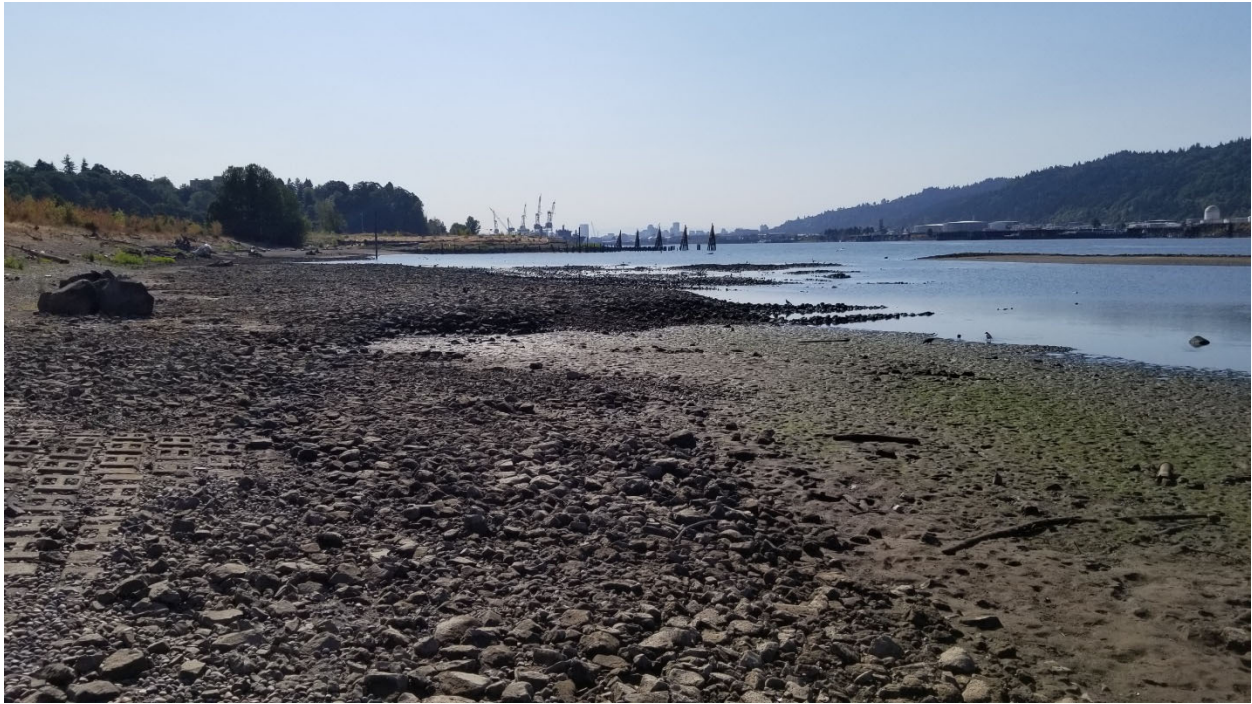
The tide level was low along the Willamette River shoreline and the tidal flats were exposed more than normal during the inspection (Photograph 5).

Photograph 5: Low-river level and exposed tidal flats along the Willamette River shoreline. View facing southeast.

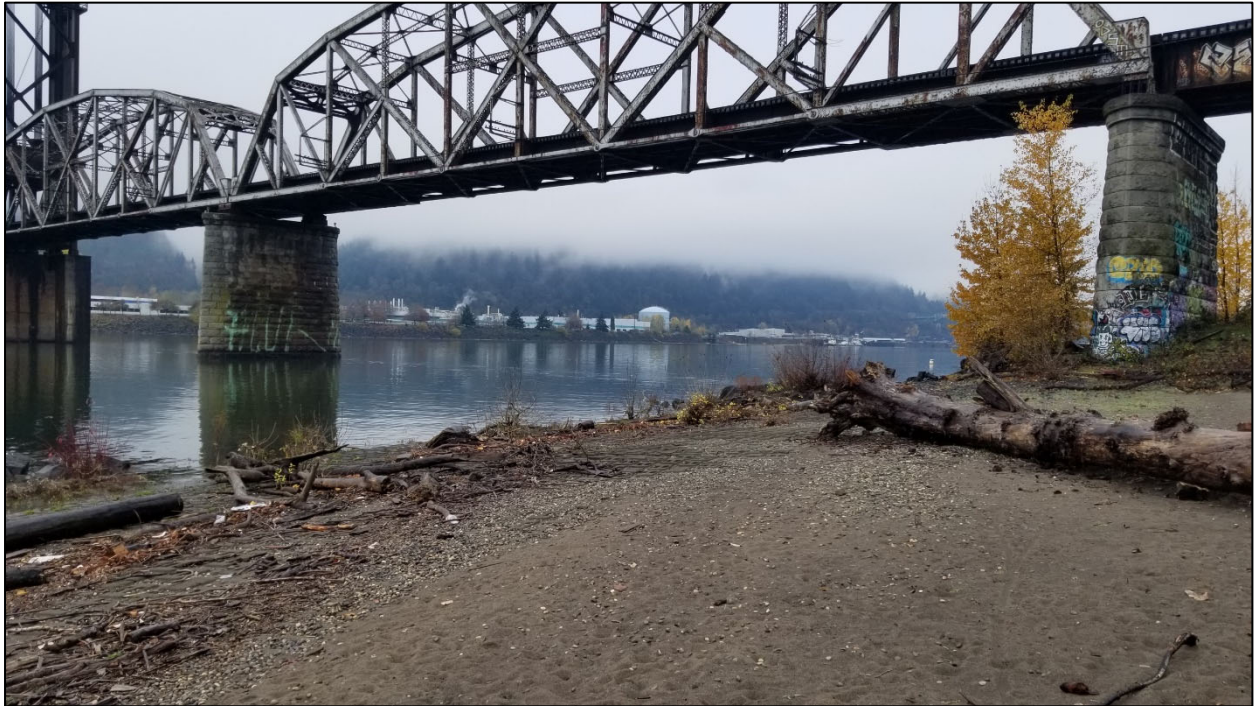
Several large rain events occurred in November that raised the river level (Photograph 1) and deposited lots of woody debris on the shoreline (Photograph 2). Compared to the summer, increased amounts of large woody debris (trunk and large branch size) were present at the high tide line and a lot of small woody debris pieces (smaller branches and logs) had accumulated at the low tide line.

Photograph 1: High tide water levels along the Willamette River shoreline. View facing northwest.

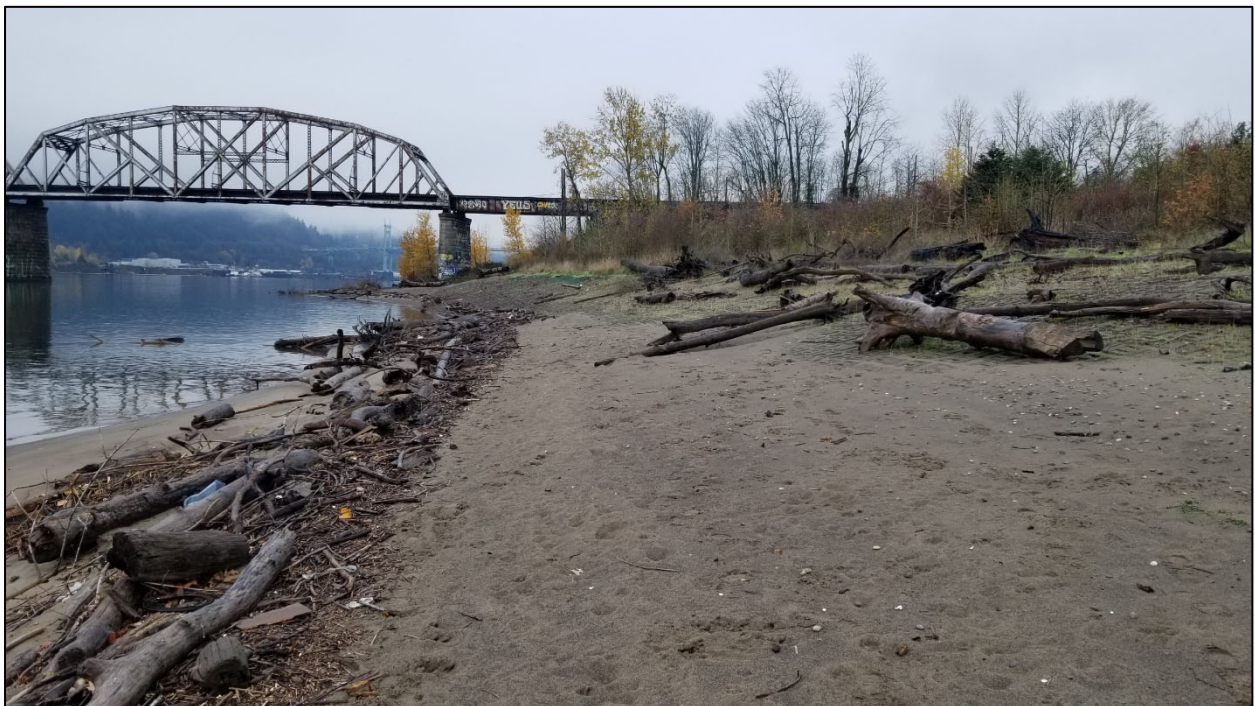
Photograph 2: Woody debris piled up on Willamette River shoreline after several rain events in November. View facing south.

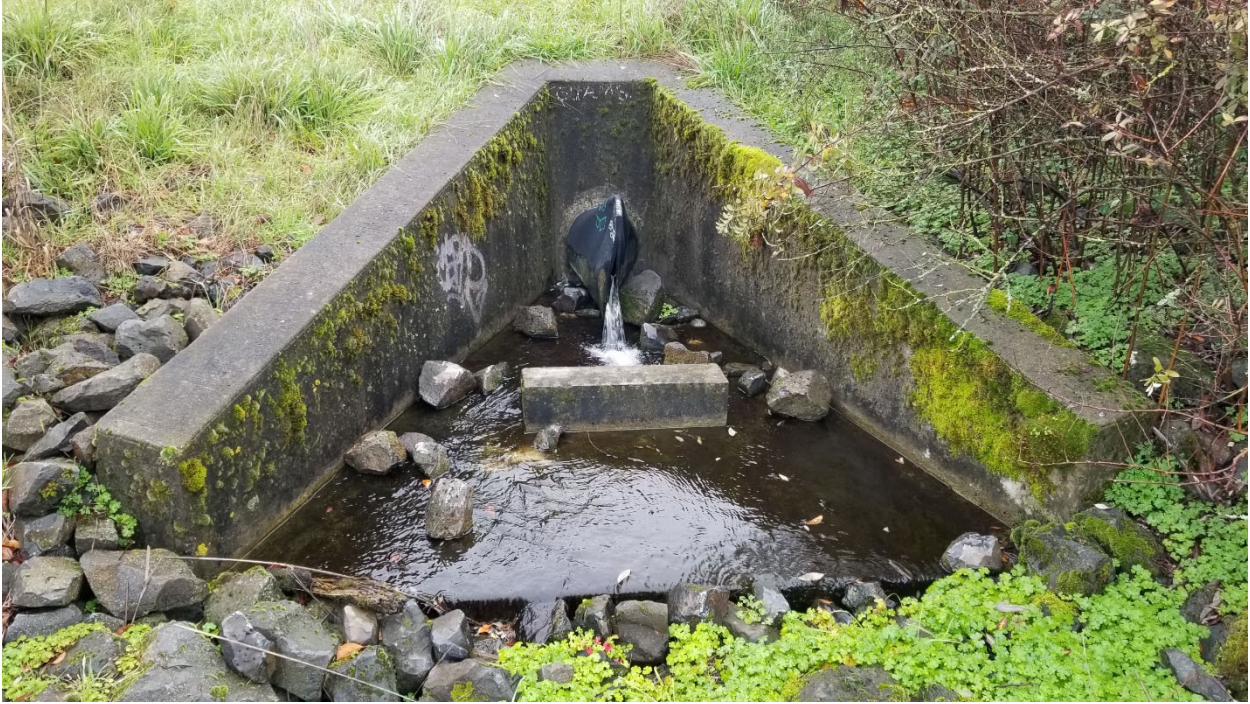
Photograph 3: Stormwater discharge through outfall. Estimated flow rate of 10 gallons per minute.
