**Operation and Maintenance Report
January 2021 to December 2021**

**McCormick & Baxter
Superfund Site
Portland, Oregon
ECSI Site No. 74**

Prepared for
**Oregon Department of
Environmental Quality**

May 6, 2022
0202315-000/003/01

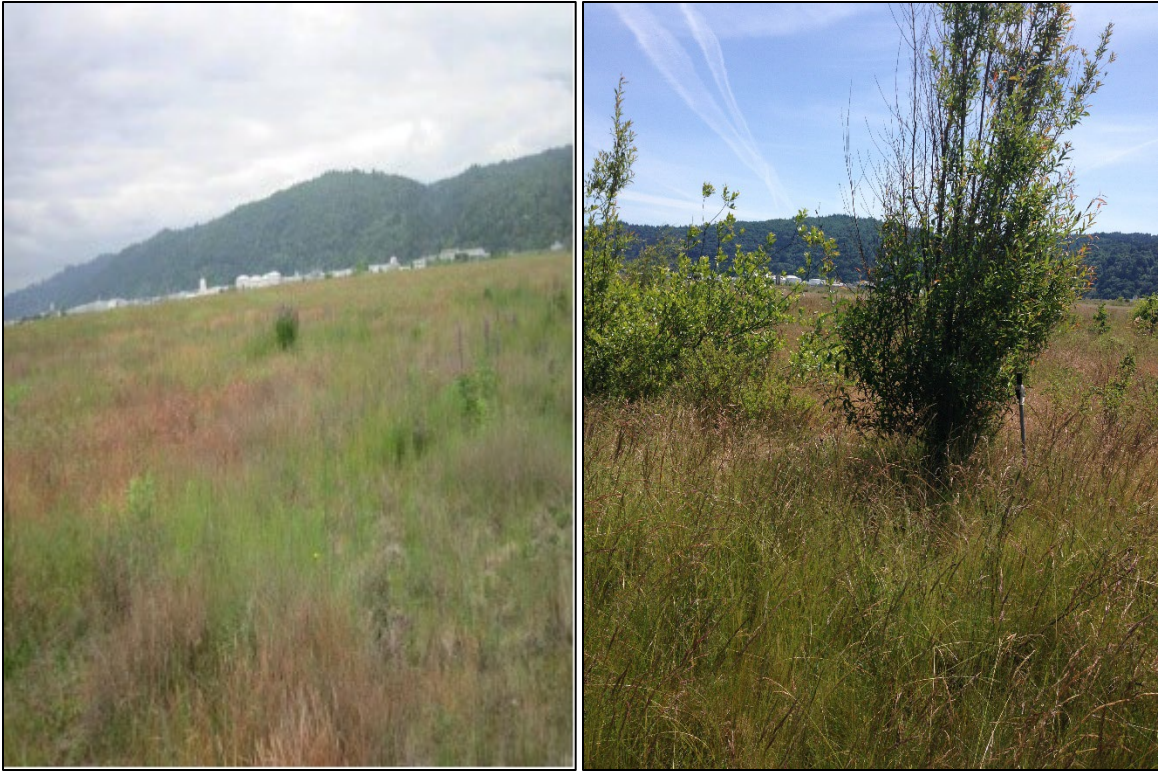
Photograph C1: Earthen cap and drainage swale in the foreground with the impermeable cap in the background. Taken looking south from Photograph Station 1 comparing baseline and conditions in 2014. (Left - June 2011, Right - June 2014).

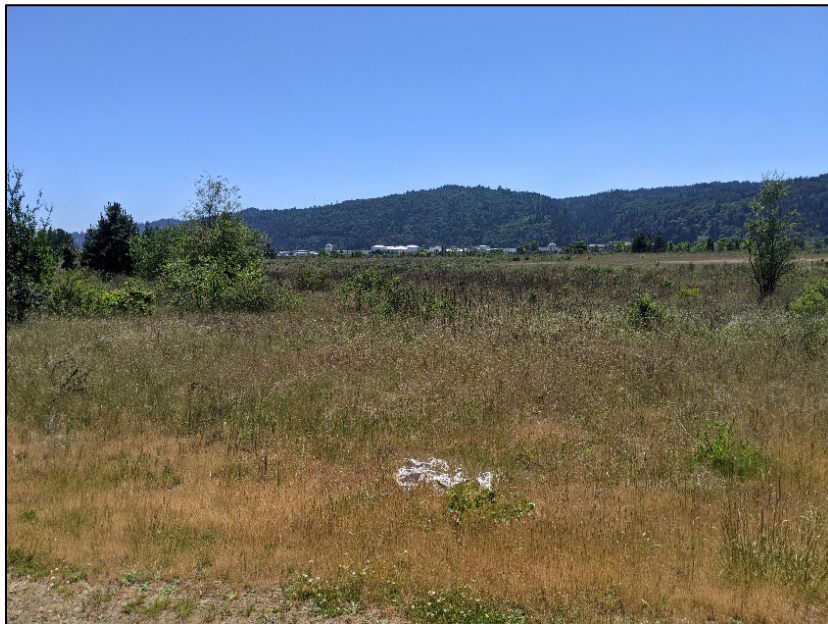
Photograph C2: Tree and shrub plantings on the earthen cap. Taken looking southeast from Photograph Station 2 (June 2021).

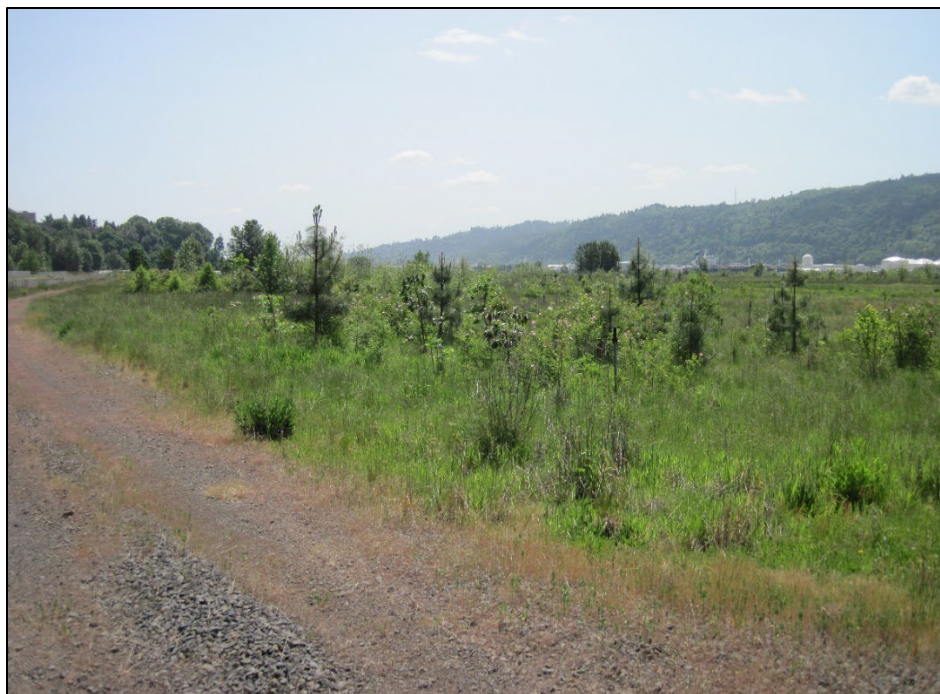
Photograph C3: Tree and shrub plantings on the earthen cap are healthy and spreading. Taken from Photograph Station 2 looking southeast (October 2012).

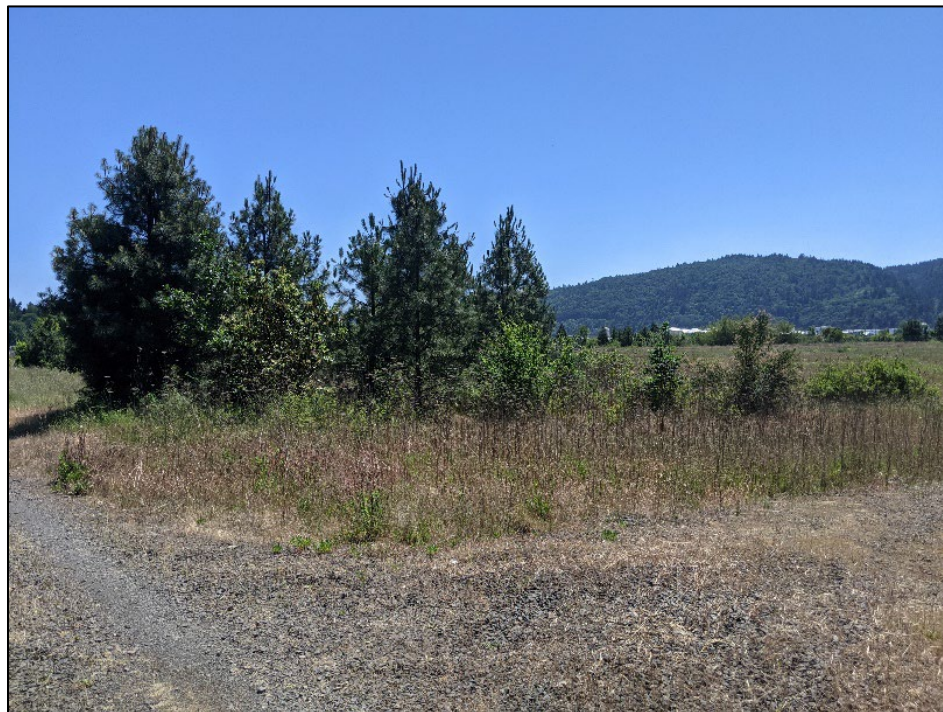
Photograph C4: Tree and shrub plantings on the earthen cap are healthy and spreading. Taken from Photograph Station 2 looking southeast (June 2021).

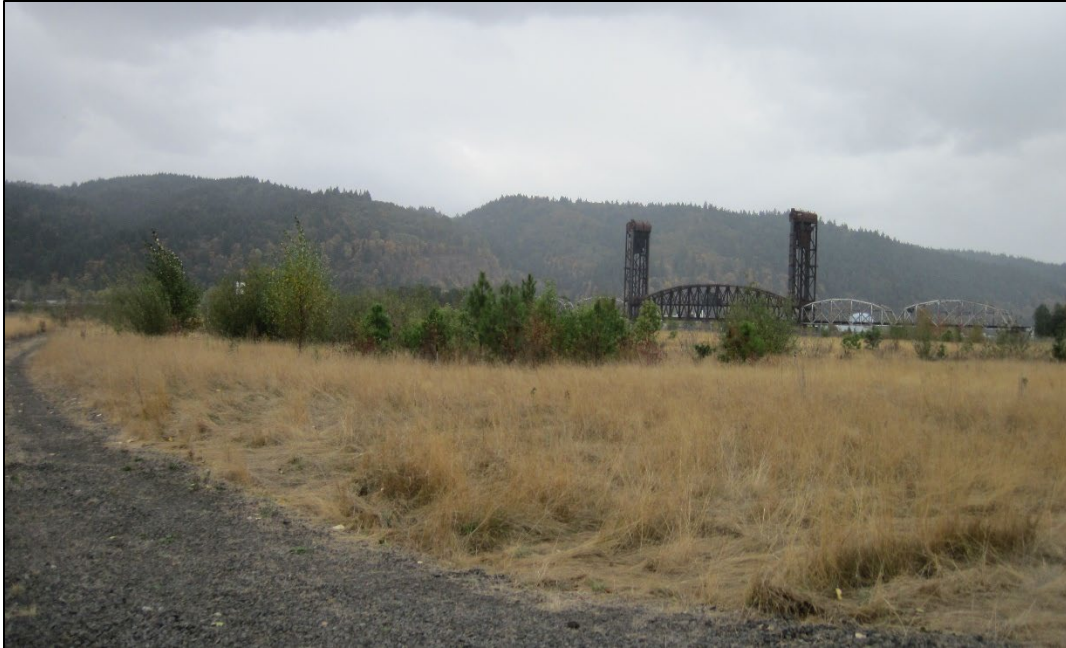
Photograph C5: Eastern edge of the earthen cap with perimeter road in foreground. Taken from Photograph Station 3 looking west (October 2012).

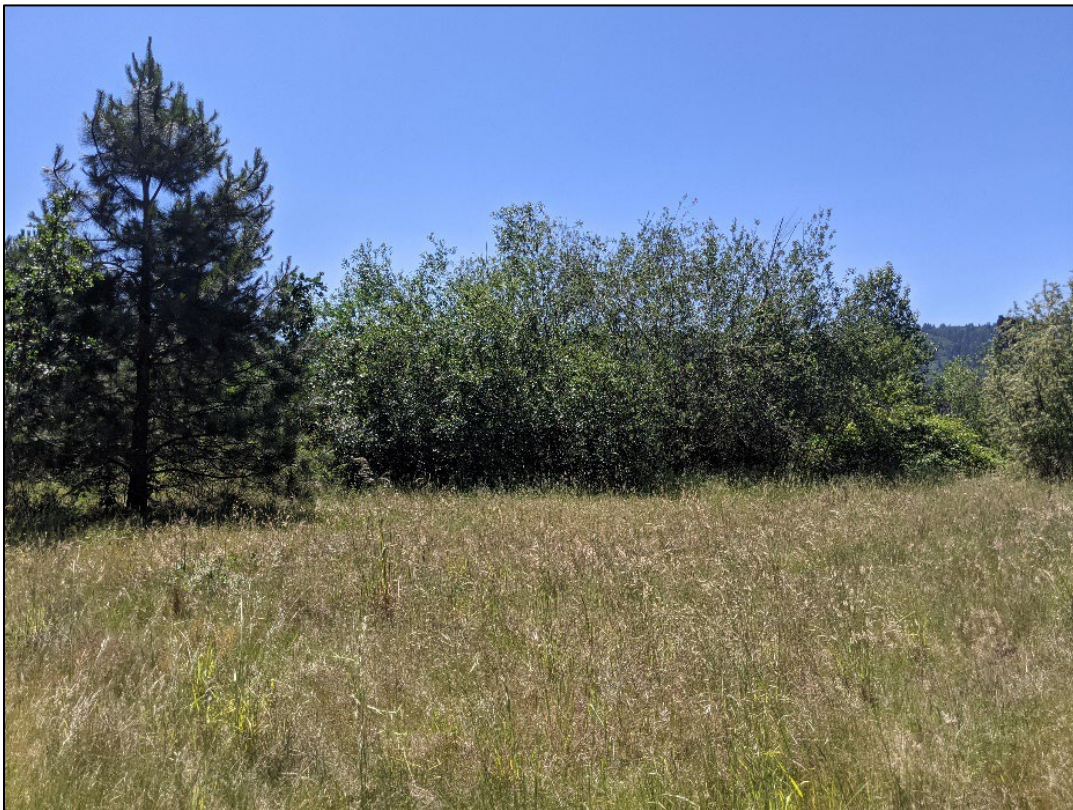
Photograph C6: Eastern edge of the earthen cap with perimeter road in foreground. Taken from Photograph Station 3 looking west (June 2021).

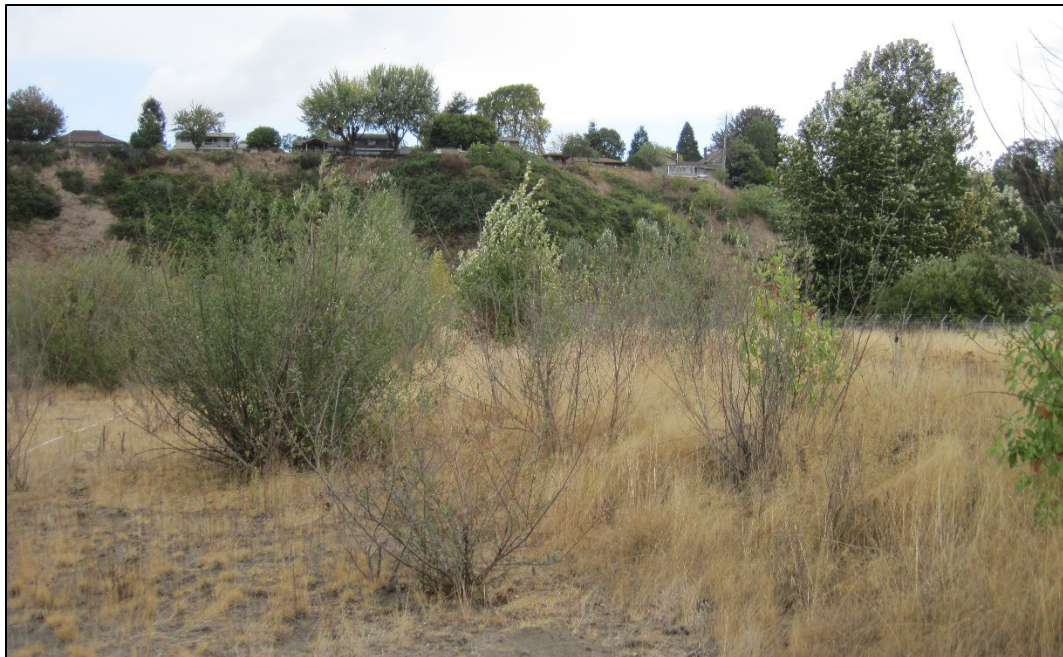
Photograph C7: Stormwater pond dominated by willow and alder. Taken from Photograph Station 4 looking northeast (October 2012).

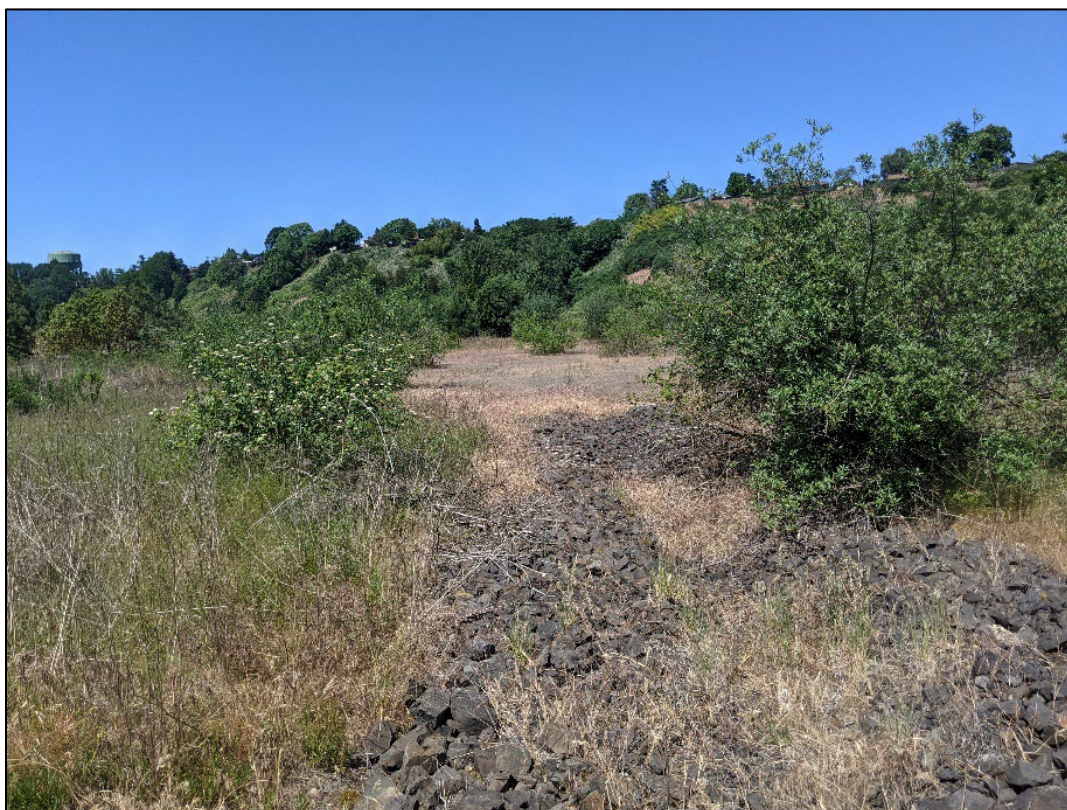
Photograph C8: Stormwater pond dominated by willow and alder. Taken from Photograph Station 4 looking northeast (June 2021).

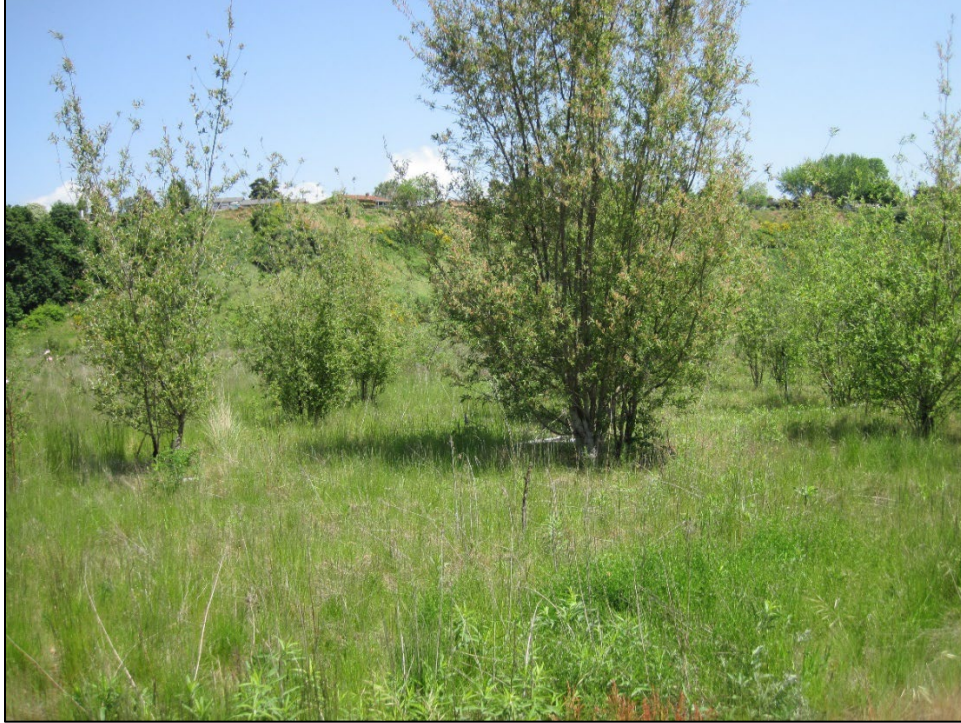
Photograph C9: Willow plantings on the earthen cap. Taken from Photograph Station 5 looking northeast (October 2012).

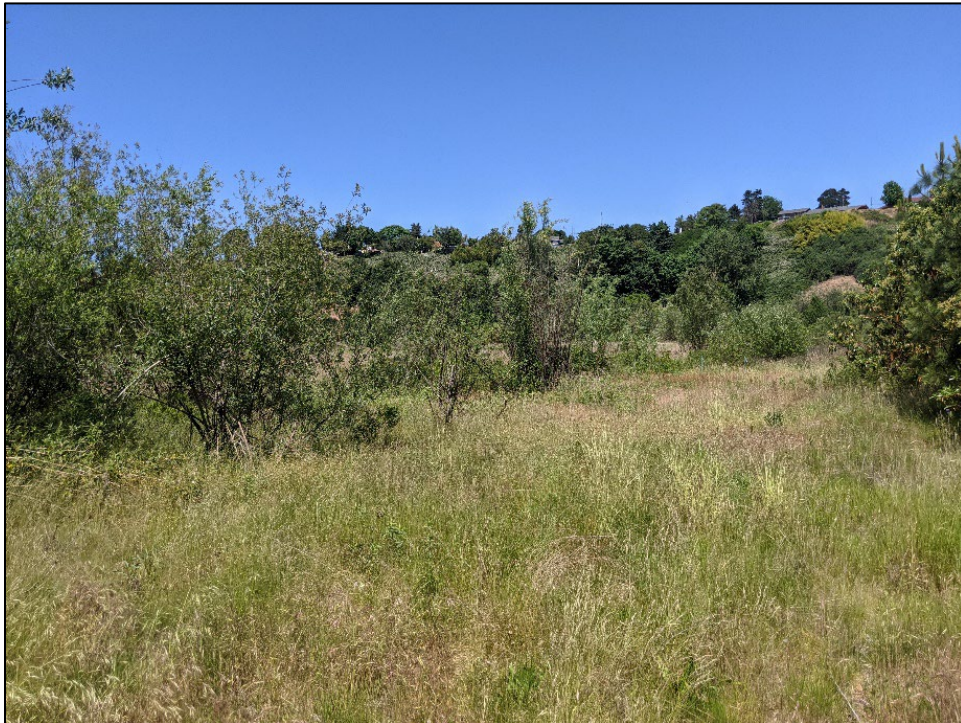
Photograph C10: Willow plantings on the earthen cap. Taken from Photograph Station 5 looking northeast (June 2021).

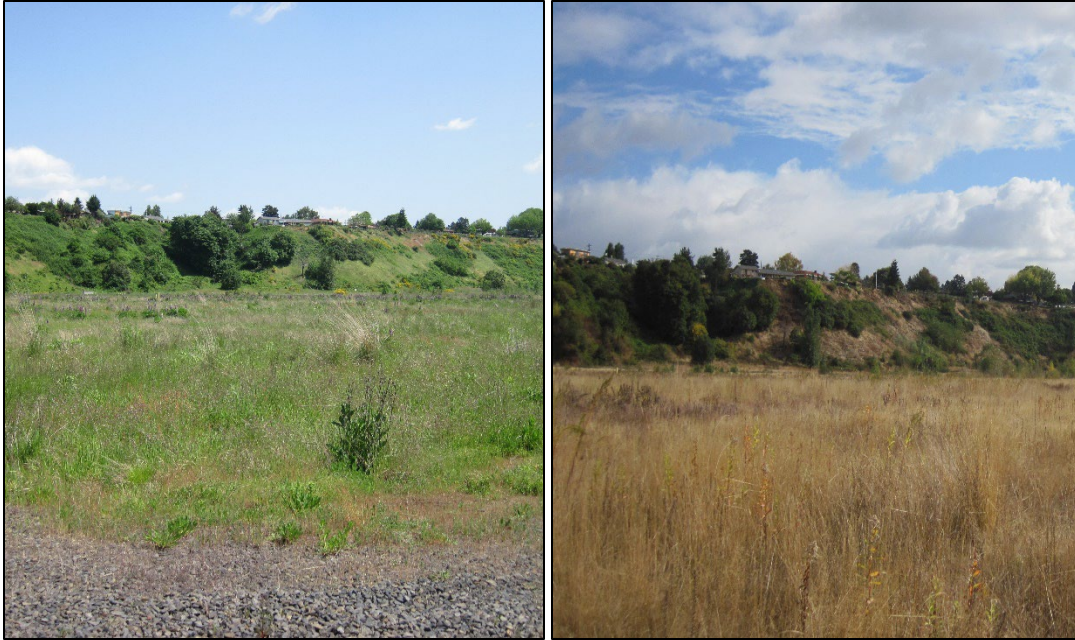
Photograph C11: Impermeable cap dominated by grasses and herbaceous vegetation in the early summer (left) and fall (right). Taken from Photograph Station 6 looking east (Left - May 2012; right - October 2012).

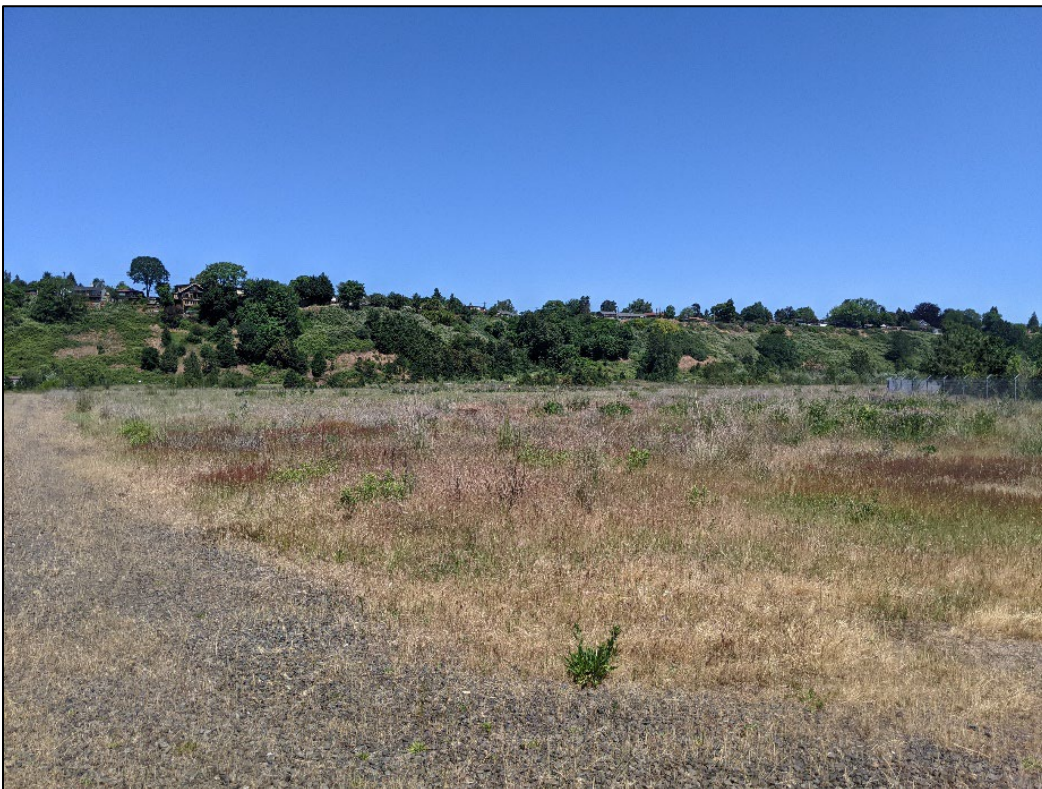
Photograph C12: Impermeable cap dominated by grasses and herbaceous vegetation. Taken from Photograph Station 6 looking east (June 2021).

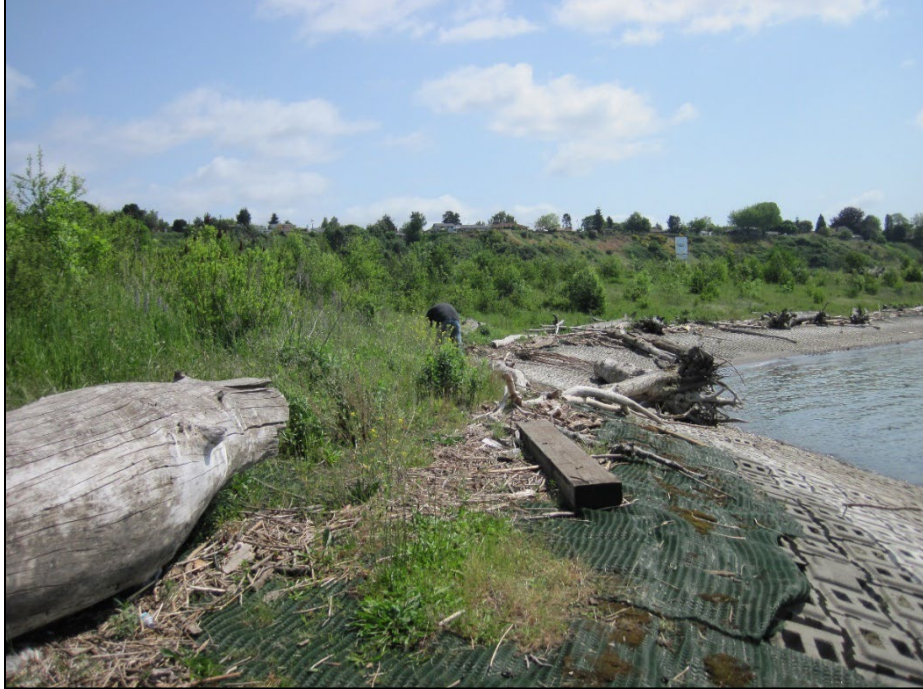
Photograph C13: Vegetation growth within the lower riparian component. Taken from Photograph Station 7 looking south (May 2012).

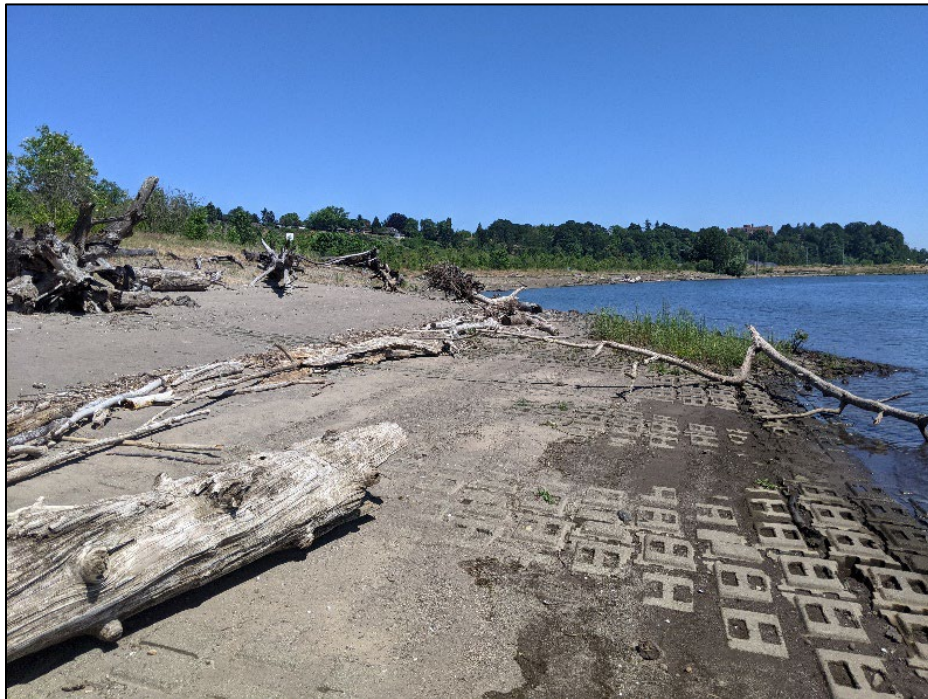
Photograph C14: Vegetation growth and wood debris within the lower riparian component and along the shoreline. Taken from Photograph Station 7 looking southeast (June 2021).

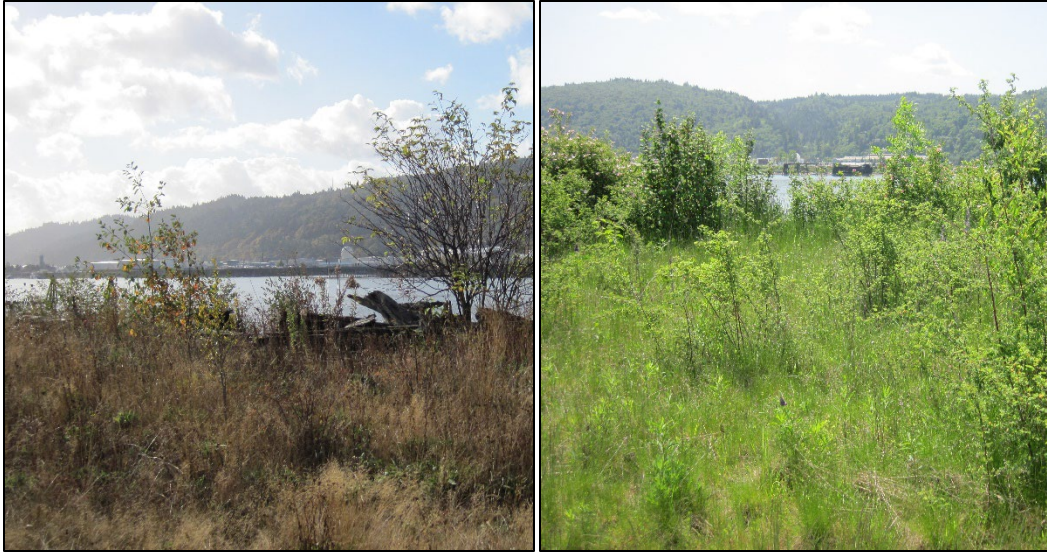
Photograph C15: Upper riparian component with trees, shrubs, and herbaceous plants. Taken from Photograph Station 8 looking southwest (Left - May 2012; right - October 2012).

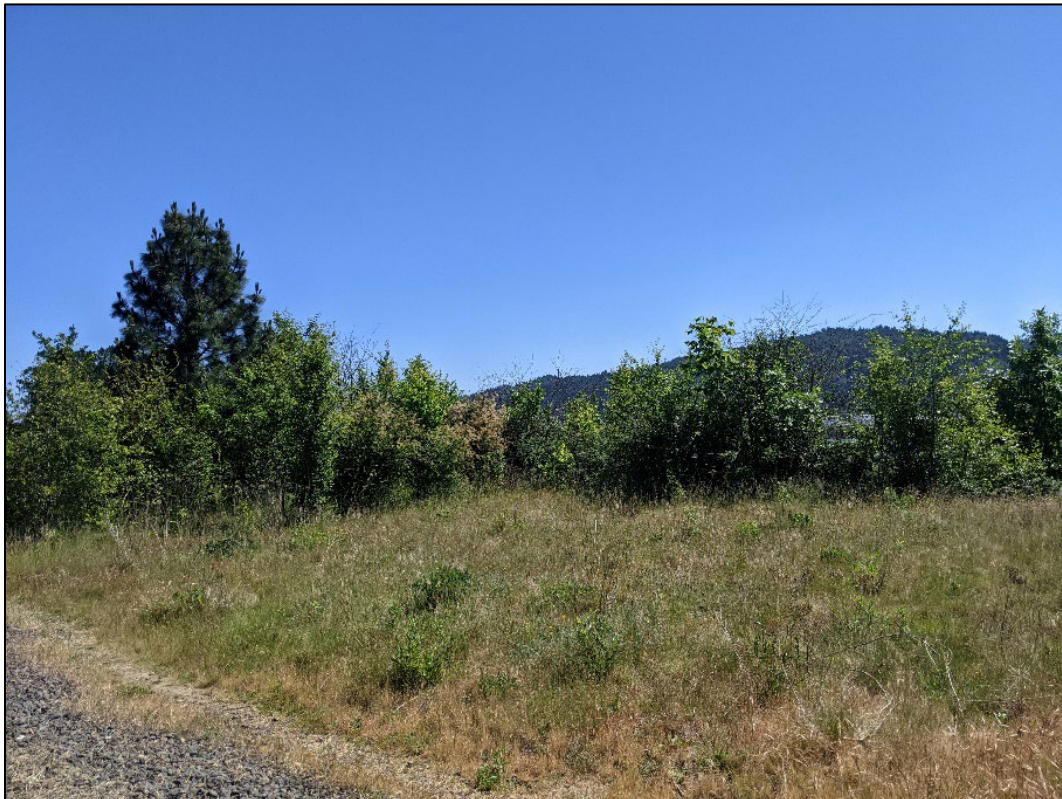
Photograph C16: Upper riparian component with trees, shrubs, and herbaceous plants. Taken from Photograph Station 8 looking southwest (June 2021).

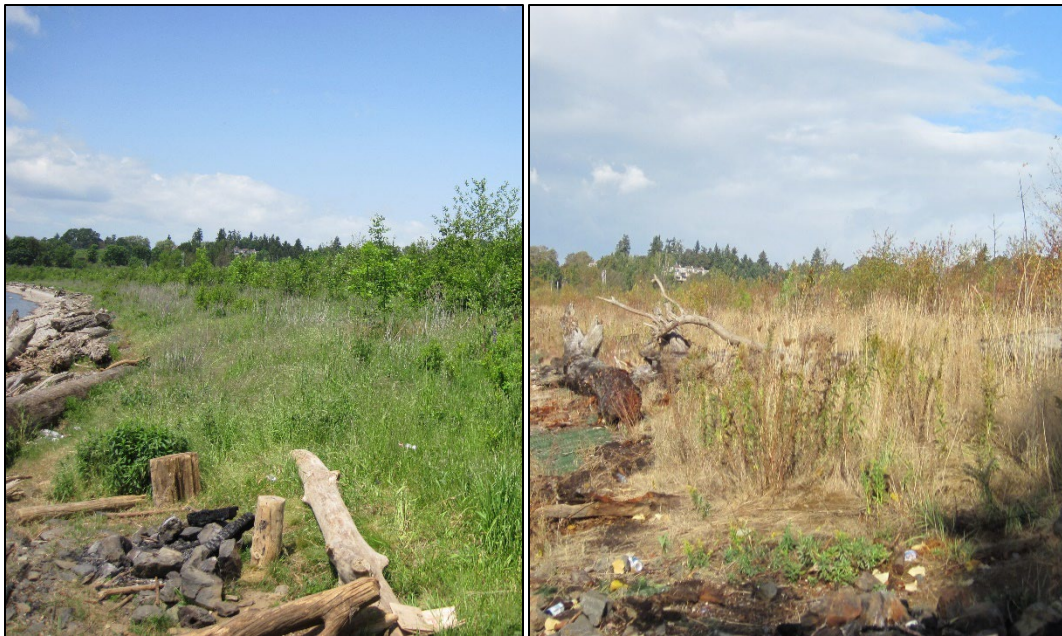
Photograph C17: Lower riparian component with large wood along the edge. Taken from Photograph Station 9 looking northwest (Left - May 2012; right - October 2012).

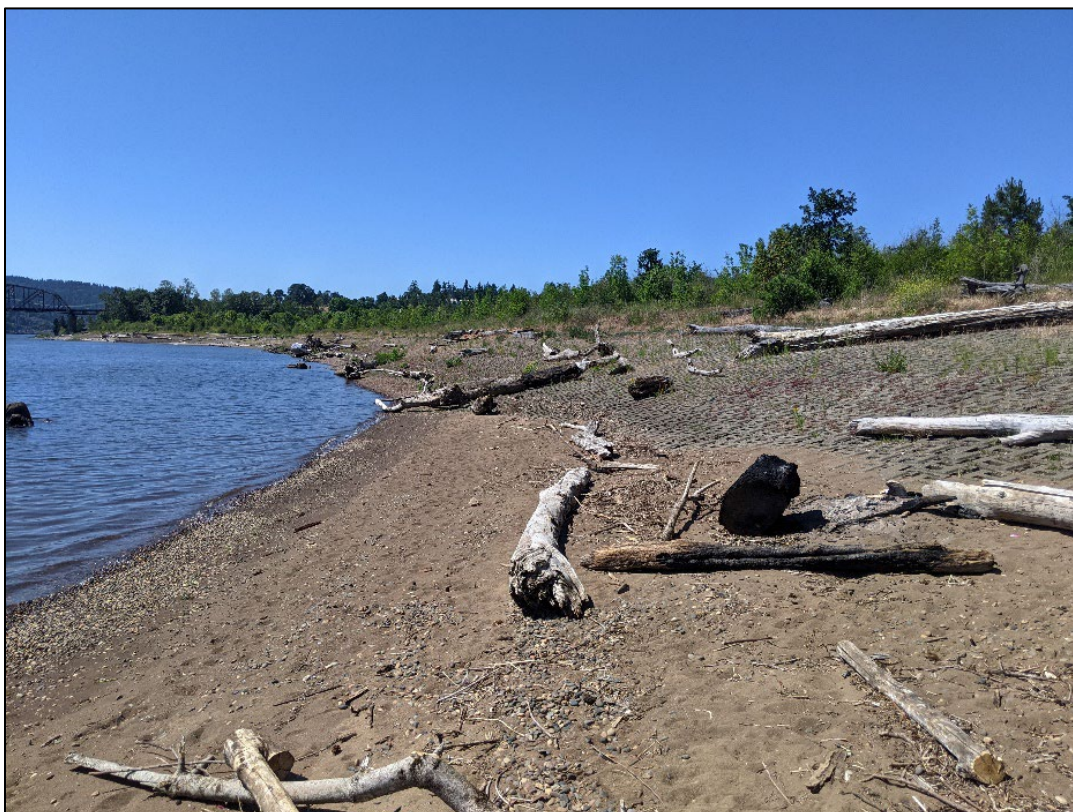
Photograph C18: Lower riparian component with large wood along the edge. Taken from Photograph Station 9 looking northwest (June 2021).
