Operation and Maintenance Report January 2018 to December 2018

McCormick and Baxter Superfund Site

Portland, Oregon ECSI Site No. 74

March 29, 2019 150-002-005/Task 3

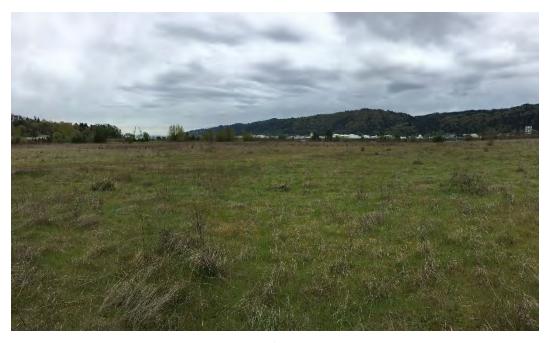
Photograph 10 – Looking south on central portion of upland soil cap in April 2018.

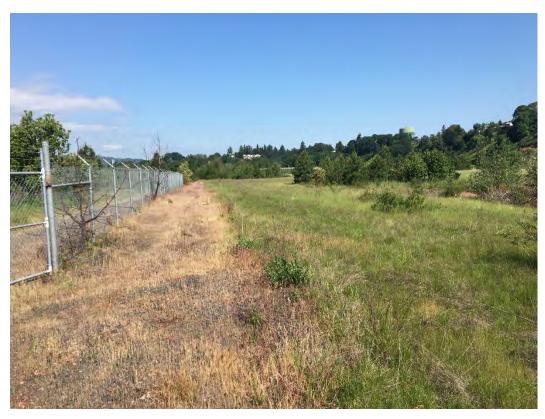
Photograph 11 – Looking northwest on southern portion of upland soil cap in May 2018.

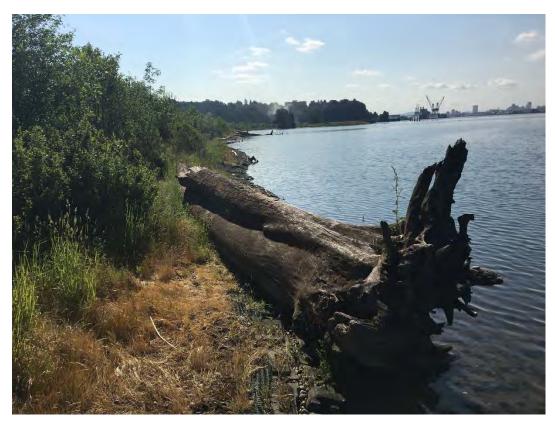
Photograph 17 – High river level observed at the middle portion of the riparian area in May 2018.

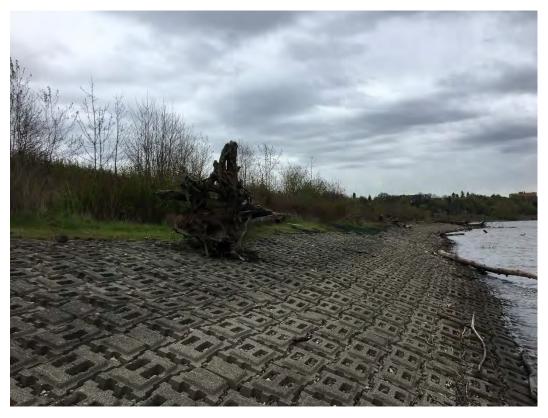
Photograph 18 – Middle portion of the ACB armoring in April 2018.

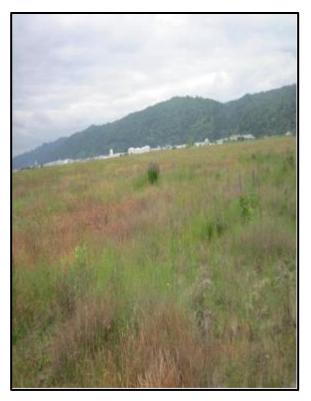
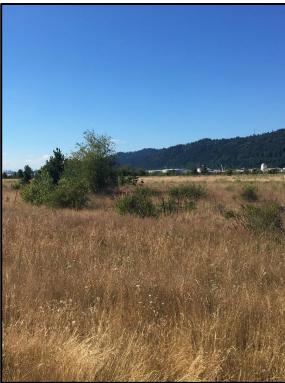
Photograph 1 – Earthen cap and drainage swale in the foreground with the impermeable cap in the background. Taken looking south from Photo Station 1 comparing baseline and current conditions (Left - June 2011; Right - June 2018).

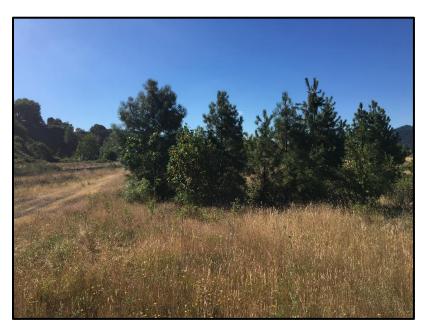
Earthen Cap Component. Tree and shrub plantings on the earthen cap were healthy and growing well (Photographs 2, 3, and 5, Appendix C). Ponderosa pine, Oregon grape, elderberry, lupine, and serviceberry continue to perform the best. Nootka rose dominated the northwest portion of the earthen cap. Trees and shrubs ranged in height from approximately 6 to 15 feet. Herbaceous species provided full coverage of the ground. During our June 2018 site visit, gumweed, mullein, and goldenrod and various grasses were frequently observed throughout the earthen cap. No indications of significant stress were observed, and oak tress appeared to have recovered following recent dry summers. Localized areas of moss were observed in the herbaceous layer. Scattered areas of noxious weeds still persist and are being monitored. Future herbicide applications may be recommended.

Photograph 2 - Tree and shrub plantings on the earthen cap. Taken looking southeast from Photo Station 2 (June 2018).

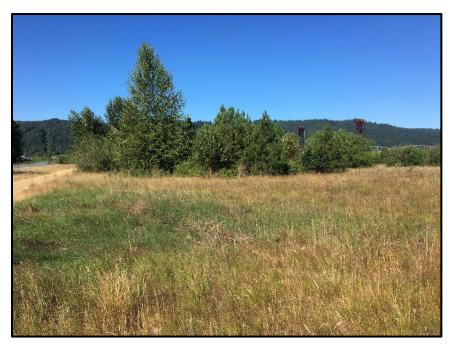
Photograph 3 – Eastern edge of the earthen cap looking toward the drainage swale. Taken looking west from Photo Station 3 (June 2018).

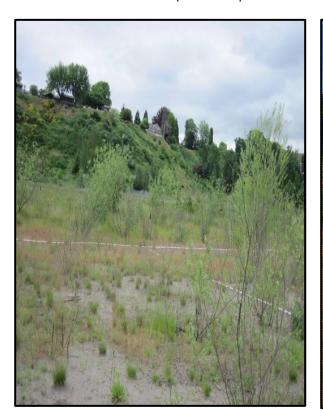
Stormwater Retention Pond/Drainage Swale Component. Vegetation in the drainage swale area are fairly well established and appeared healthy in 2018 (Photograph 4, Appendix C). Various grasses make up nearly all of the groundcover in the retention pond; however, a few bare areas were observed. Red-osier dogwood volunteers were observed within the northwest portion of the swale. Sitka willow had grown to 10 to 15 feet tall, and the Piper's willow were 6 to 8 feet tall. Volunteer cottonwoods were observed to range from 20 to 25 feet tall. Alder and willow were present and expanding around the periphery of the stormwater retention pond. In the past, during water stressed years like 2017, dead shrubs were observed.

Photograph 4 – View of stormwater pond. Willow and alder have increased in size, although most of the pond remains barren or vegetated with grasses. The irrigation system was removed in 2015. Taken looking northeast from Photo Station 4 comparing baseline and current conditions (Left - June 2011; Right - June 2018).

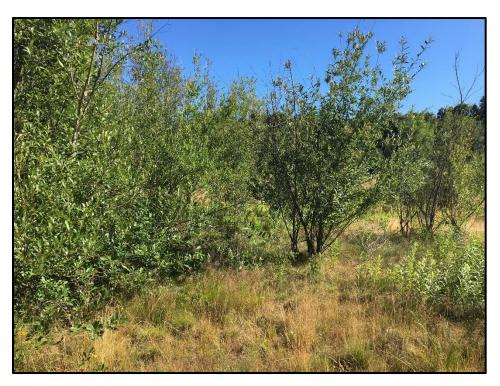
Photograph 5 – Tree plantings on the earthen cap. Taken looking north from Photo Station 5 (June 2018).

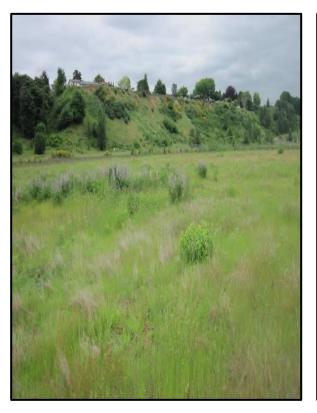
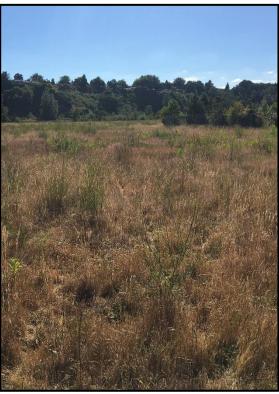
Impermeable Cap Component. The grassland species on the impermeable cap provided excellent coverage of the ground (Photograph 6, Appendix C). Gumweed was observed along the southwestern edge of the impermeable cap and provides increased diversity in this area. The remaining grasses and forbs were thriving, and no issues were noted in 2018.

Photograph 6 – Impermeable cap dominated by grasses and herbaceous vegetation. Baseline photograph on the left taken looking east from Photo Station 6 (Left – June 2011; Right – June 2018).

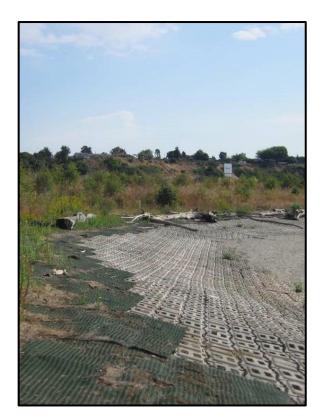
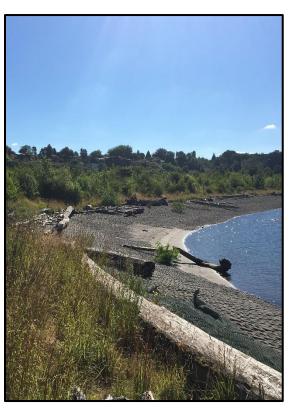
Large driftwood continues to accumulate along the shoreline to the middle of the bank near the break between the upper and lower components (Photographs 7 and 9, Appendix C). This large driftwood provides habitat for birds, small mammals, and other wildlife using this portion of the site.

Photograph 7 – Vegetation growth and wood debris within the lower riparian component and along the shoreline. Taken looking southeast from Photo Station 7 comparing baseline and current conditions. (Left - September 2011; Right - June 2018)

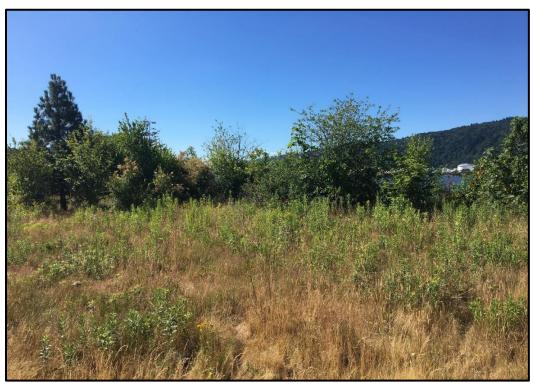
Photograph 8 – Upper riparian component with native trees and shrubs performing well. Taken looking southwest from Photo Station 8 (June 2018).

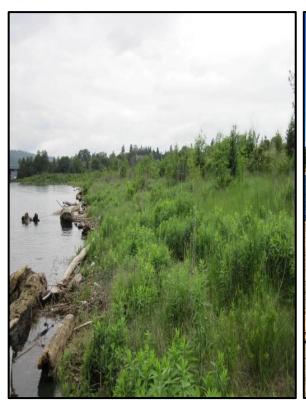
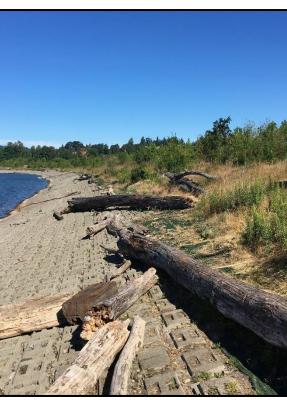
Photograph 9 – Lower riparian component with large wood debris along the edge. Taken looking northwest from Photo Station 9 comparing baseline and current conditions. (Left - June 2011; Right – June 2018)
