Operation and Maintenance Report January 2017 to December 2017

McCormick and Baxter Superfund Site Portland, Oregon ECSI Site No. 74

Prepared forOregon Department of
Environmental Quality

March 29, 2018 15670-10/Task 4

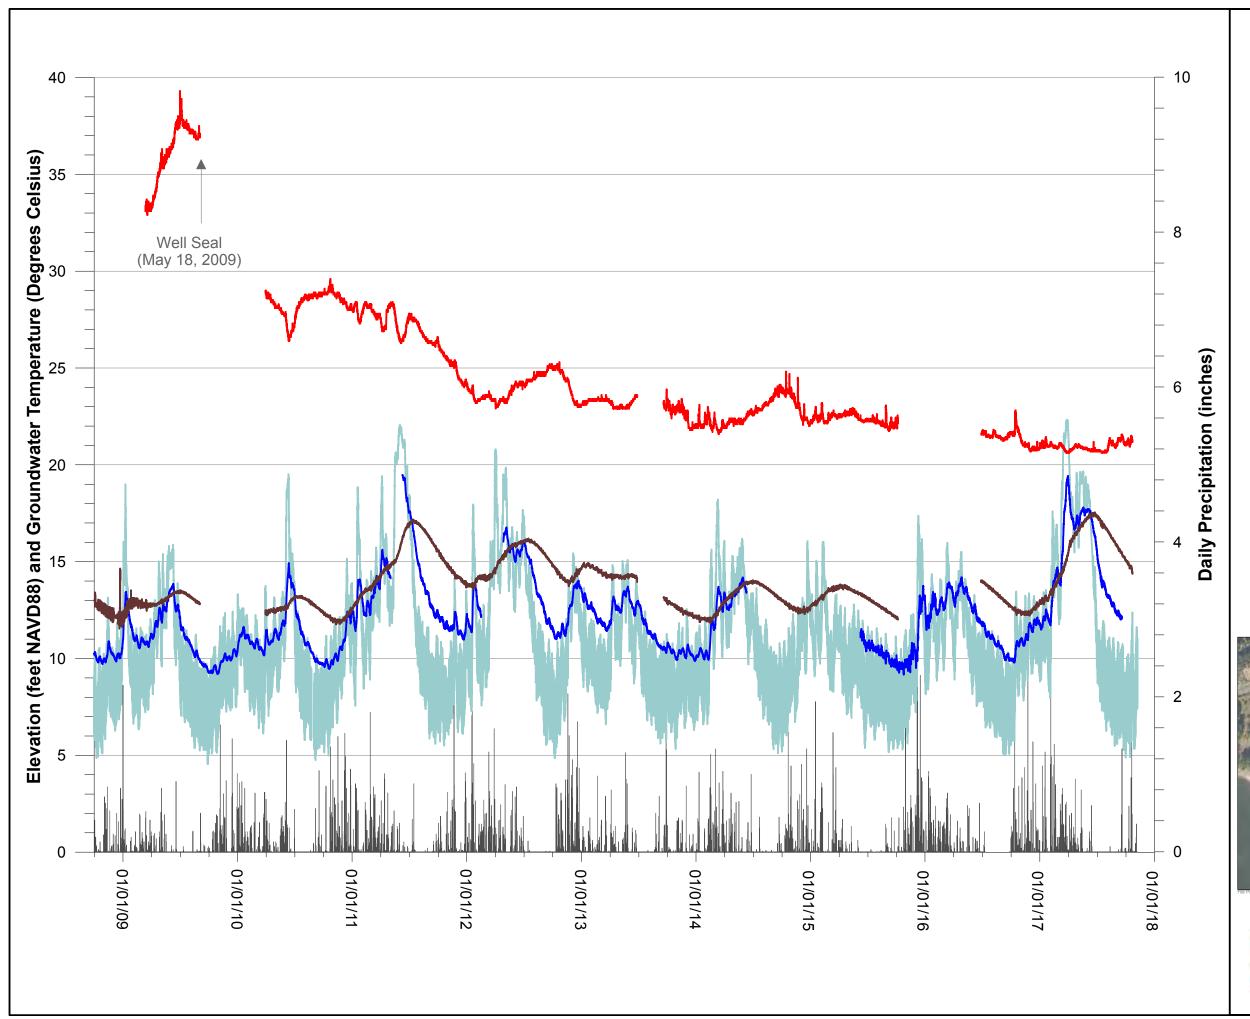
Figure 4-6: 2008 to 2017 Groundwater Temperature in Montoring Well EW-1s and Groundwater Elevations Monitoring Wells MW-36s and EW-1s

The muted or nonexistent response of interior shallow wells compared with the deep zone wells suggests a clear hydraulic disconnect between the shallow aquifer within the barrier wall and the deeper water-bearing zones. The location where the response is greatest, but still significantly muted, is in well MW-36s (Figures 4-6 through 4-9), where a hydraulic connection exists at the base of the barrier wall. While a muted response of well MW-36s to changes in daily river stage elevation is still observed, water levels in the shallow interior wells MW-44s and EW-1s are virtually nonresponsive to the daily changes in the Willamette River stage (Figures 4-10 and 4-11 for MW-44s, and Figures 4-6 and 4-7 for EW-1s). This reflects the presence of a confining silt layer between the shallow and intermediate zones near wells MW-44 and EW-1s.

Breaks in transducer data are the result of removal for calibration, removal for well modification, or a transducer was not collecting accurate pressure readings.

Groundwater elevation manually adjusted 0.25 ft up between 17:00 on May 6, 2010 and 14:00 on June 15, 2010 due to apparent displacement from field activities.

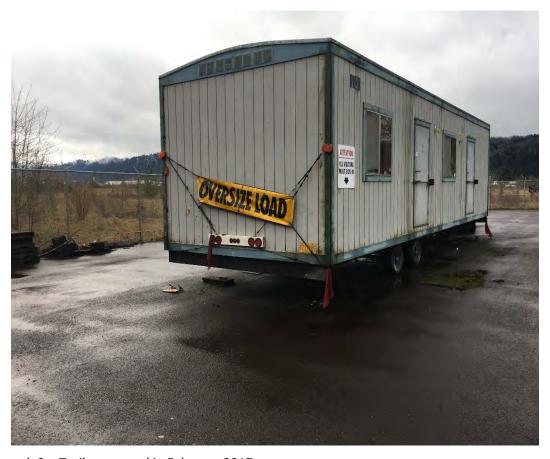
Following the July 20, 2017, site inspection, burrows were filled around the perimeter fence. Additional site infrastructure activities were conducted. The power to the trailers was disconnected and the alarm system removed on January 26, 2017. Oregon Demolition removed and took title to the two job trailers, which were deteriorating and obsolete, on February 9, 2017 (Photograph 2; Appendix A). The backflow preventer on the waterline was tested on September 15, 2017.

Photograph 2 – Trailer removal in February 2017.

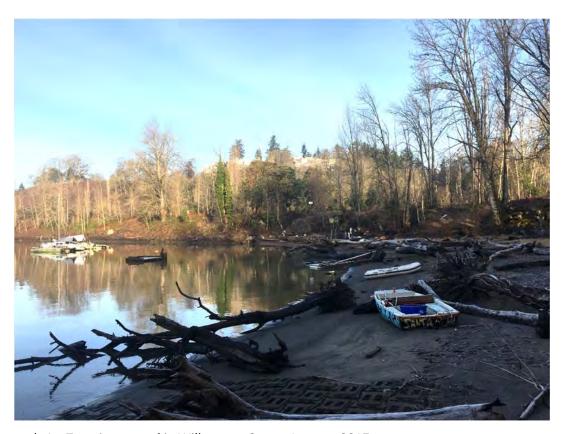
The shoreline along the site and in the Willamette Cove is accessible and is used by the public for various forms of recreation. Throughout 2017, shoreline trash and graffiti were observed, including scattered car parts above the Riparian Area. Numerous dilapidated boats (used as dwellings) were also seen anchored in the Willamette Cove during every site visit (Photograph 4, Appendix A). Boats were not observed to be anchored on the sediment cap during site inspections. No effects to the sediment cap were observed from mooring or from physical contact with these boats on the sediment cap. The US Coast Guard and Oregon State Marine Board rules prohibit anchoring on the sediment cap.

Photograph 4 – Transient vessel in Willamette Cove – January 2017.

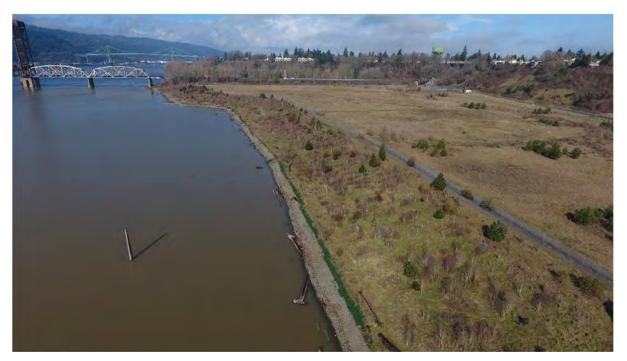
Photograph 5 – Looking north at riparian area on February 23, 2017.

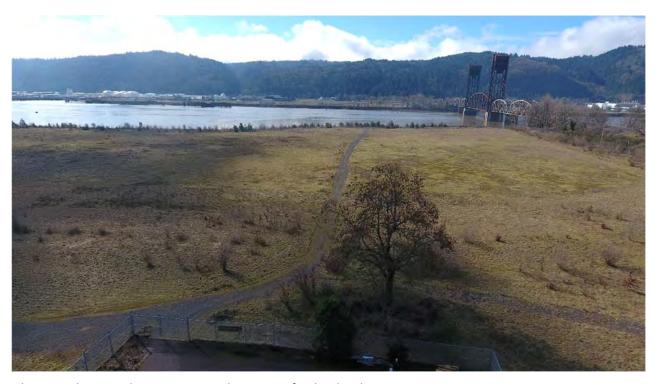
Photograph 6 – Looking east at north section of upland soil.

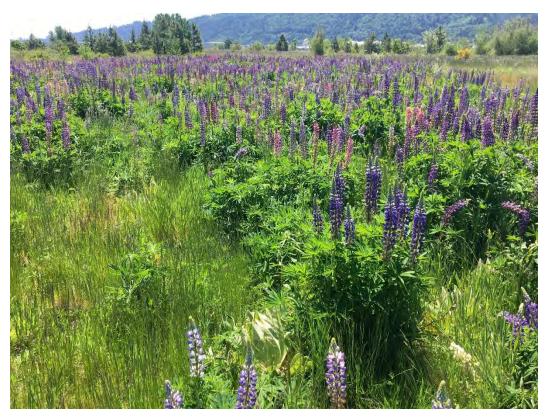
Photograph 7 – Looking southeast at lupine on central portion of upland soil cap in May 2017.

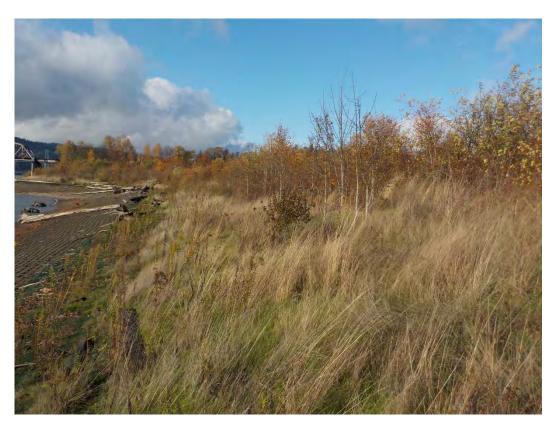
Photograph 10 – Looking south at the riparian area observed during the fall vegetation inspection.

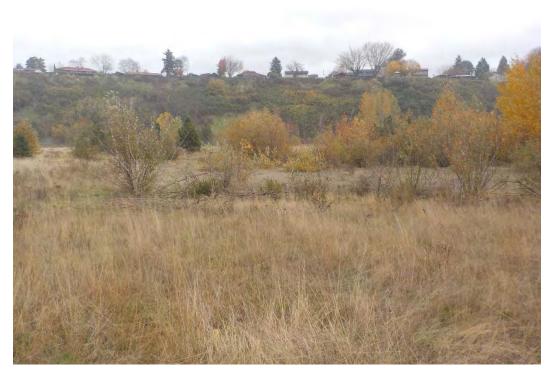
Photograph 12 – Detention pond in October 2017.

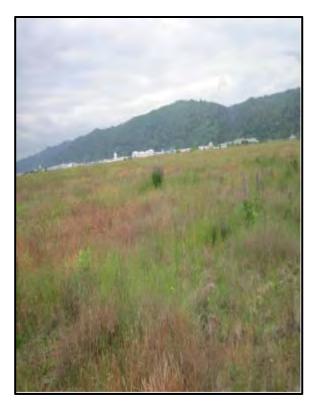
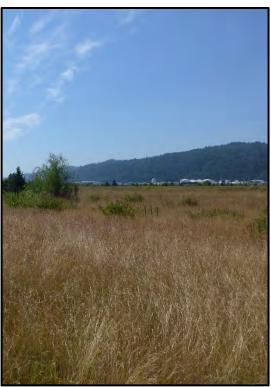
Photograph 1 – Earthen cap and drainage swale in the foreground with the impermeable cap in the background. Taken looking south from Photograph Station 1 comparing baseline and current conditions. (Left - June 2011; Right - June 2017)

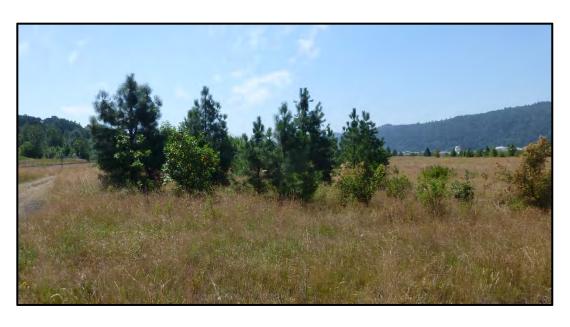
Earthen Cap Component. Tree and shrub plantings on the earthen cap were healthy and growing well (Photographs 2, 3, and 5, Appendix C). Ponderosa pine, Oregon grape, elderberry, lupine, and serviceberry continue to be performing the best. Nootka rose dominated the northwest portion of the earthen cap. Trees and shrubs ranged in height from approximately 6 to 15 plus feet. Herbaceous species provided full coverage of the ground. During our June 2017 site visit, gumweed, mullein, and goldenrod and various grasses were frequently observed throughout the earthen cap. No indications of significant stress were observed and oak tress appear to have recovered following recent dry summers. Localized areas of moss were observed in the herbaceous layer. Scattered areas of noxious weeds continue to be observed, but recent herbicide applications have been effective at reducing the weed density.

Photograph 2 - Tree and shrub plantings on the earthen cap. Taken looking southeast from Photograph Location 2. (June 2017)

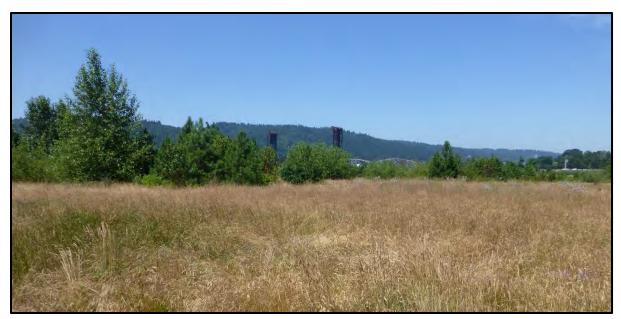
Photograph 3 – Eastern edge of the earthen cap looking toward the drainage swale. Taken looking west from Photograph Location 3. (June 2017)

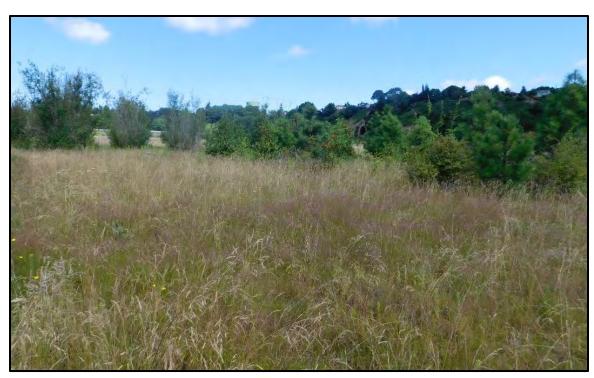
Photograph 5 – Tree plantings on the earthen cap. Taken looking north from Photograph Location 5. (June 2017).

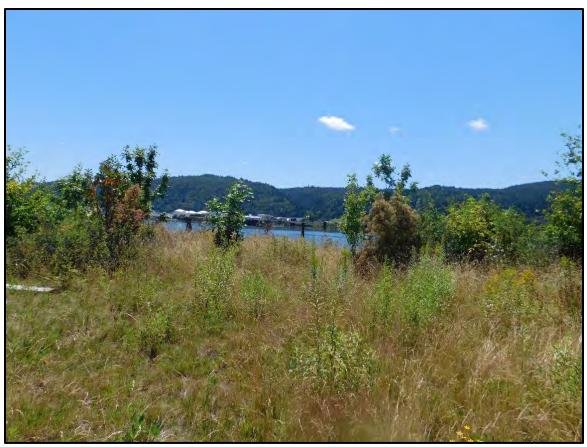
Photograph 8 – Upper riparian component with native trees and shrubs performing well. Taken looking southwest from Photograph Location 8. (June 2017)
