# **BASIN M VEGETATED INFILTRATION BASIN OPERATIONAL YEAR 4 ANNUAL SUMMARY REPORT**

## **Terminal 4 Slip 1**

**Port of Portland**

October 2025

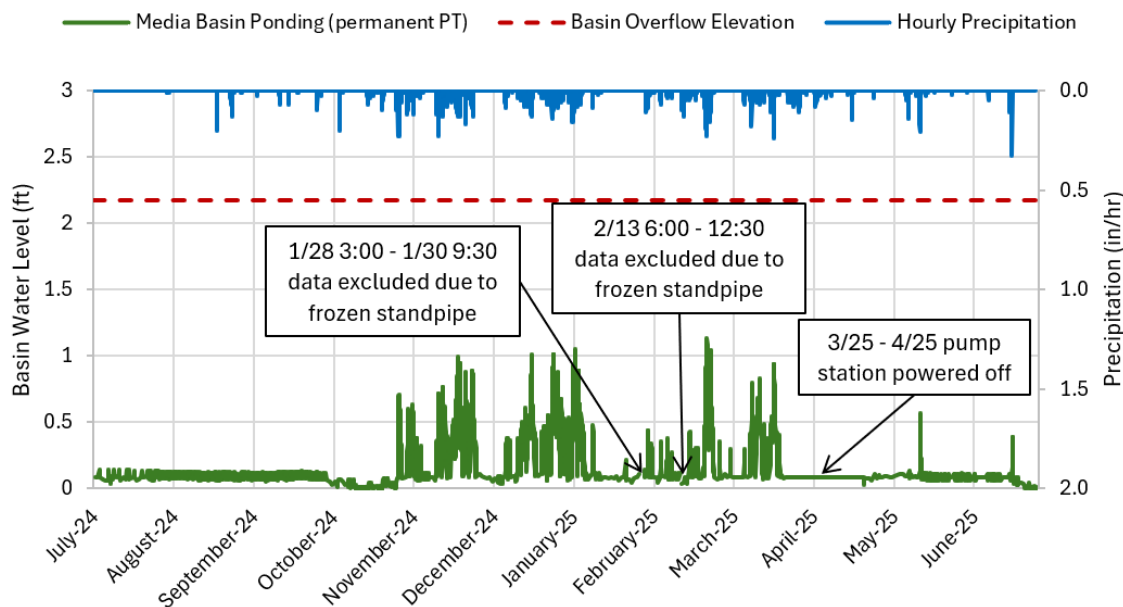
**Figure 3. Basin Ponding Depth Time Series**

Figure 3 highlights that no overflow occurred within the bioinfiltration basin during the period from 1 July 2024 to 30 June 2025.

The water level above the media exceeded 12 inches during one storm event throughout the reporting year, with a maximum water level of 13.6 inches during the 23 February 2025 storm event. The estimated maximum infiltration rate when the water level above the media was at least 12 inches was 23.7 inches per hour and the estimated average infiltration rate was 22.4 inches per hour.

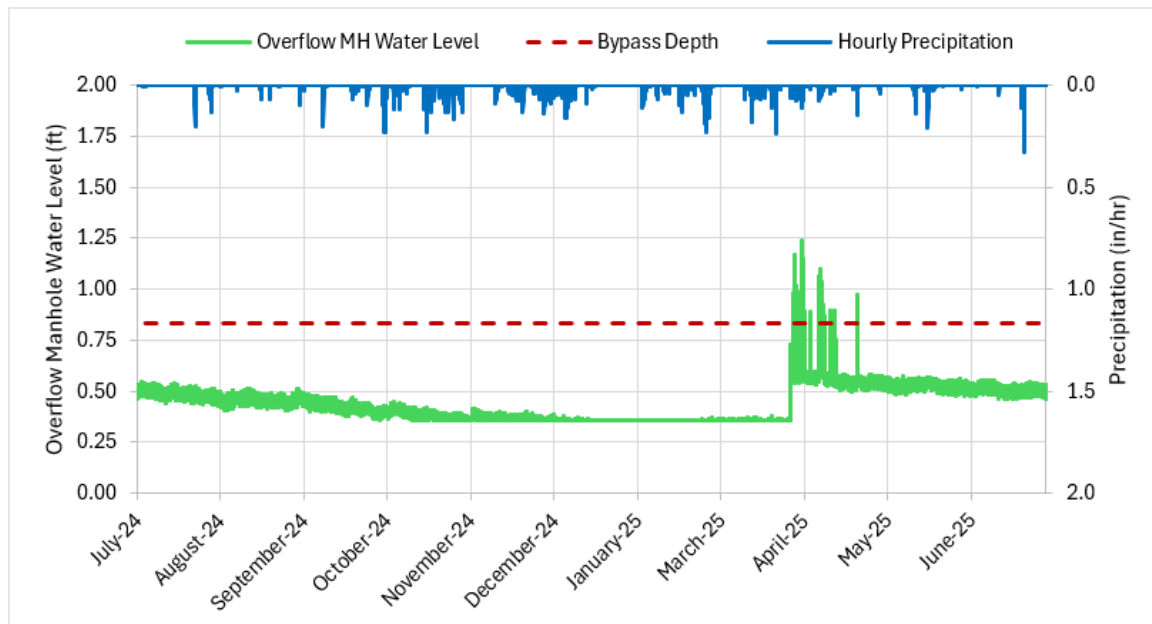
**Figure 4. Overflow Manhole Time Series**

Bypass at the diversion manhole only occurred during the month where the pumps were shut off due to power failure. During this time, bypass occurred approximately 12 times (Table 3).
