APPENDIX B

Daily Field Reports Continued

Phase II RA

OFFSITE REMOVAL ACTION - DAILY FIELD REPORT
JH BAXTER OFFSITE REMEDIAL ACTION
EUGENE, OREGON

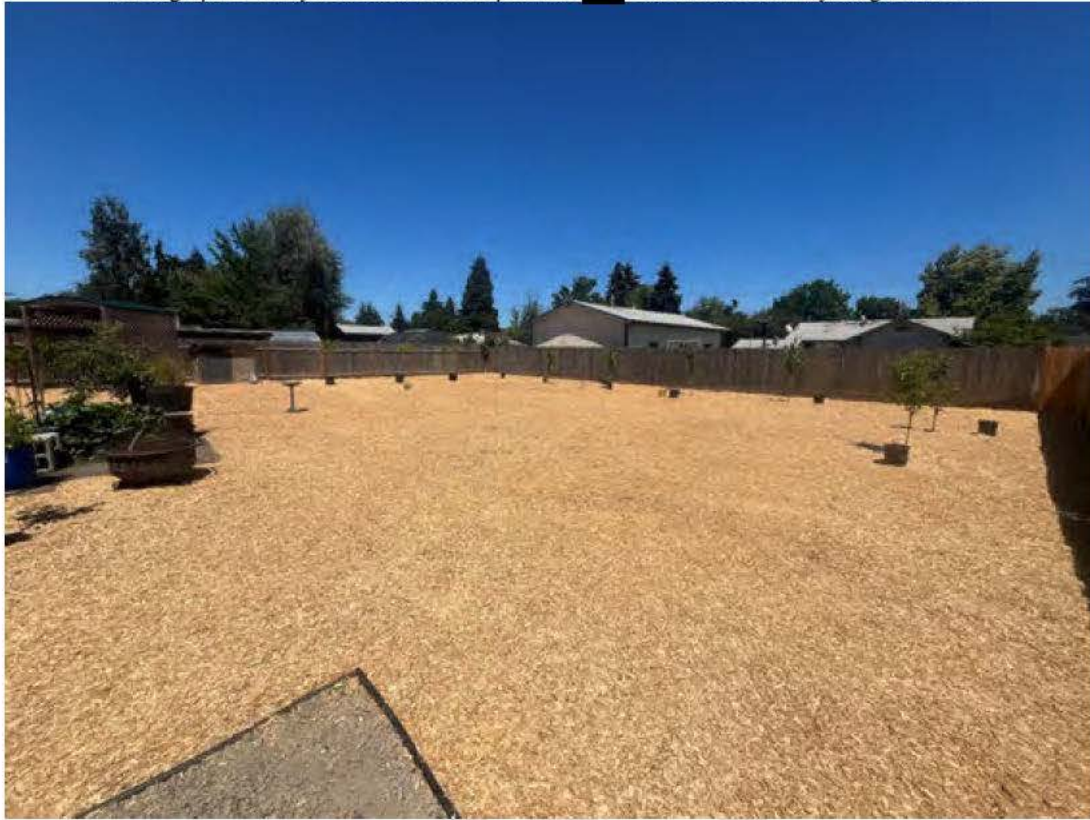
Photograph 20. Surface restoration completed at [REDACTED] Baxter. Photo taken facing northeast.
