Final Remedial Action Report

Former Astoria Marine Construction Company
DEQ Task Order 067-23-13
ECSI No. 1898
92134 Front Road
Astoria, Oregon

December 22, 2025

Maul Foster & Alongi, Inc.

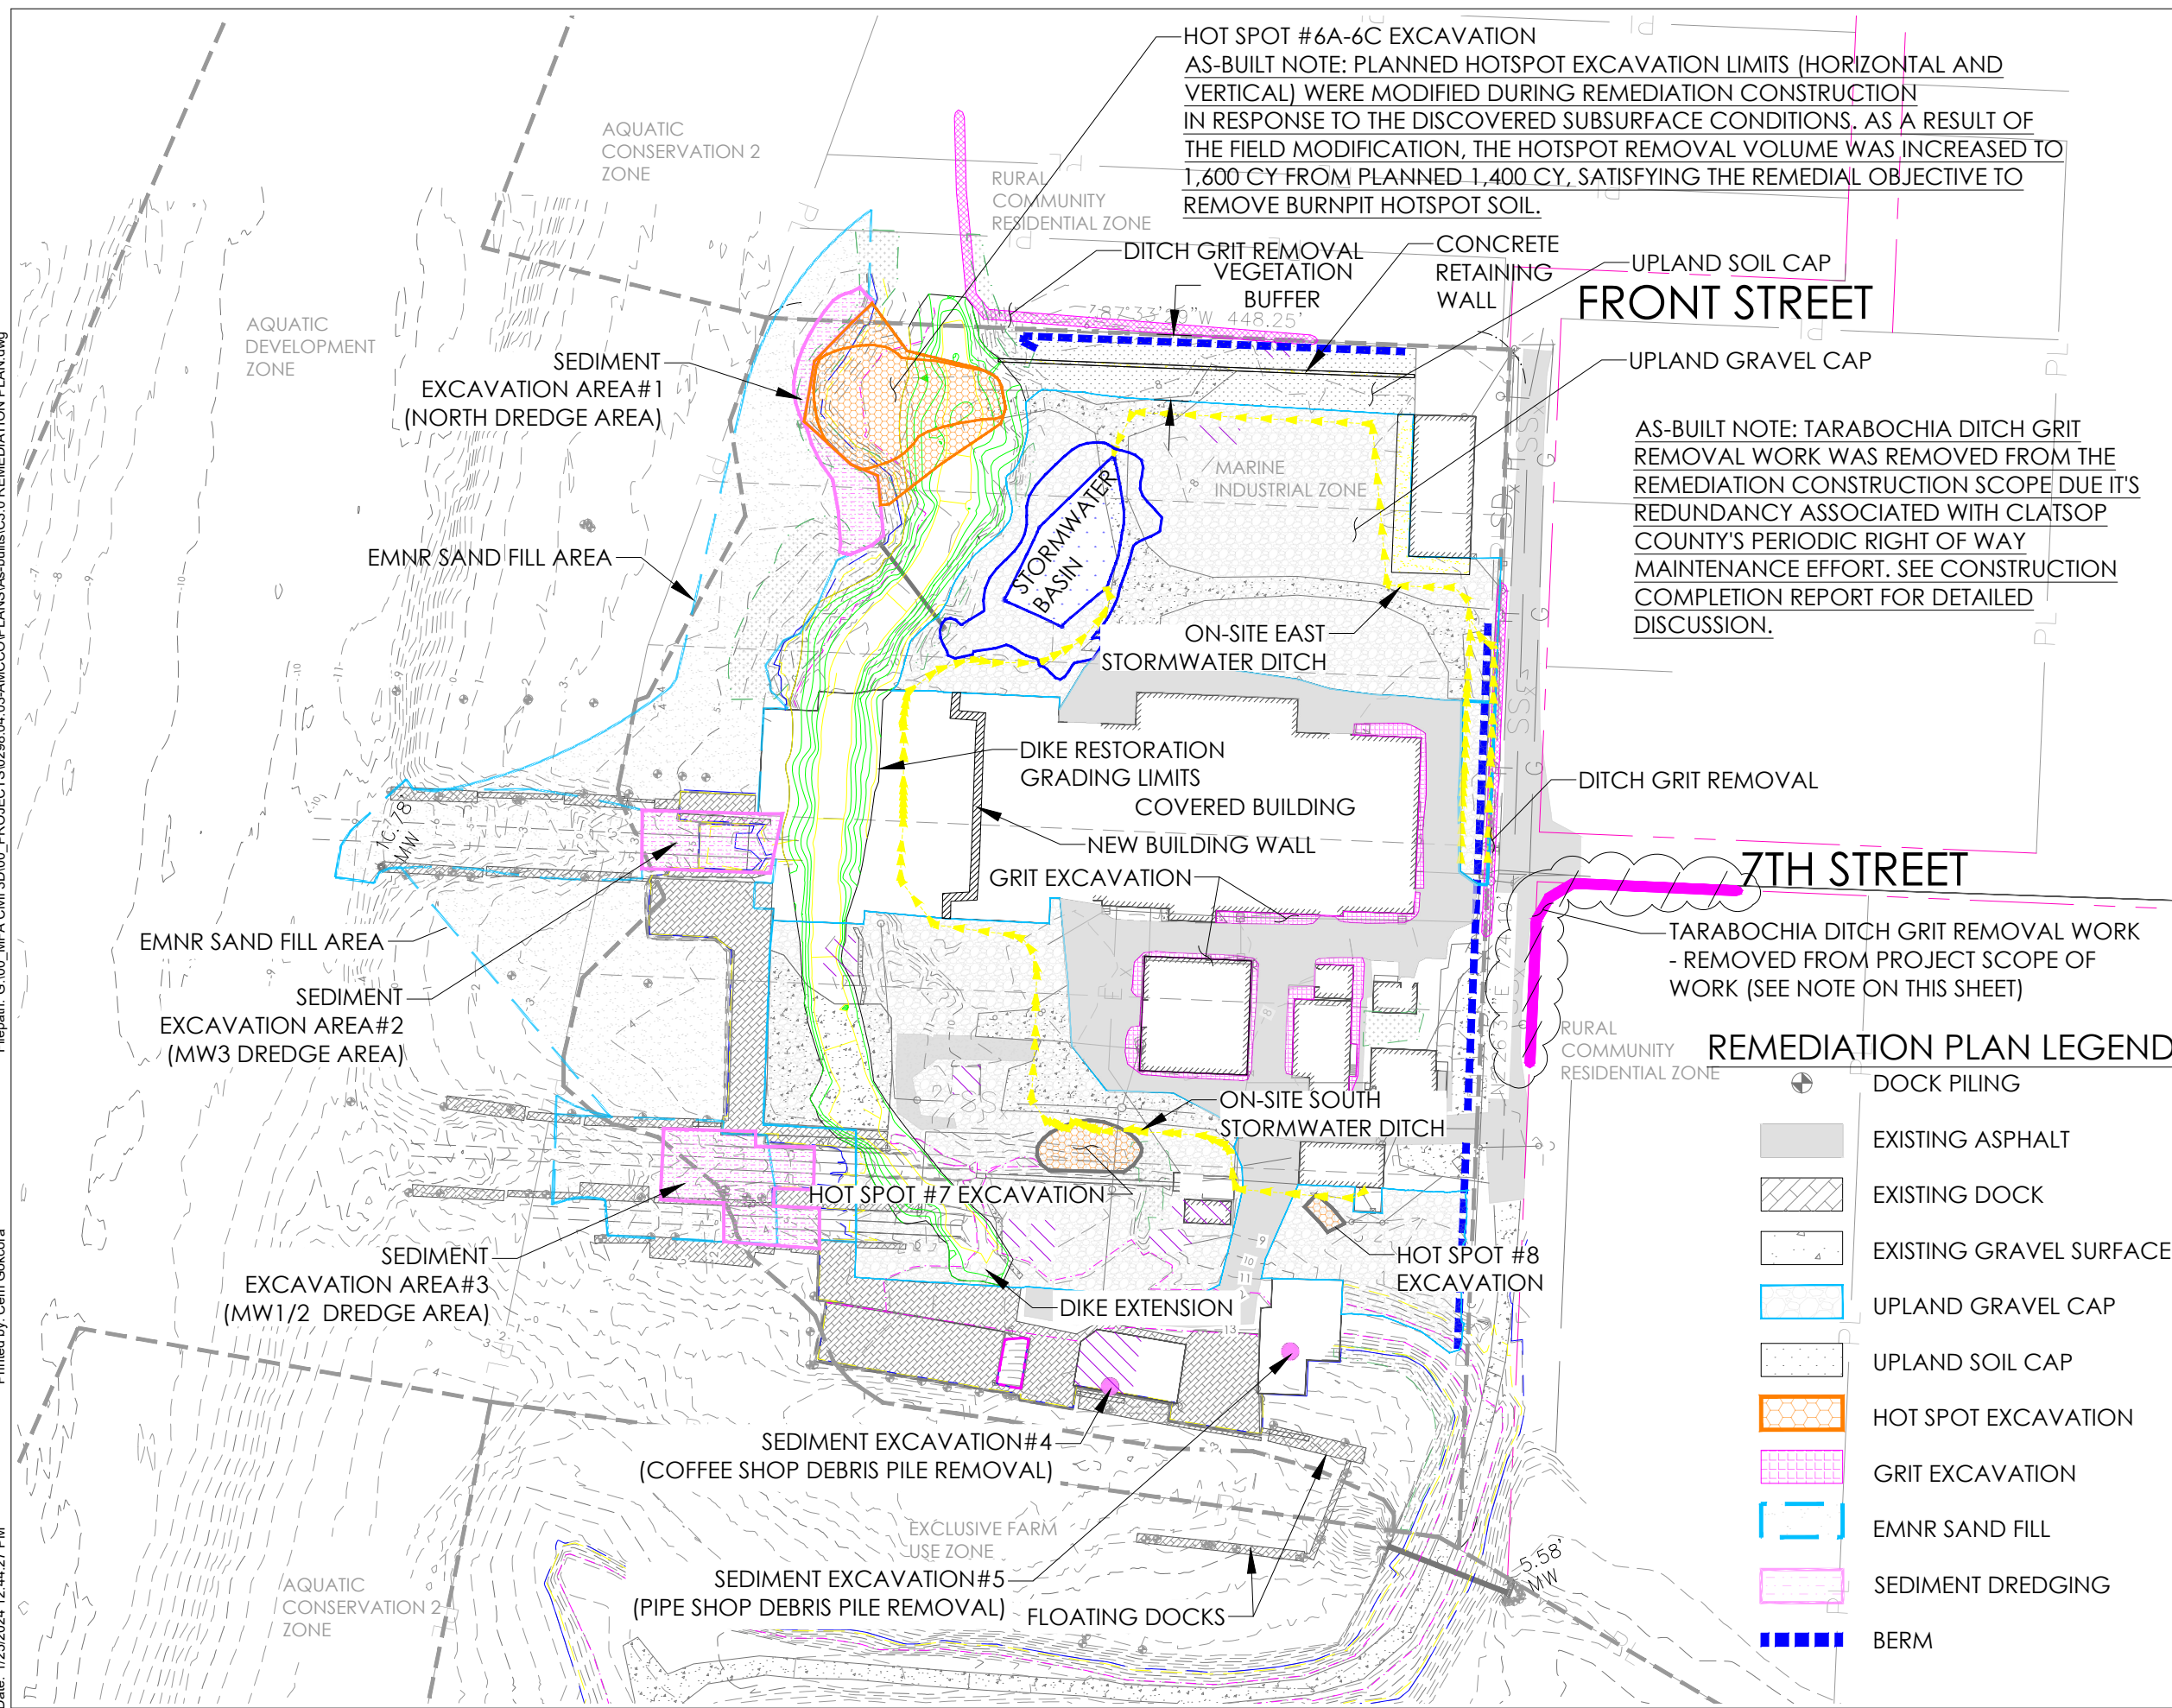
**Figure 1-3
 Master
 Remediation
 Plan**

Figure 1-3 shows locations of sediment and upland soil hot spot excavation areas. The selected RA consisted of the following elements:

2020—In consultation with and approval by DEQ, AMCCO performed a focused removal of debris piles early in 2020 to minimize potential erosion of contaminated solids that would have resulted from the removal of overwater structures protecting the debris piles (see Figure 1-3 for locations of debris piles) (MFA 2020b). Prior to removal activities, the Upland Contractor installed upland and water quality best management practices (BMPs) in related areas. Overwater building structure demolition work took place between February 1 and February 28, 2020. Following demolition of the pipe shop and partial demolition of the work shop/lunch room, debris piles located below the pipe shop and work shop/lunch room were removed and staged in an upland area that was located directly over one of the upland hot spots. The debris piles were later separated and removed from the Site and disposed with other excavated hot spot materials and dredge materials. The rest of the upland structures were demolished between February and June 2020.
